Airframe Entry - Aircraft SN: 145421

Package / Inspection

RECEIVED LH MAIN KANDING GEAR DUE FOR OVERHAUL. NO MAJOR DAMAGE EXTERNALLY NOTED.  
UNIT WILL BE OVERHAULED IN ACCORDANCE WITH LIEBHERR CMM 32-10-01

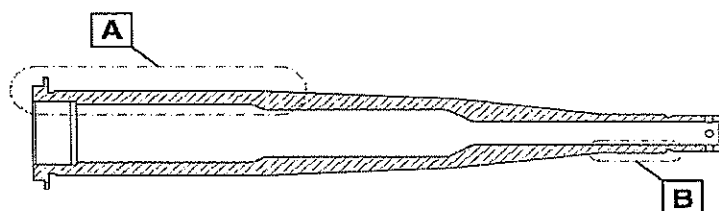
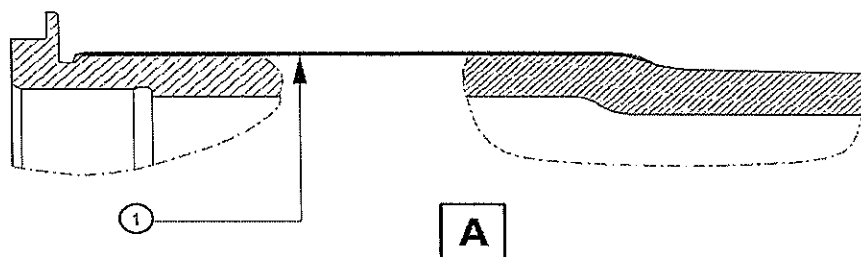
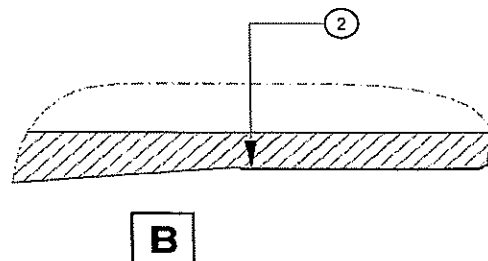
DIA (2) O/D  
HAS BEEN MACHINED U/S TO REMOVE CORROSION

| <p align="center"><b>Description</b></p> <p>To remove corrosion, the subject part's outer diameter (2) was machined beyond the post rework dimensions as indicated the drawing below. All other dimensions within CMM limits.</p> | | | | |

| <p align="center"><b>Proposed Resolution</b></p> <p>HPA proposes to:</p> <ul style="list-style-type: none"> <li>- Restore the OD to design dimension by chrome plating in accordance with Service Bulletin 145-32-0114, if the part is structurally acceptable.</li> <li>- Refinish will be completed per CMM.</li> </ul> | | | | |

3. If no cracks and corrosion is found, repair the axle according to SB 145-32-0114 or CMM TP 145/1170, section 601 instructions (whichever is applicable);

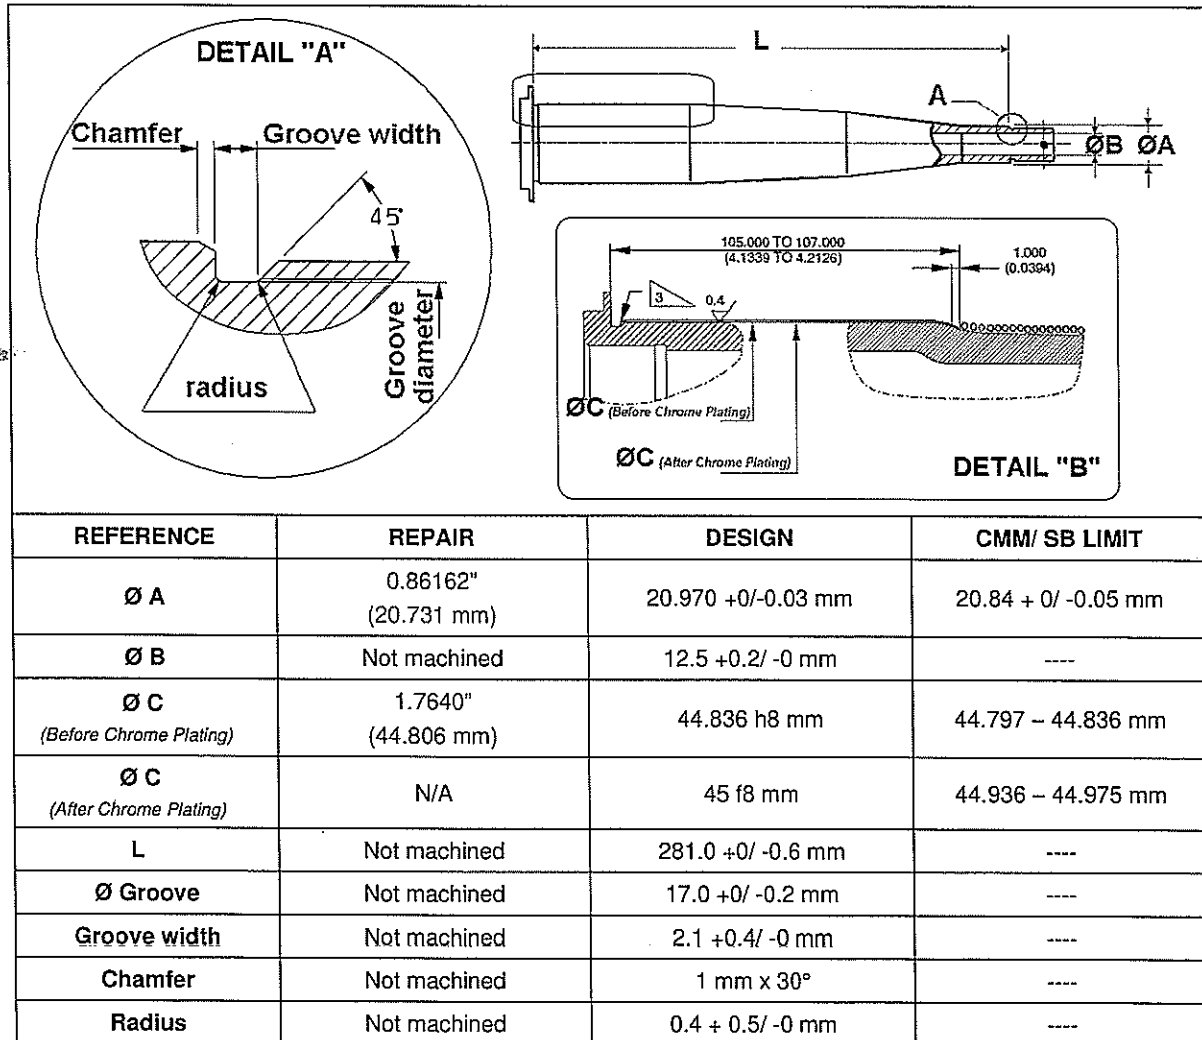
" To remove corrosion, the subject part's outer diameter (2) was machined beyond the post rework dimensions as indicated the drawing below. All other dimensions within CMM limits.

HPA proposes to:

- Restore the OD to design dimension by chrome plating in accordance with Service Bulletin 145-32-0114, if the part is structurally acceptable.
- Refinish will be completed per CMM."

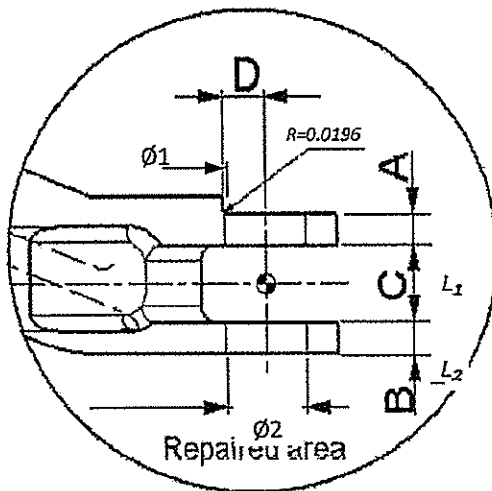
| DIA. (L2) & (6) MACHINED BEYOND CMM REPAIR LIMITS TO REMOVE CORROSION | | | |

| <b>Description</b><br>Lug thickness L2 machined undersize to remove corrosion.<br>All other dimensions within CMM limits. | | | | | |

| <b>Proposed Resolution</b><br>If structurally acceptable, HPA proposes:<br>- Perform NDT to ensure defect free condition.<br>- Fabricate and install repair bushings similar to 2309-5006-005 with over size flange to restore back to design dimensions.<br>- Complete rest of repair in accordance with CMM. | | | | | |

1. Perform a dye penetrant inspection in the repaired area according to CMM TP145/1170\_32-10-01 section 501;

2. If no cracks and corrosion are found, restore the protective surface coating as per CMM TP145/1170\_32-10-01;
3. Apply a coat of epoxy primer (BMS 10-11, Type I, Class A, Grade A, BAC452) to the bores ØA and ØB housing with a thickness from 0.007 to 0.015 mm (0.0003 to 0.0006 in), when dry, according to the item 4.D.(2) procedures;
4. Install the repair bushings according to CMM TP145/1170\_32-10-01 instructions;
5. In order to recover the design dimension, do the "Special Restoration" bore Ø C as follows:
  - a. Refer to reference # E, apply an uniform coating of the Epoxy Paste Adhesive, Hysol EA 9394 (Commercially Available) to the repaired bore ID;
  - b. Wait the curing time as per Technical Data Sheet requirements;
6. After curing time, drill the bore Ø C to the design dimension of Ø 8.00 +0.2 mm
7. Perform the remaining restoration activities according to CMM instruction.

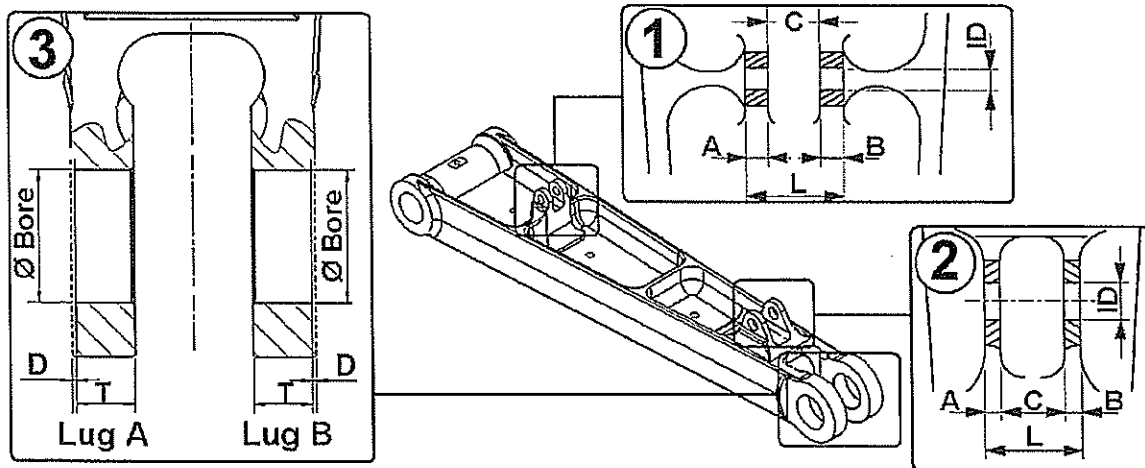
As reported by HPA through Reference # B, in order to remove corrosion, the MLG Upper Main Side Strut lugs needed to be machined according to dimension shown in the sketch and tables below:

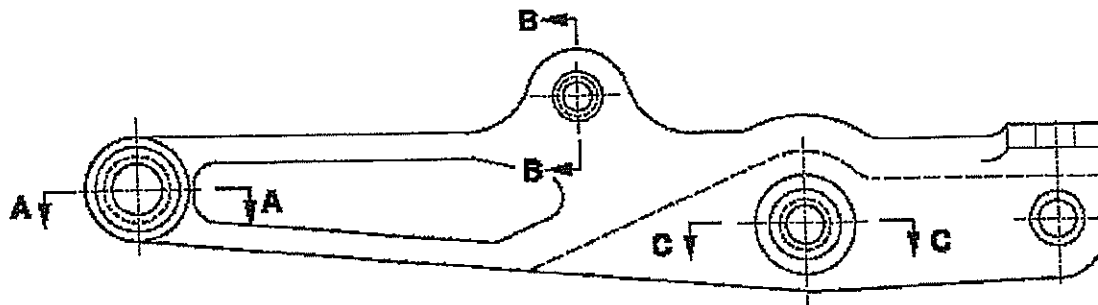
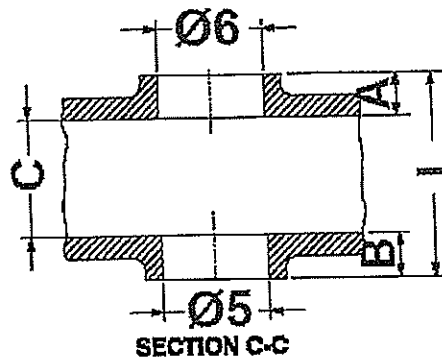
As per reported per reference # B, due to corrosion, the section "C-C" indicated in the figure below needed to be machined beyond CMM limits:

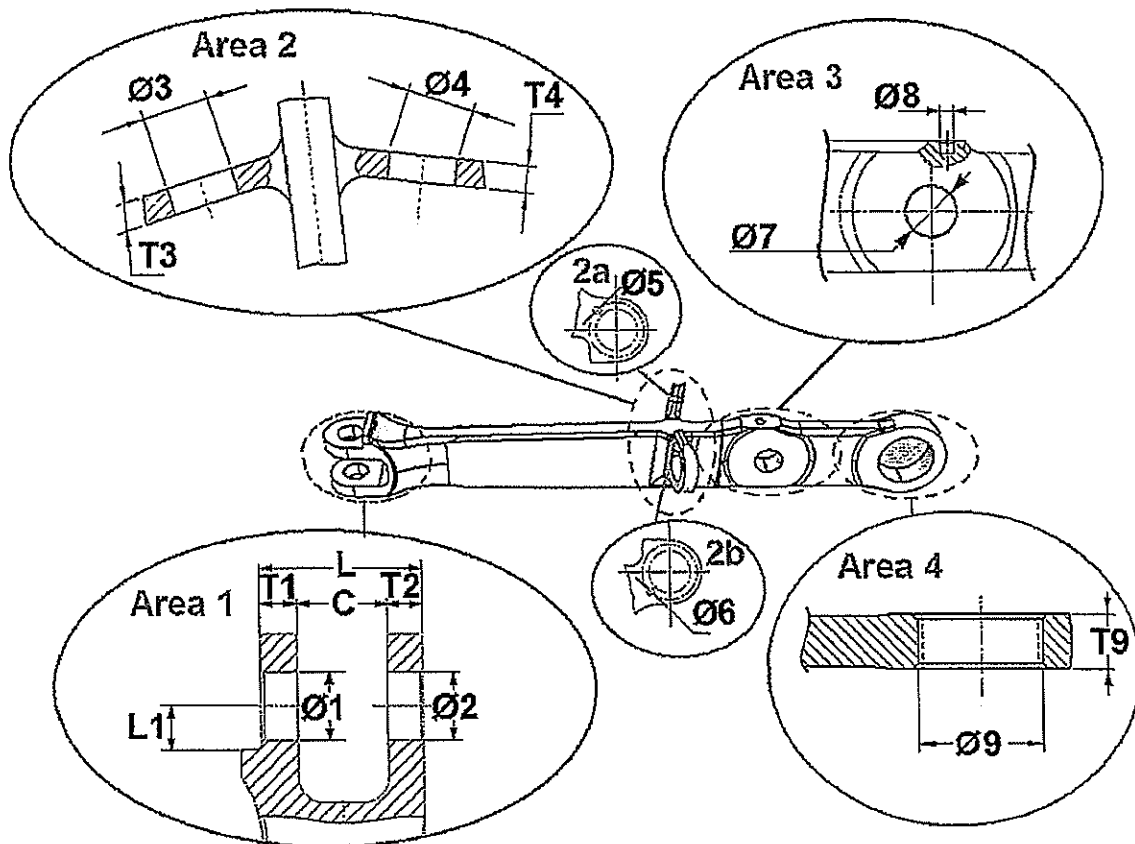
As per reported by Hawker Pacific Aerospace through reference # B, in order to remove corrosion from the bores, inner and outer lugs faces (refer to: Area 1), the subject Upper Secondary Side Strut was re-worked to the final dimensions as noted on the sketch and tables below:
