Location: Hood River, OR

# Underside Front Fuselage

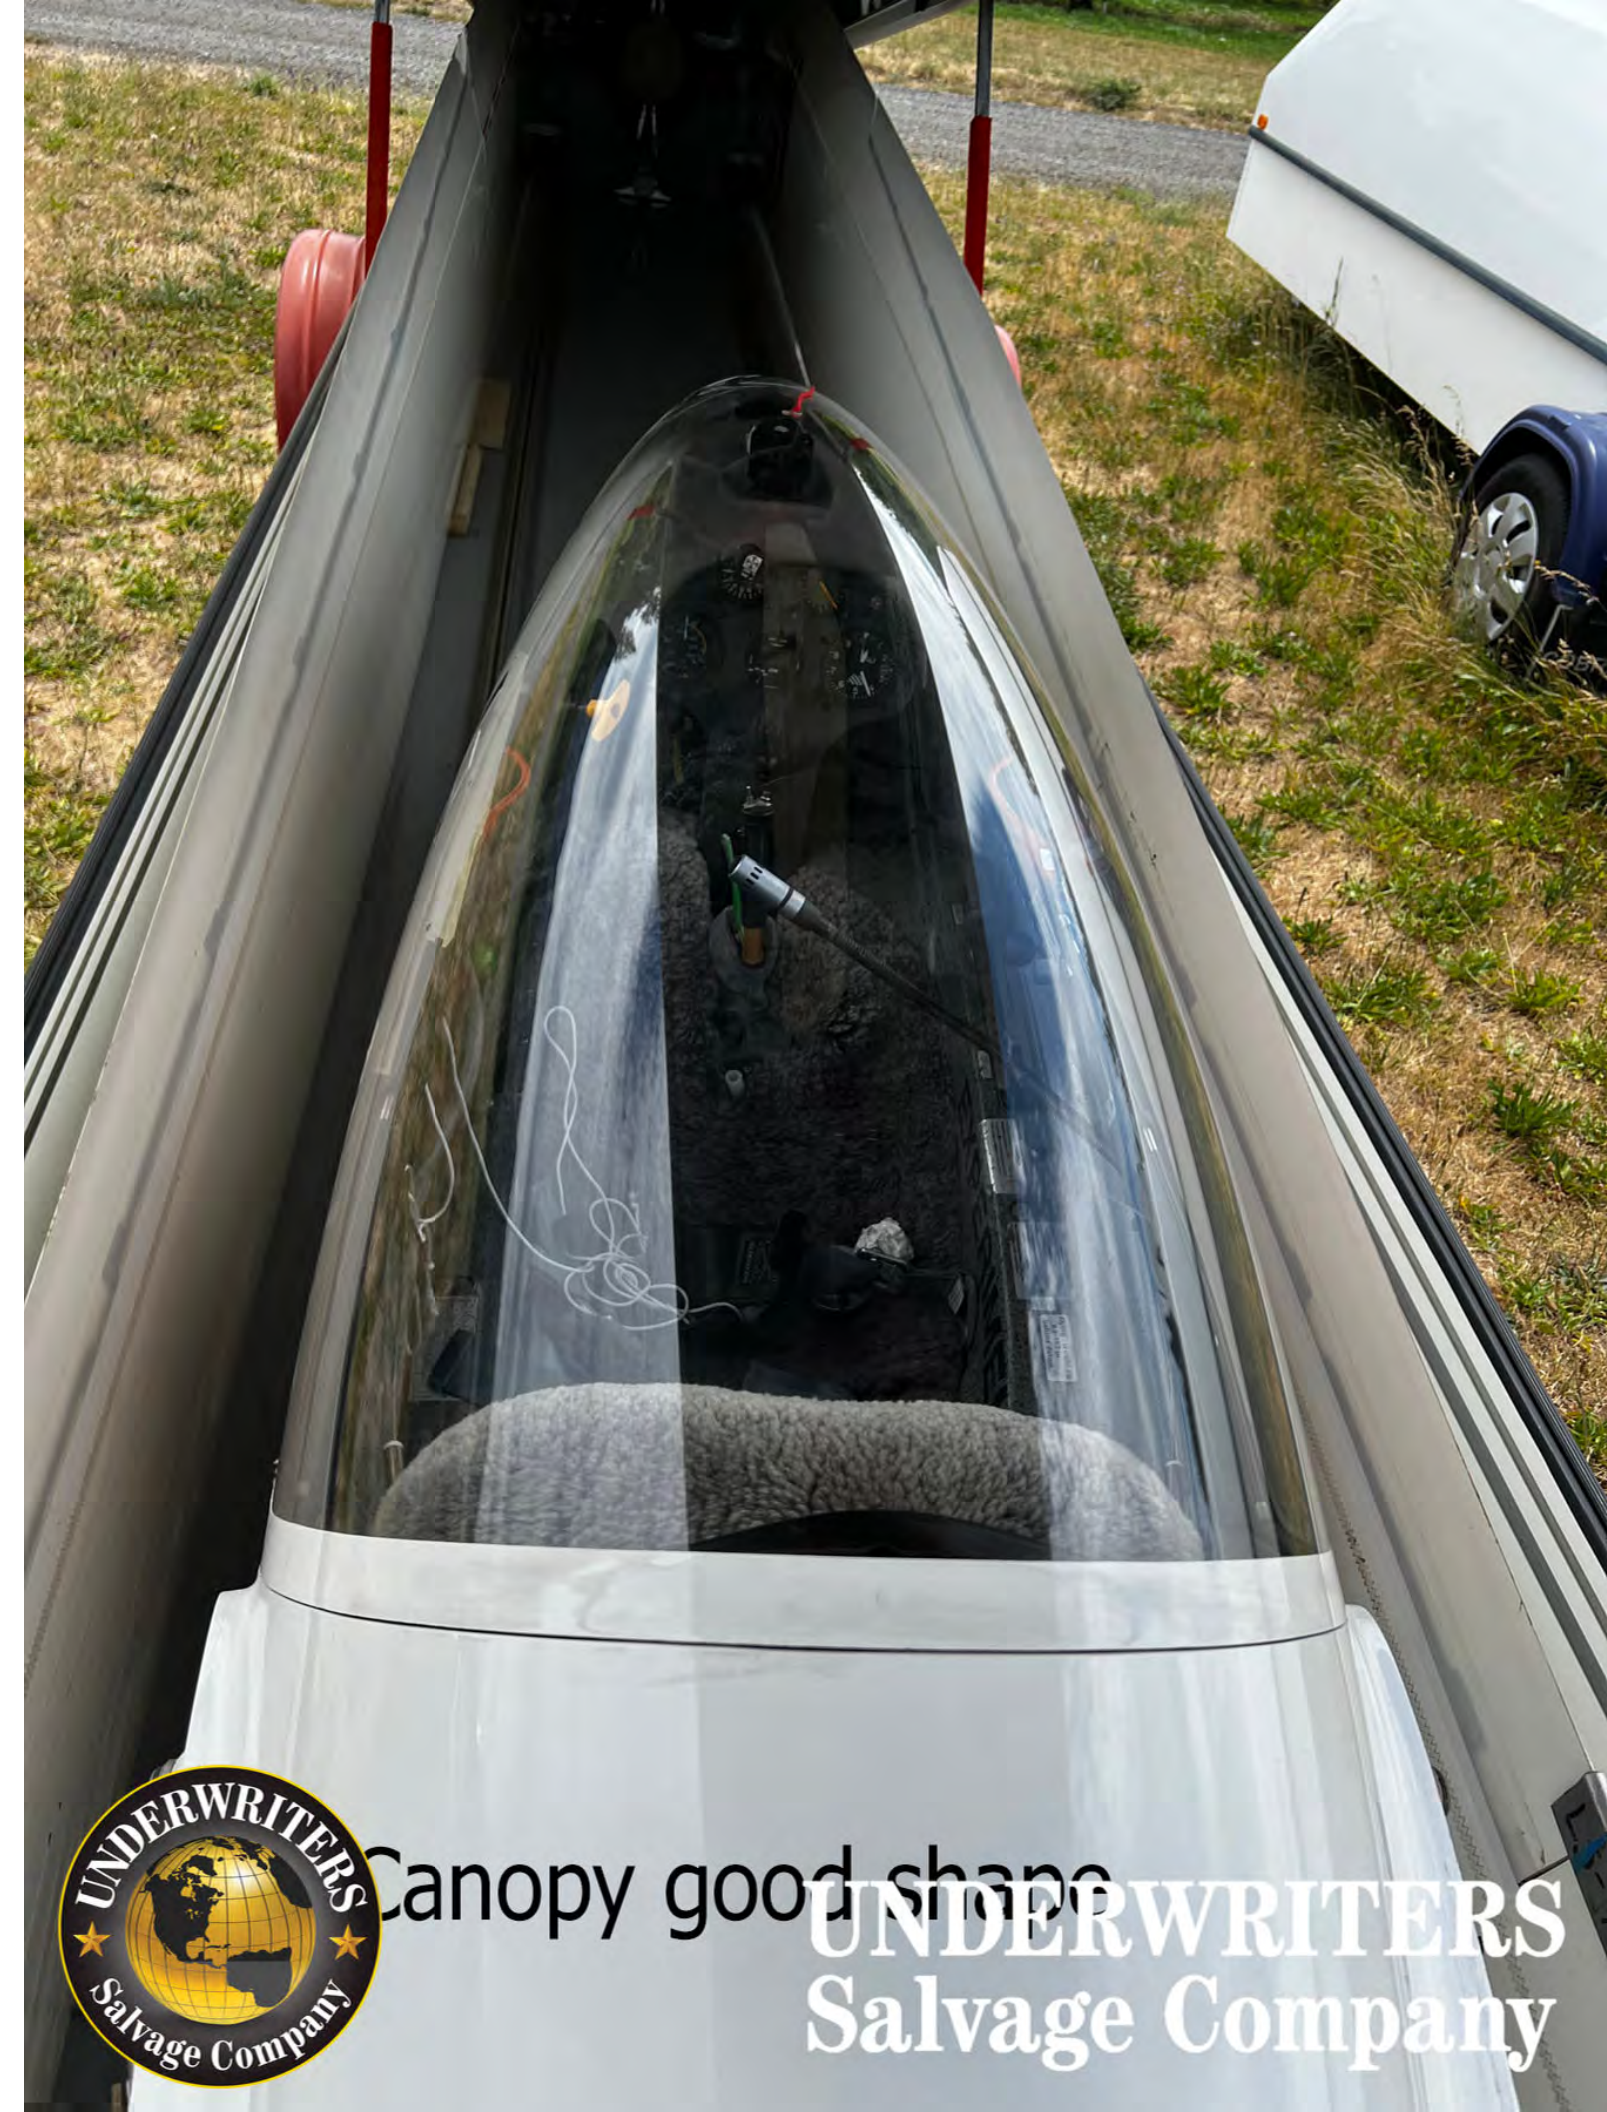
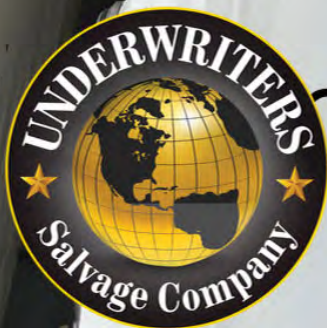
Canopy good shape
