National Transportation Safety Board

CEN22LA430

Group Chair's Factual Report

Helicopter: Leonardo AW139, registration N811TA

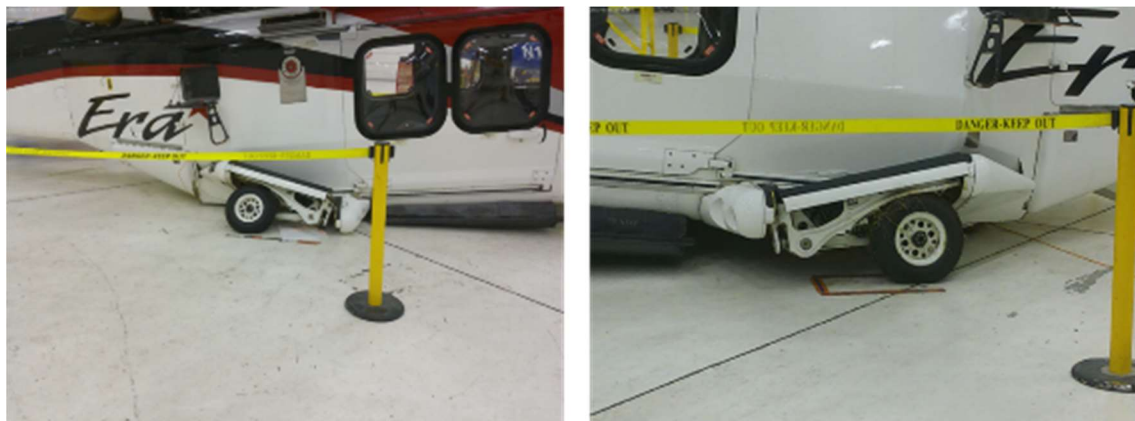
The main landing gear remained extended but collapsed (Photo 2).

Photo 2: N811TA's collapsed landing gear.

The left main¹ landing gear tire showed significant wear / loss of tread. (The accident helicopter had landed hard, at high speed, and departed the runway laterally at the end of the emergency landing.)

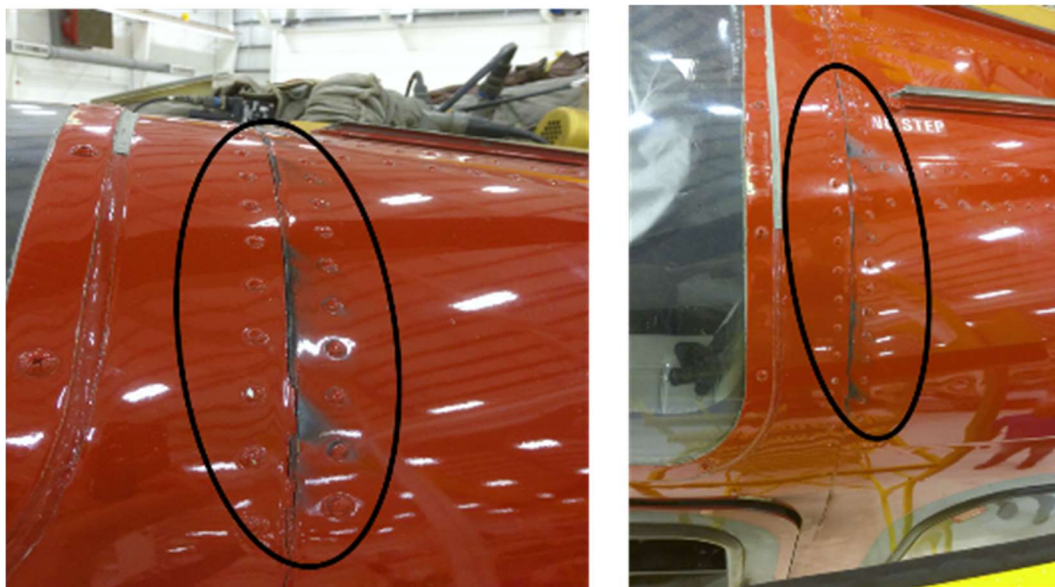
Photo 4: Thermal degradation along the rivet line

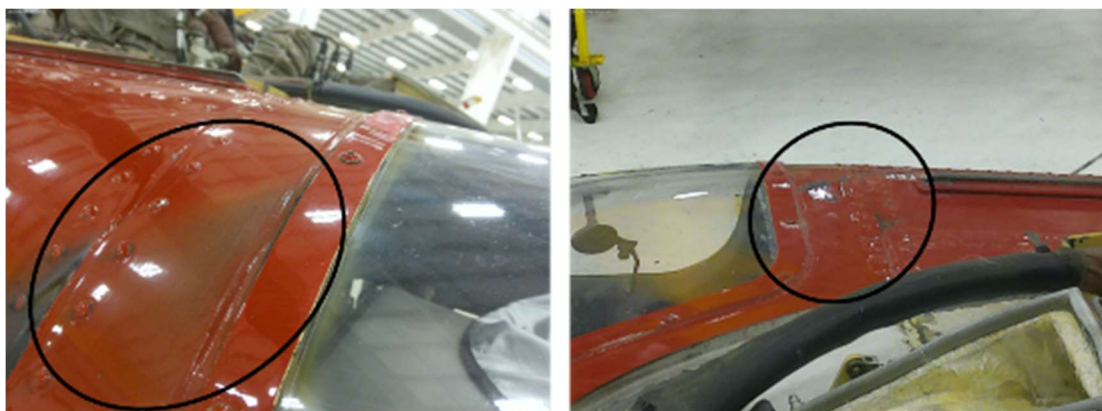
There was evidence of thermal degradation along the rivet line just aft of the

greenhouse where the cockpit joins to the fuselage, above the mixing unit (Photo 3 and Photo 4).

Photo 3: Soot and thermal degradation behind the greenhouse (Photo modified by NTSB).

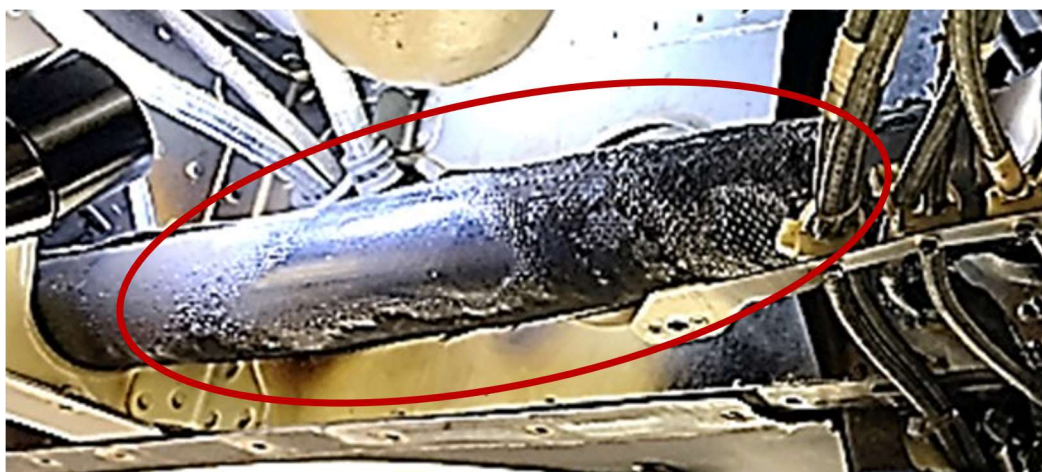
C3 exhibited evidence of thermal damage; there was a visible longitudinal split in the carbon fiber the length of the tube, and the exposed fibers were brittle and sooted (Photo 5). A test with no hydraulic power, or boost, applied while manipulating the collective control was conducted by moving the collective control between its minimum and maximum stops, and observing the torque tube. C3 did not exhibit fragmentation and remained installed at both ends, with fasteners installed and intact. Limited transfer of rotation was observed between the pilot (right seat) collective control and the mixing unit, as the outboard end of collective tube C3 was twisting while the inboard end (by the mixing unit) did not; rather, C3 deformed torsionally. In a typical AW139 helicopter, because the flight controls are hydraulically assisted, no motion of the cockpit flight control system should be possible without hydraulic pressure.

Photo 5: Collective Flight Control Torque Tube C3.

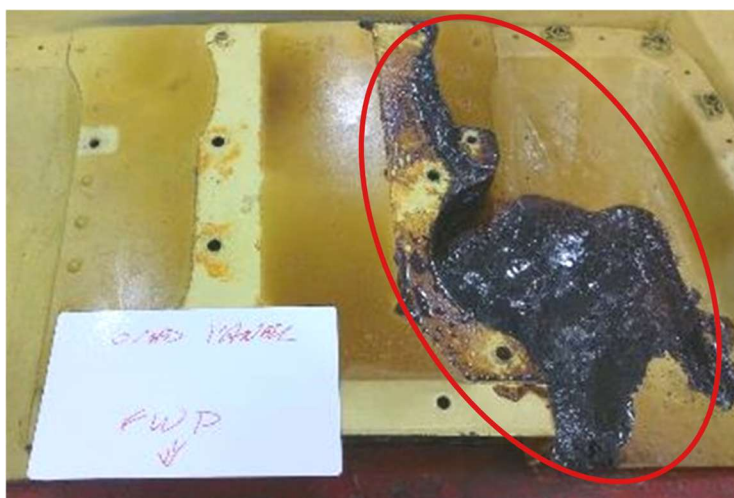
There was no evidence of thermal damage to control rod C2. Sooting was present laterally along the overhead adjacent to C3 and the panels that covered it, in addition to melted resin from C3 (Photo 6).

Photo 6: Melted Resin from C3 onto the Overhead Panel

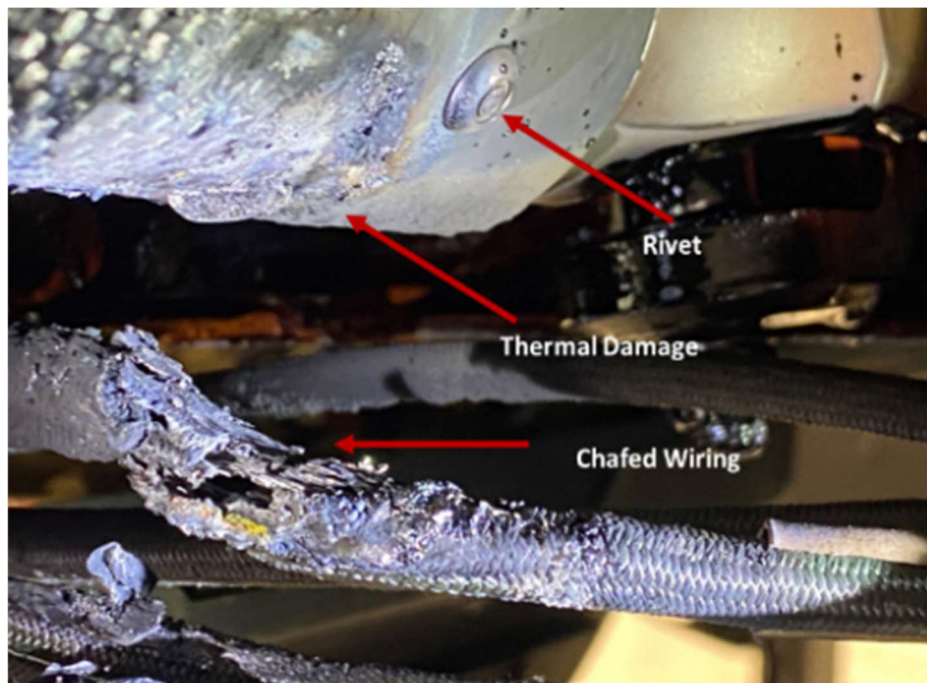
The AW139 is powered by two, 30 volt (V) 300 ampere (A) DC generators. Wire P190A6-G (3G9B11A1911) receives power from the No. 1 generator through Terminal T3 on the No. 1 Diode Module and supplies it to distribution bar No. 5 on Essential Bus No.1 in the cockpit overhead. It was found chafed through its insulation and contacting the collective torque tube C3 (Photo 7). The chafed area was in-line with a rivet line running circumferentially on C3.

Photo 7: Rivet Line On, And Damage To, C3. Chafed Wire P190A6-G

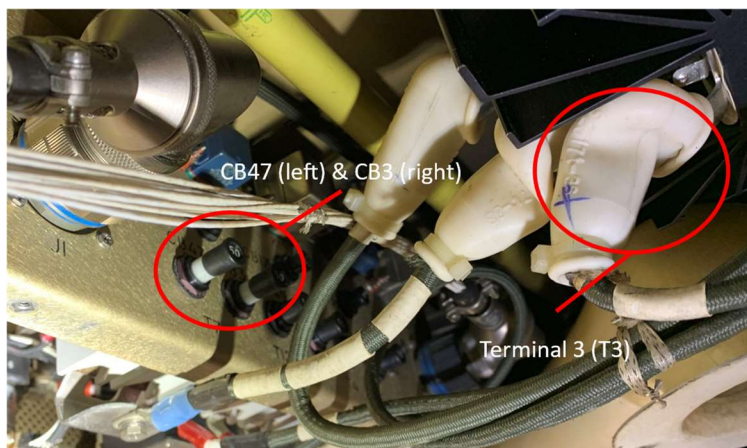
Circuit Breakers 47 and 3 (50 amps each) on Terminal Block 7 in the Power Distribution Panel (PDP) No. 1 were found extended (Photo 8). The Essential Bus Tie (ESS BUS TIE) circuit breaker on the overhead panel was also extended.

Photo 8: Circuit Breakers (CB) 3 and 47, And Terminal 3 (T3) on PDP No. 1

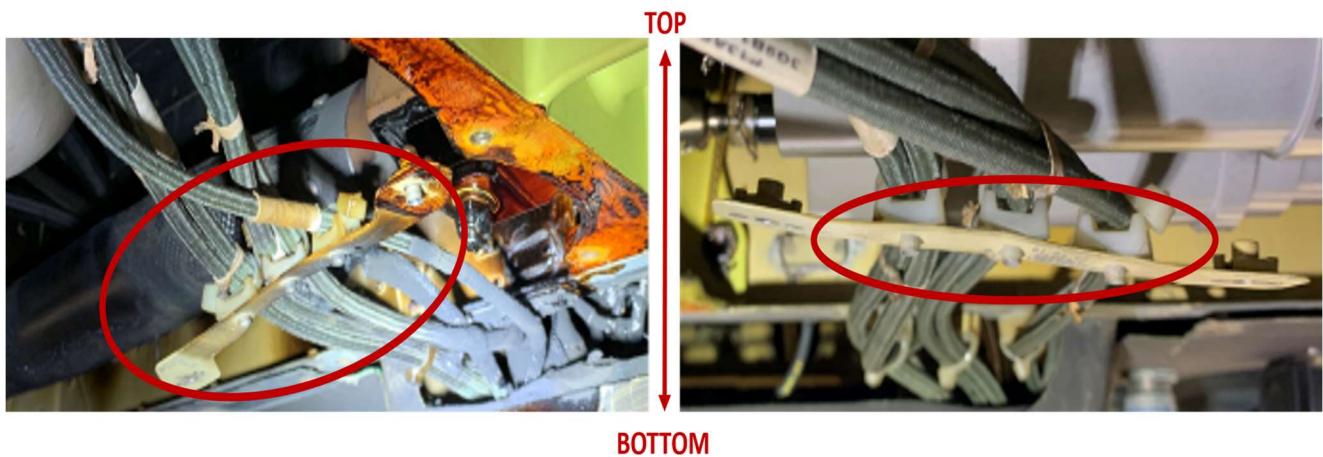
On the accident helicopter, the retaining clips were oriented such that the wire bundles on both the left and right sides were routed over the support strips (Photo 10).

Photo 10: Incorrect Support Strips, Left and Right, as Installed on the Accident Helicopter (Modified by NTSB)

On the accident helicopter, the electrical supports and nut plates were both mounted on the same [upper] side for both the left and right strip assemblies.

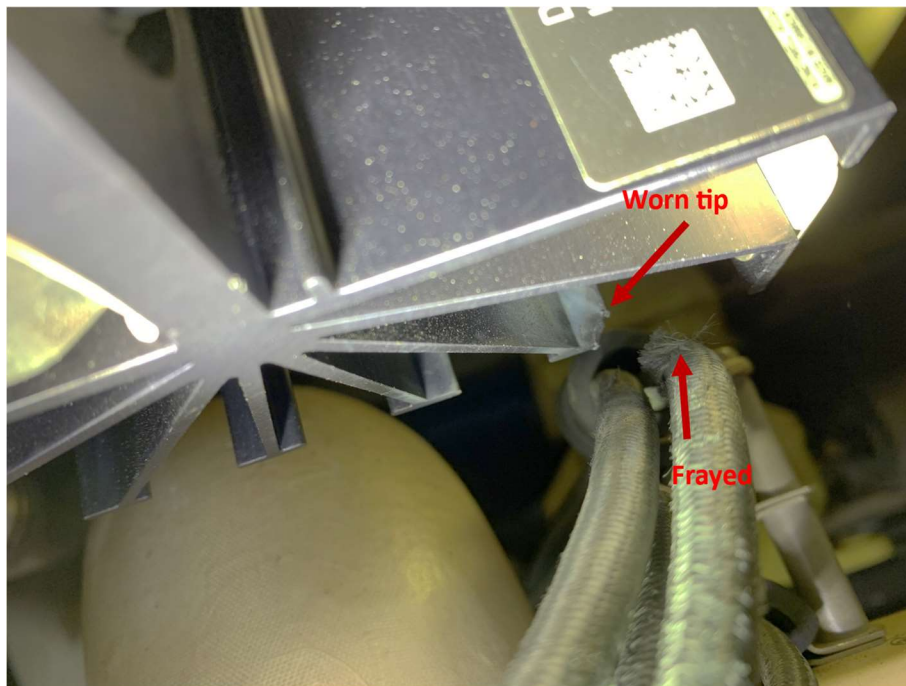
The same wire was found chafed further aft in the main cabin overhead, rubbing against the lower outer corner of a cooling fin on the No. 1 Diode Module (labeled A77) (Photo 11). The external sheathing to the wire was damaged, but no internal wiring was exposed.

Photo 11:No.#1 Diode Module with Worn Fin Tip and Chafed Wire

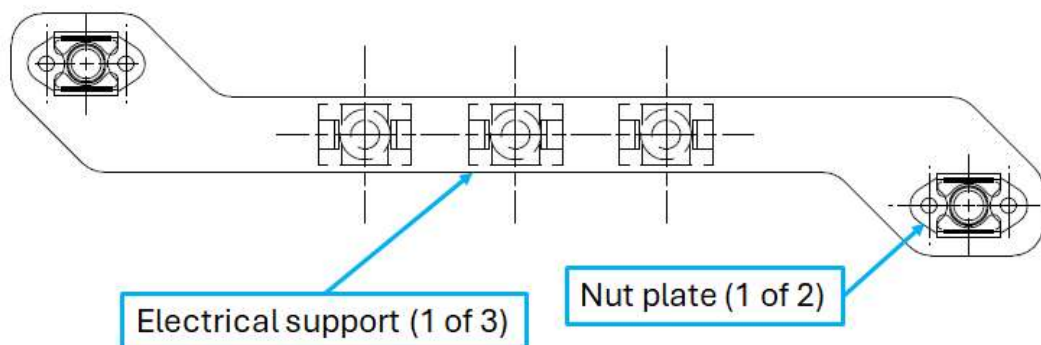
At the time of its manufacture, the manufacturing job card for the left side wiring support strip assembly, No. 3P5315A10531, contained only a single planform view of the strip assembly. Figure 8 shows an excerpt of this view taken from the manufacturing job card for the left side strip assembly. According to Leonardo, the solid [drawing] lines for the nut plates³ versus the dashed [drawing] lines for the electrical supports⁴ inferred that the electrical supports were mounted on the side opposite that of the nut plates.

Figure 8. The single view of the left strip assembly in its manufacturing job card. (Courtesy of Leonardo, modified by NTSB)

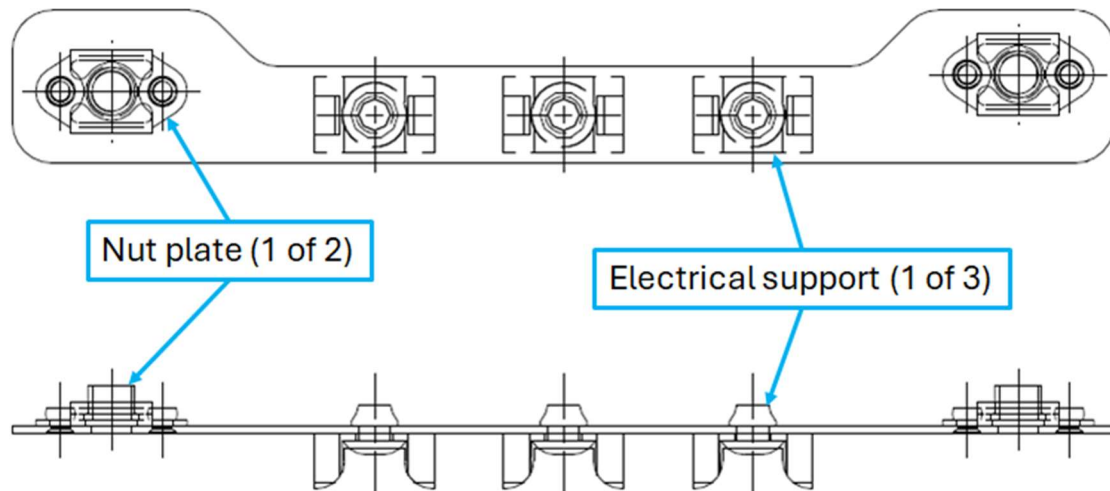
At the time of its manufacture, the manufacturing job card for the right side wiring support strip assembly, No. 3P5315A12931, contained two views of the strip assembly. Figure 9 shows an excerpt of this view taken from the manufacturing job card for the right side strip assembly. These two views of the strip assembly distinctly show that the electrical supports were mounted on the side opposite that of the nut plates.

Figure 9. The two views of the right strip assembly in its manufacturing job card. (Courtesy of Leonardo, modified by NTSB)
