AIRCRAFT DAMAGE ASSESSMENT REPORT

Model:	SF50	Registration:	N184AS	Serial:	0585	Hobbs:	114.1	Flight Hours:	95.4
Location:	KLOZ London, KY			A/C Operator:					
Work Order #:	DLH23637-06-2025			Date of Damage:	5/16/2025				
Cirrus Case #:	00449020			Report Completed:	6/9/2025				
Inspector:		Phone:		Email:					
DOM:		Phone:		Email:

Hangar Collapse Due to Tornado

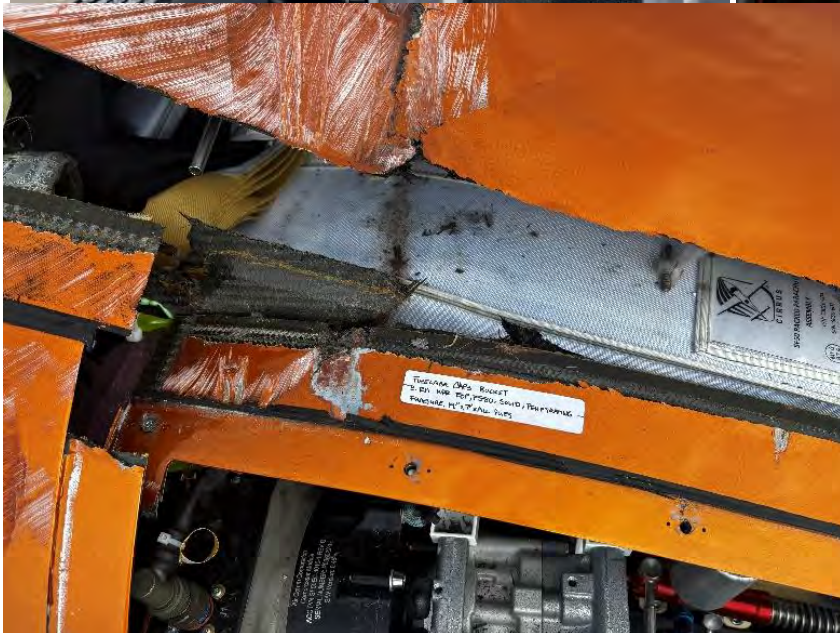
2. Fuselage - CAPS Bucket, RH UPR EOP, FS80 / Sandwich Structure - Laminate Only - Penetrating - Fracture / 19" x 7", All Plies.

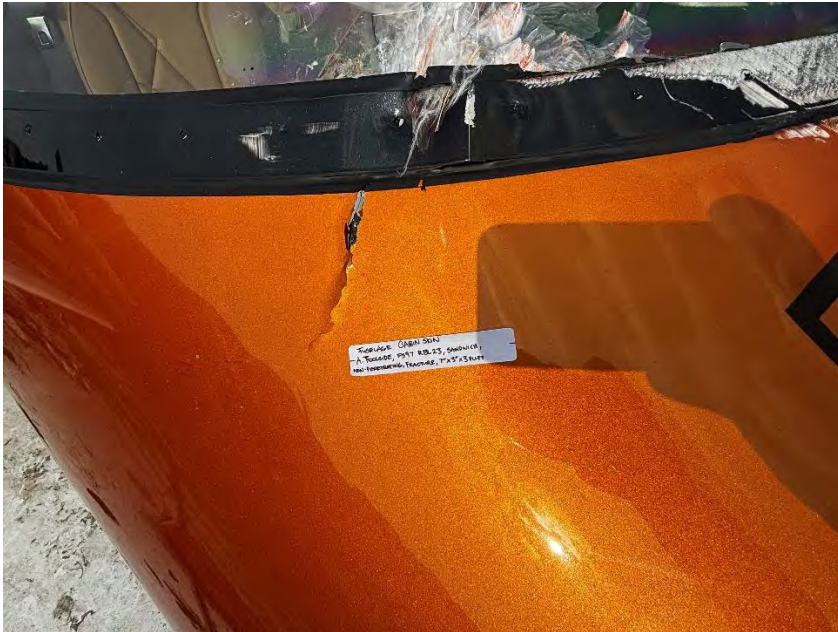
4. Fuselage - Cabin Skin, FS97 RBL23, Toolside / Sandwich Structure - Laminate Only - Non-Penetrating - Fracture / 7" x 3", 3 Plies.

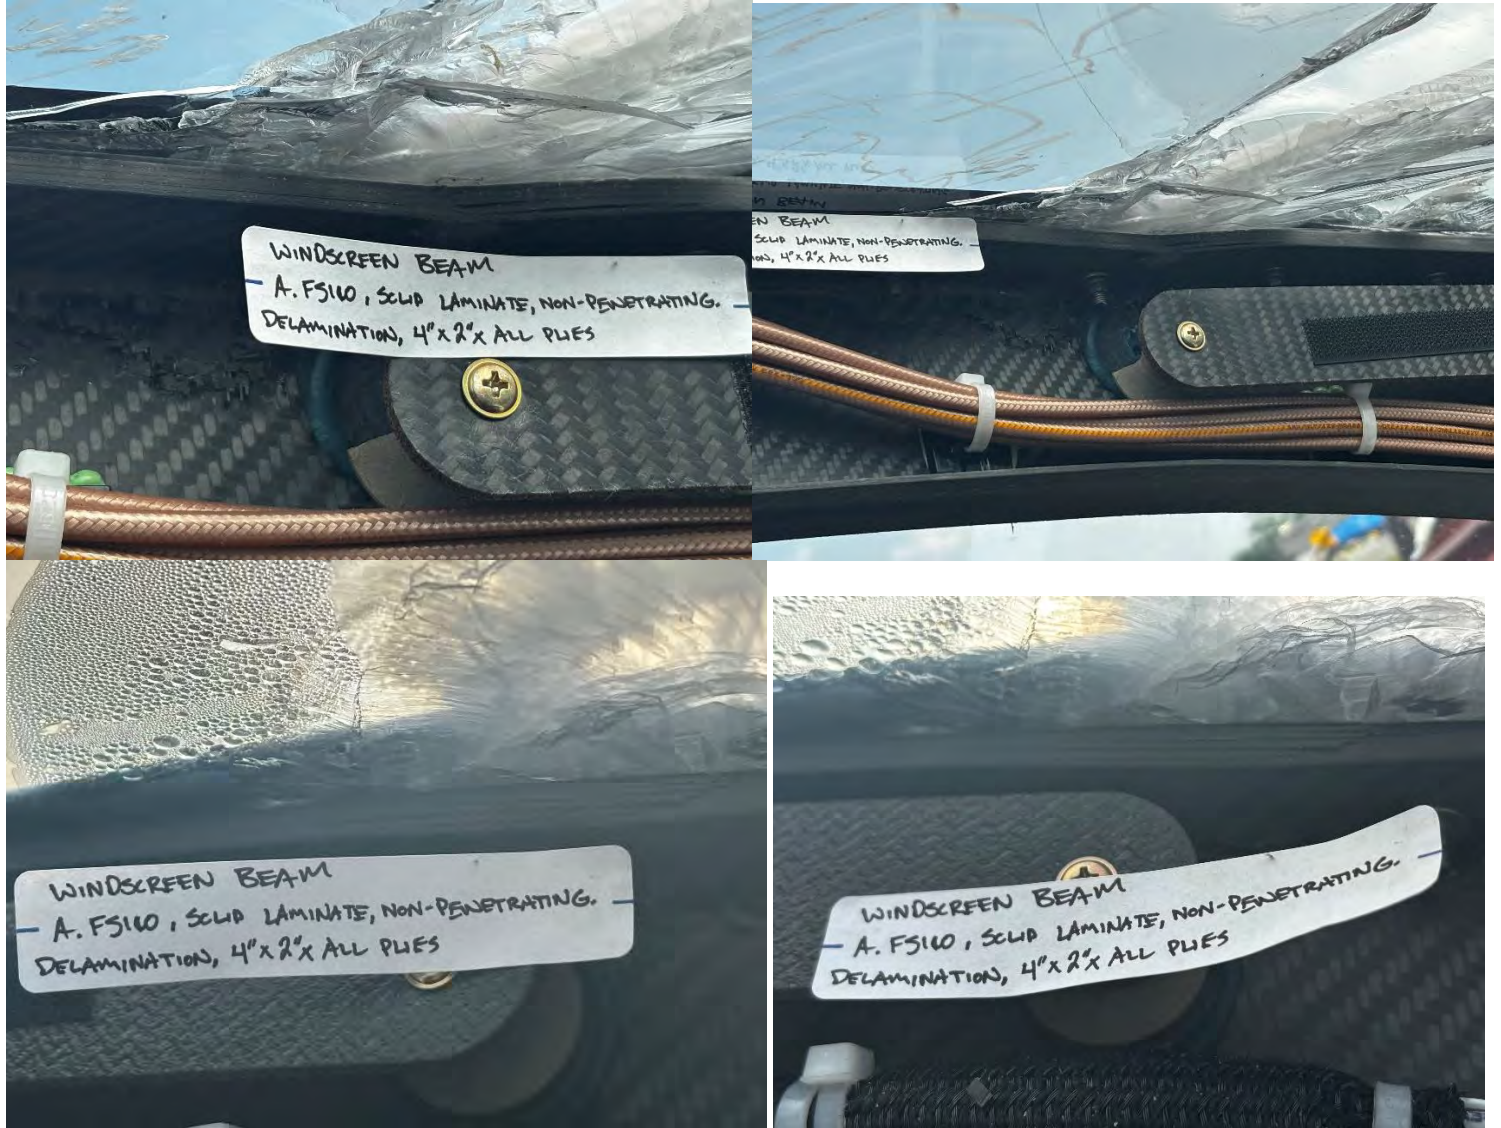
6. Fuselage - Windscreen Beam, FS110 / Solid Laminate - Non-Penetrating - Delamination / 4" x 2", All Plies.

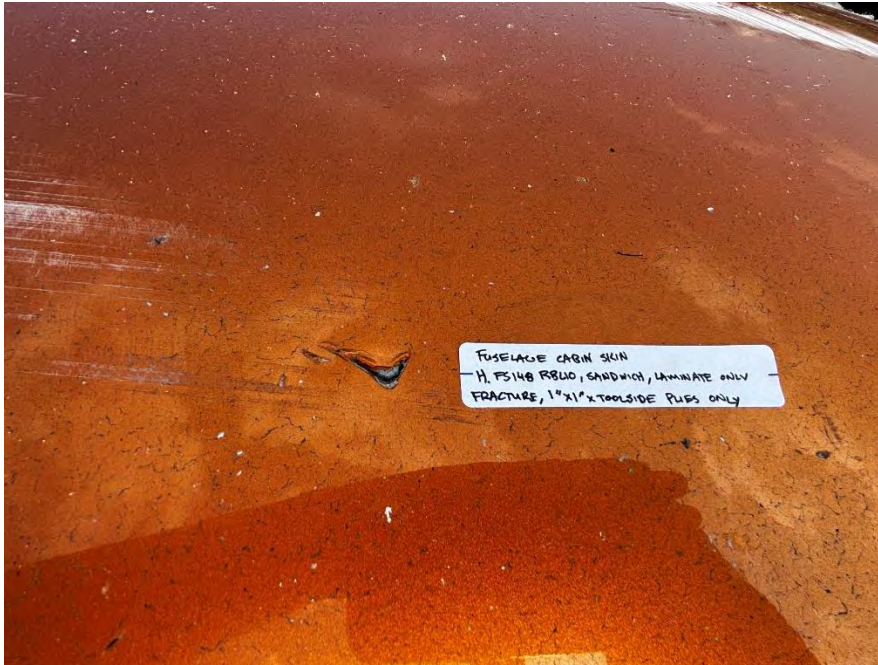
17. Fuselage - Cabin Skin, FS148 RBL10, Toolside / Sandwich Structure - Laminate Only - Non-Penetrating - Gouge / 1" x 1", Toolside Plies Only.

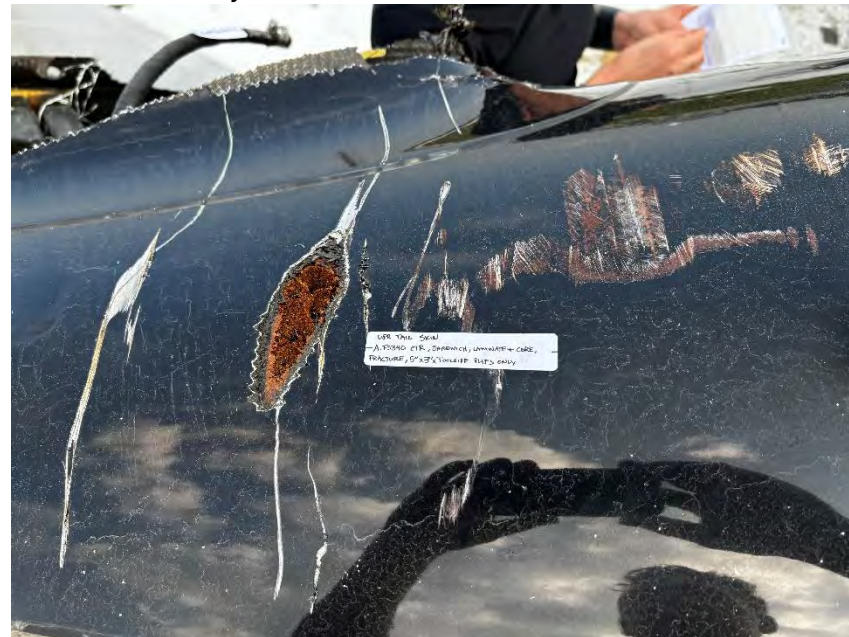
18. Fuselage - UPR Tail Skin, FS340 CTR / Sandwich Structure - Laminate Only - Non-Penetrating - Fracture / 5" x 3", Toolside Plies Only.

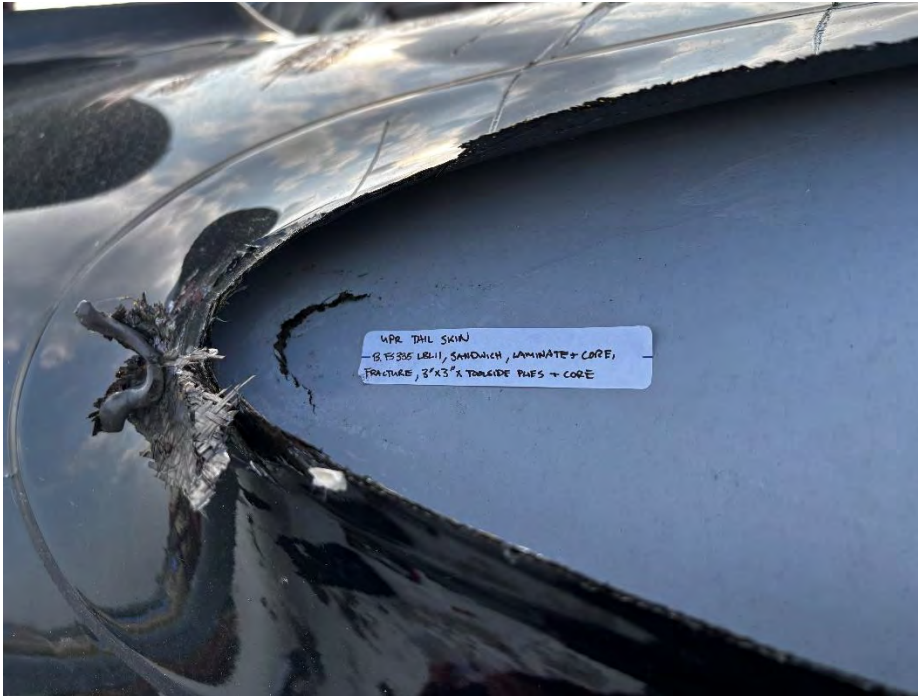
19. Fuselage - UPR Tail Skin, FS335 LBL11, Toolside / Sandwich Structure - Laminate Only - Non-Penetrating - Fracture / 3" x 3", Toolside/Core.

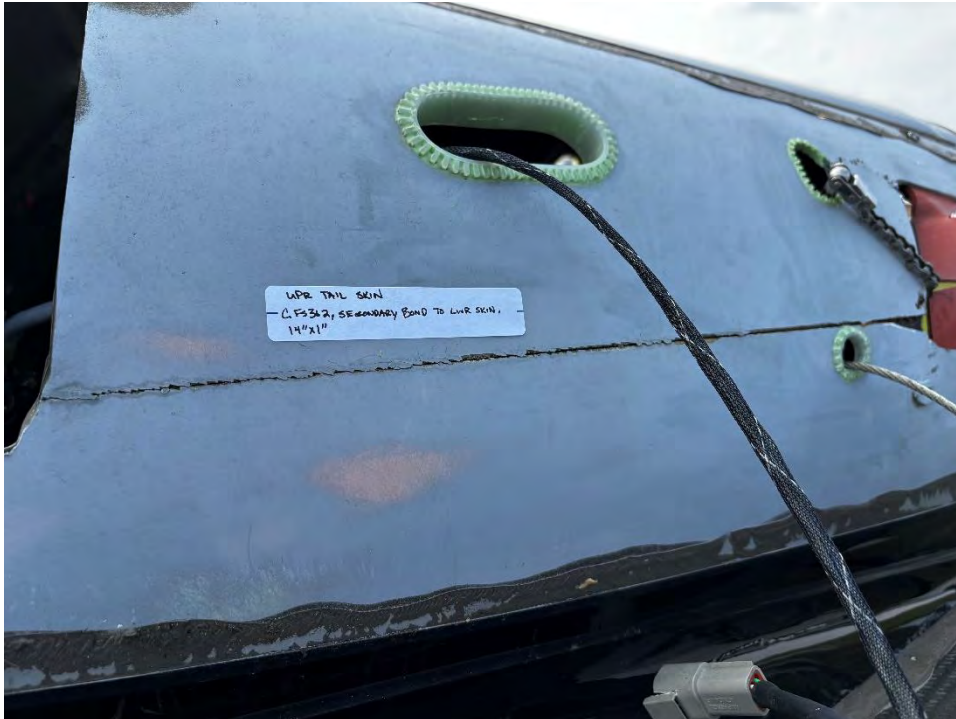
20. Fuselage - UPR Tail Skin, FS362 to LWR Skin / Secondary Bond / 14" x 1"

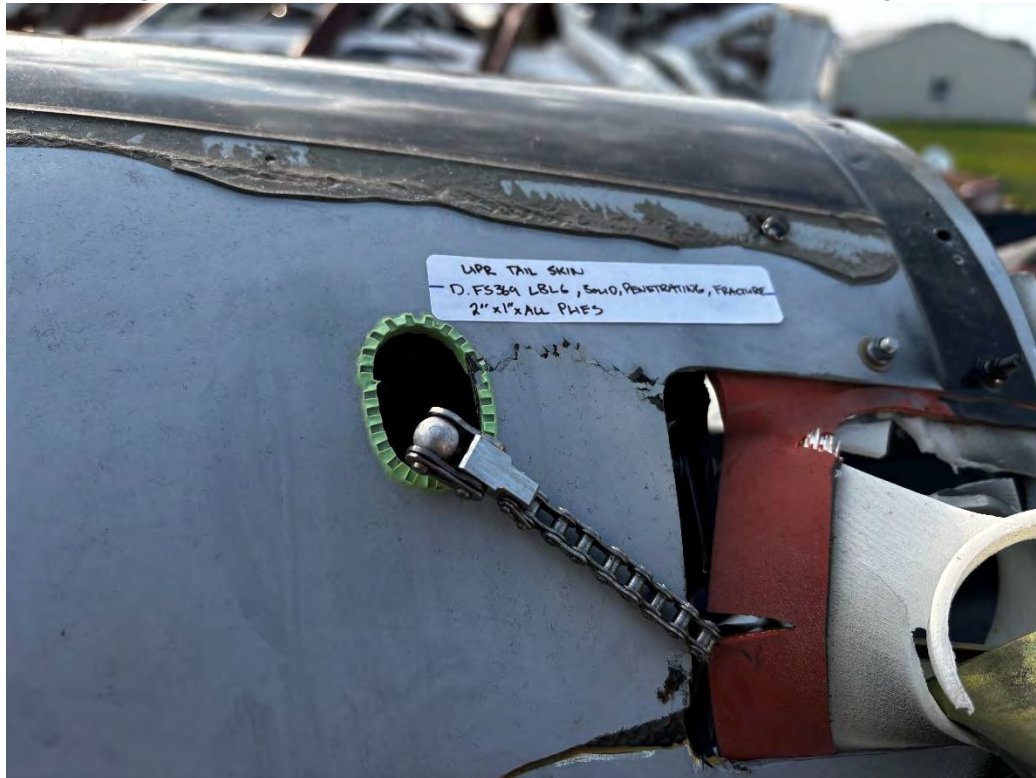
21. Fuselage - UPR Tail Skin, FS369 LBL6 / Solid Laminate - Penetrating - Fracture / 2" x 1", All Plies.

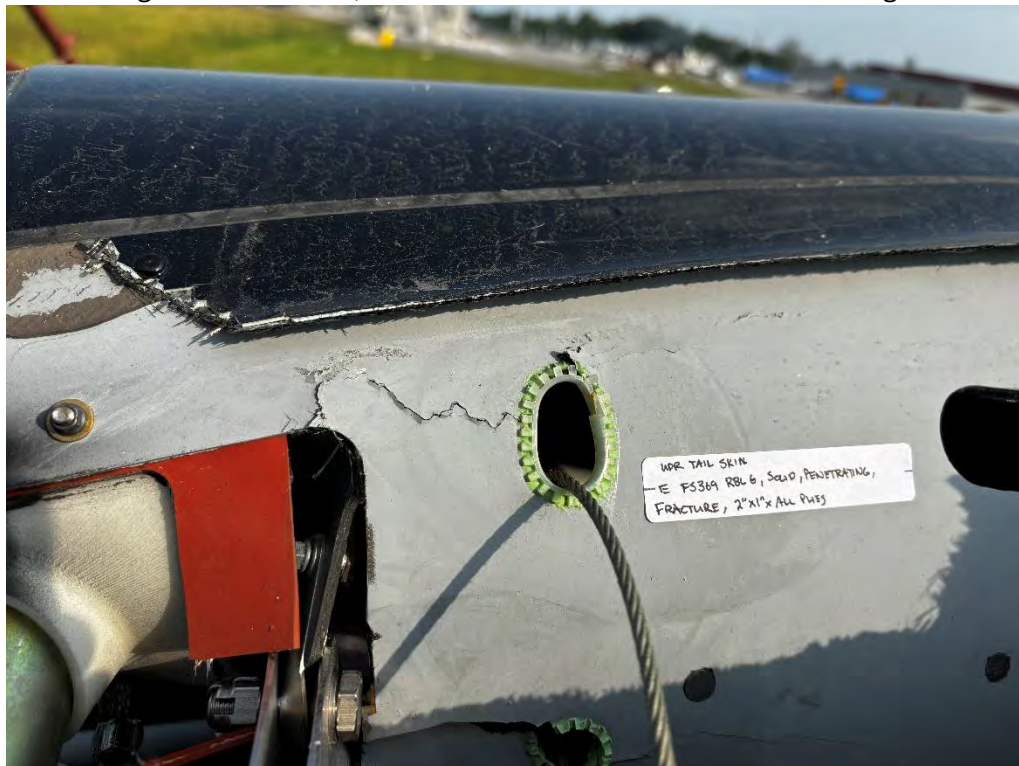
22. Fuselage - UPR Tail Skin, FS369 RBL6 / Solid Laminate - Penetrating - Fracture / 2" x 1", All Plies.

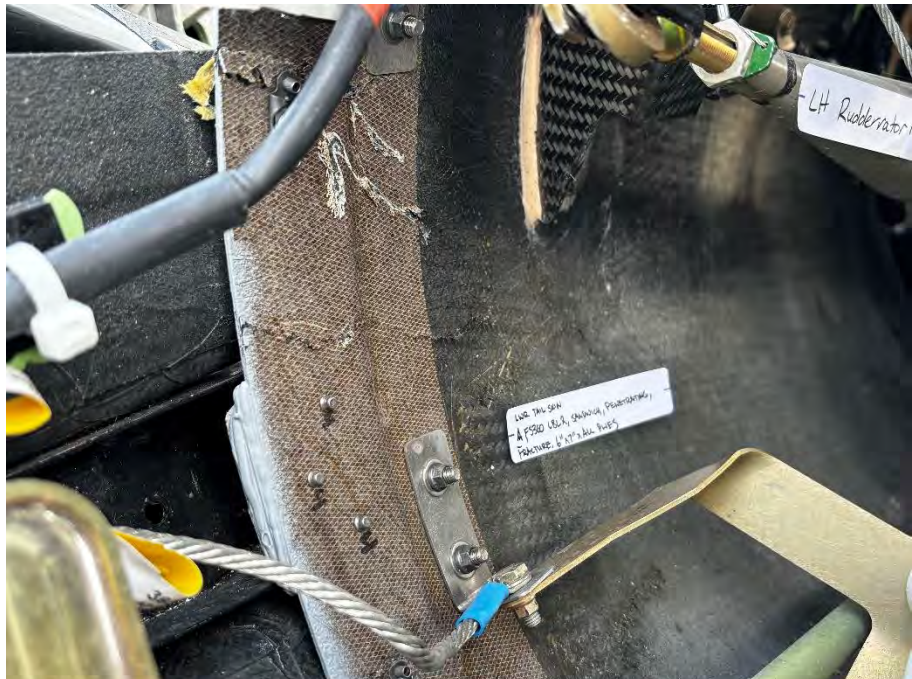
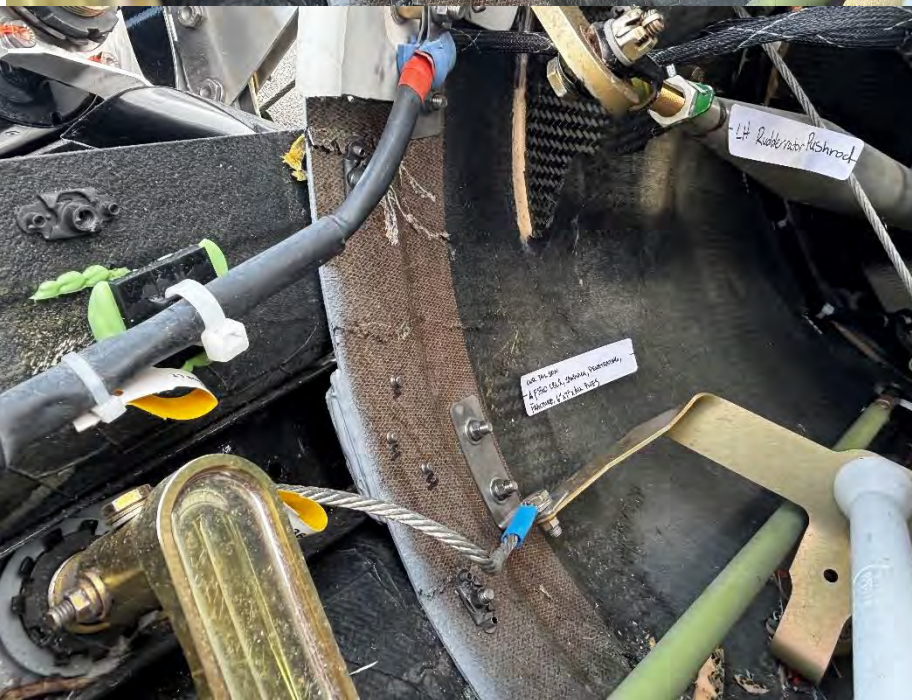
23. Fuselage - LWR Tail Skin, FS360 LBL2, Toolside / Sandwich Structure - Laminate Only - Penetrating - Fracture / 6" x 7", All Plies.

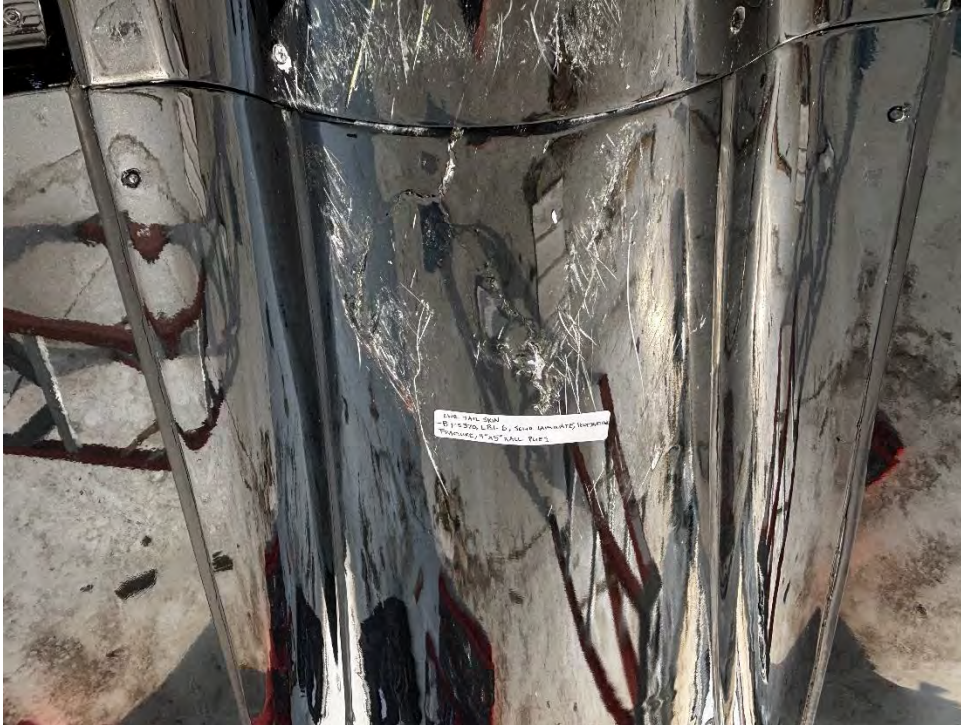
24. Fuselage - LWR Tail Skin, FS370 LBL6, Toolside / Solid Laminate - Penetrating - Fracture / 4" x 5", All Plies.

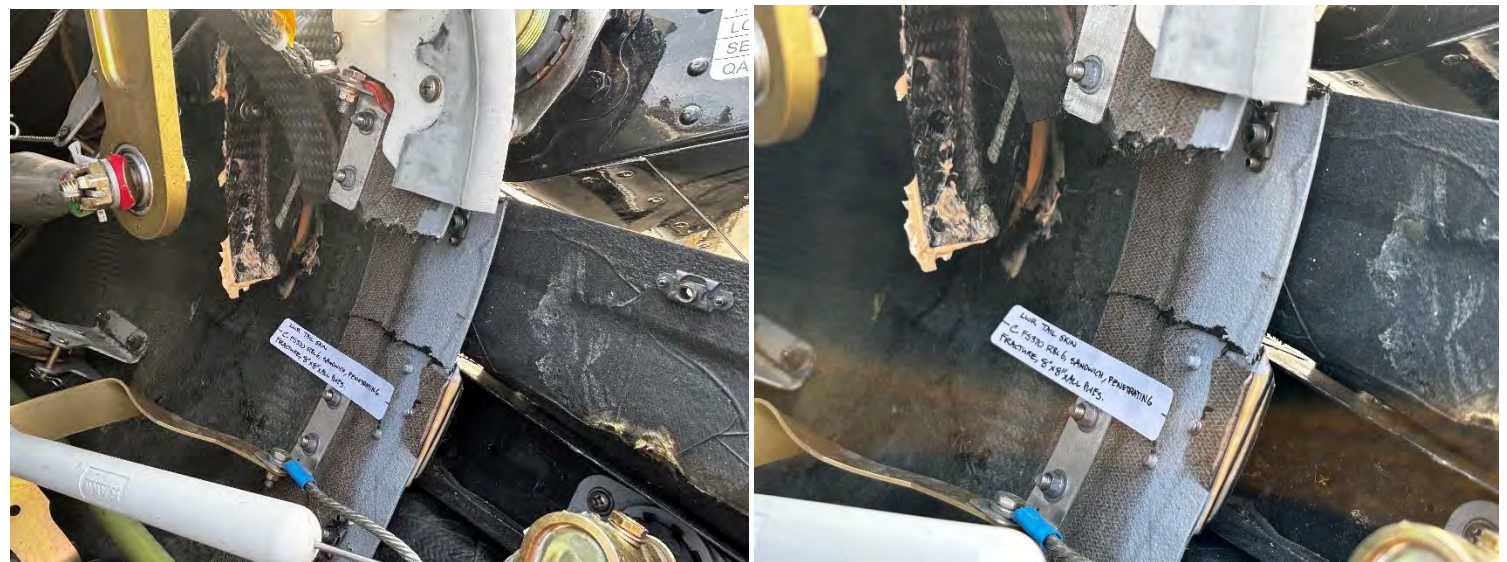
25. Fuselage - LWR Tail Skin, FS370 RBL6, Toolside / Sandwich Structure - Laminate Only - Penetrating - Fracture / 8" x 8", All Plies.

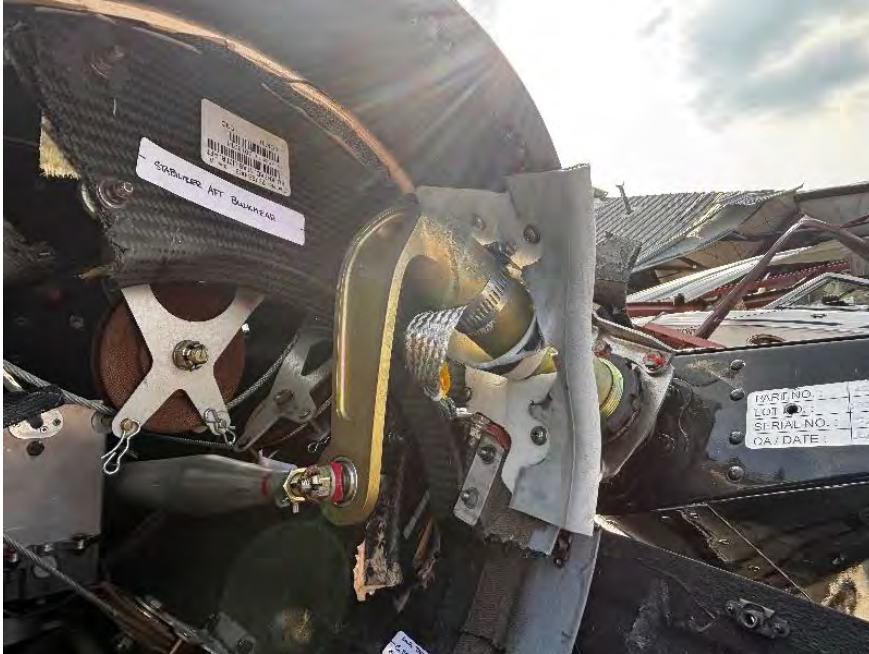
26. Fuselage - Stabilizer Aft Bulkhead / Component - Damage Beyond Repair

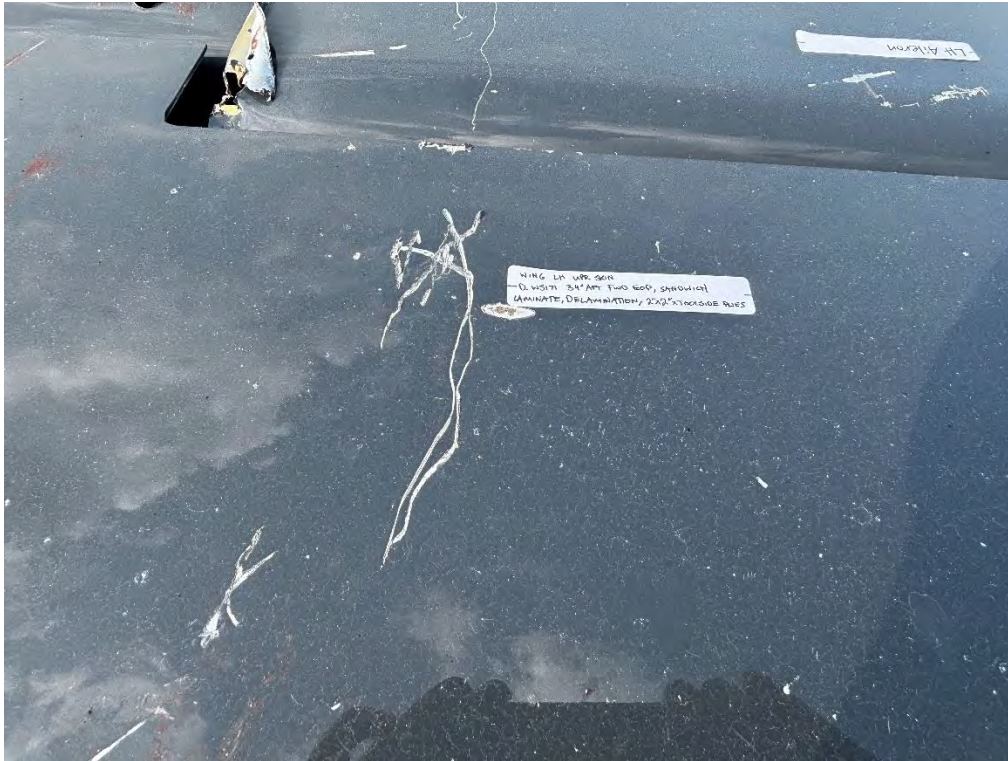
30. Wing - LH UPR Wing Skin, WS171, 34" Aft of LEOP, Toolside / Sandwich Structure - Laminate Only - Non-Penetrating - Delamination / 2" x 2", Toolside Plies Only.

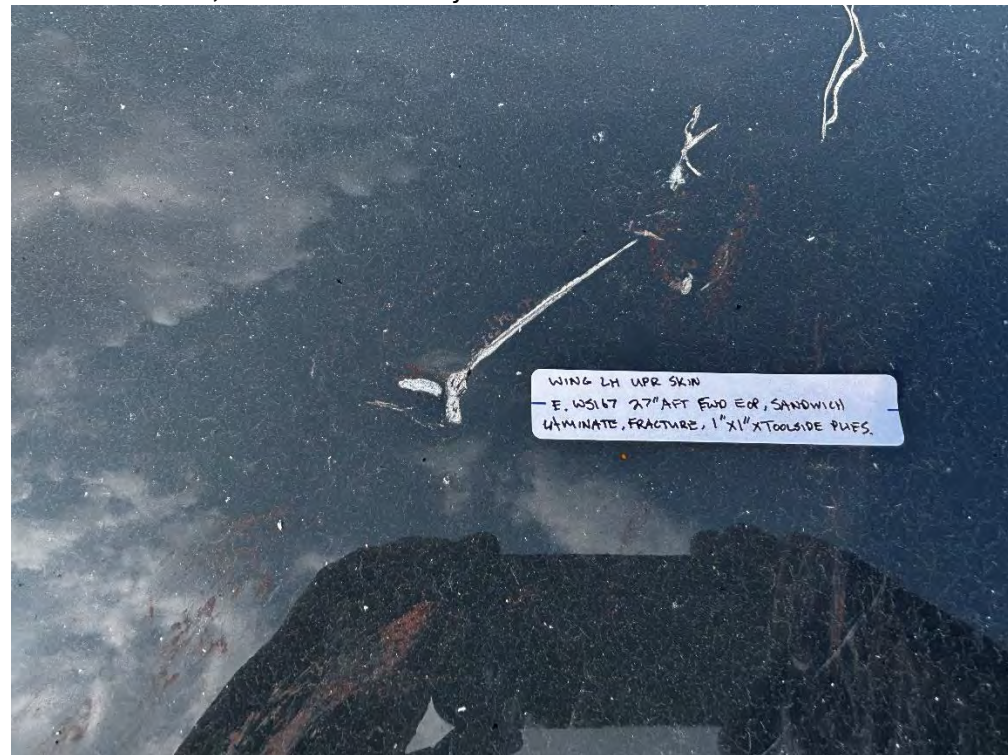
31. Wing - LH UPR Wing Skin, WS167 27" Aft LEOP, Toolside / Sandwich Structure - Laminate Only - Penetrating - Fracture / 1" x 1", Toolside Plies Only.

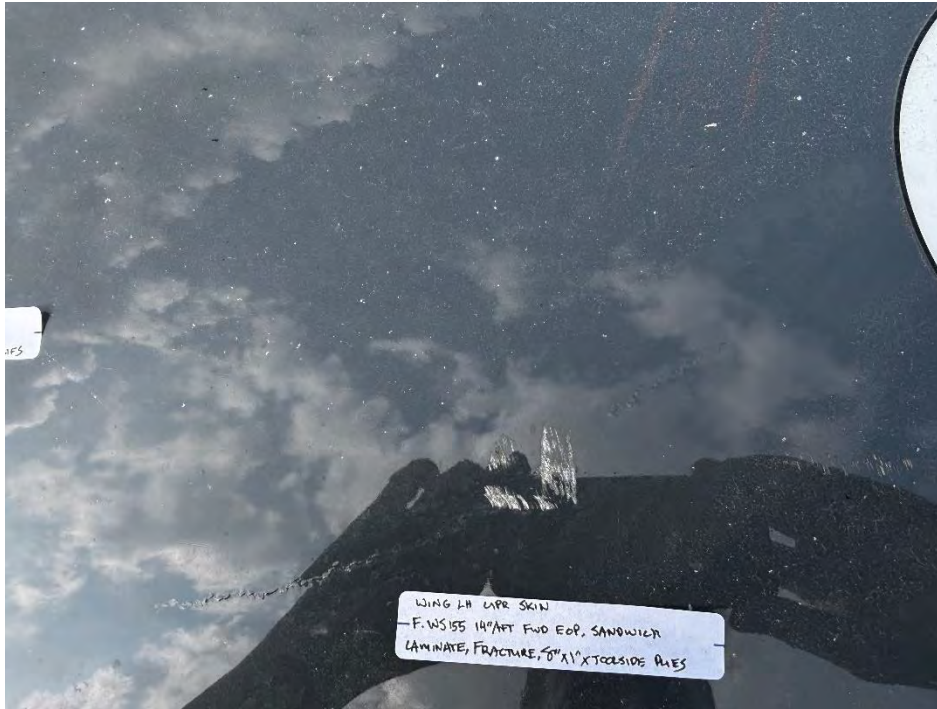
32. Wing - LH UPR Wing Skin, WS155 14" Aft of LEOP, Toolside / Sandwich Structure - Laminate Only - Penetrating - Fracture / 8" x 1", Toolside Plies Only.

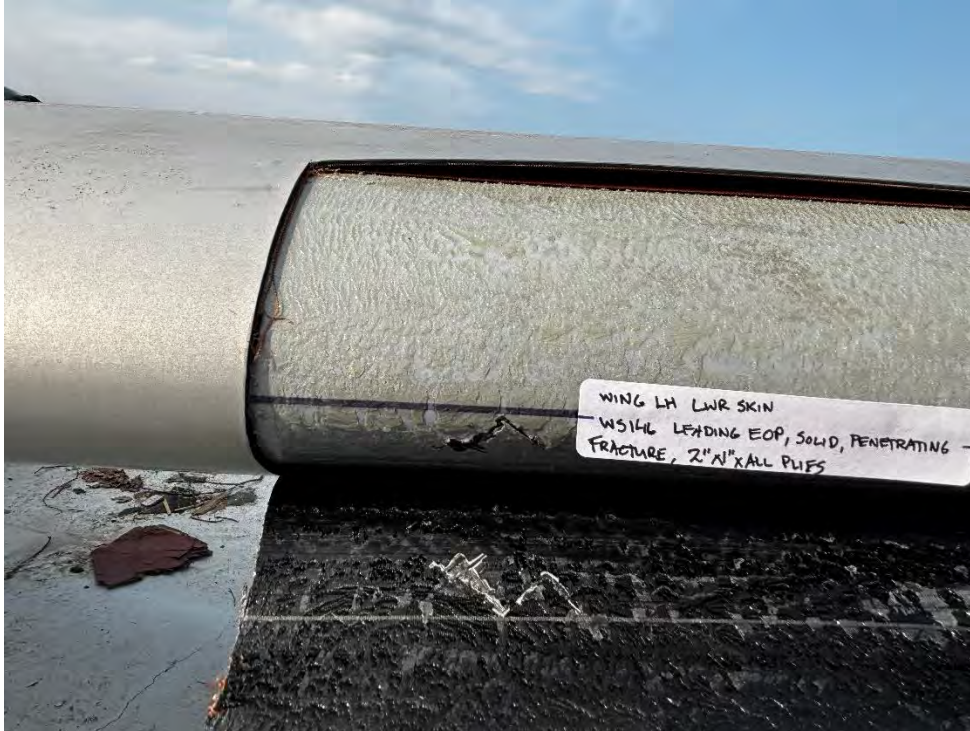
34. Wing - LH LWR Wing Skin, WS146, LEOP, Toolside / Solid Laminate - Penetrating - Fracture / 2" x 1", All Plies.

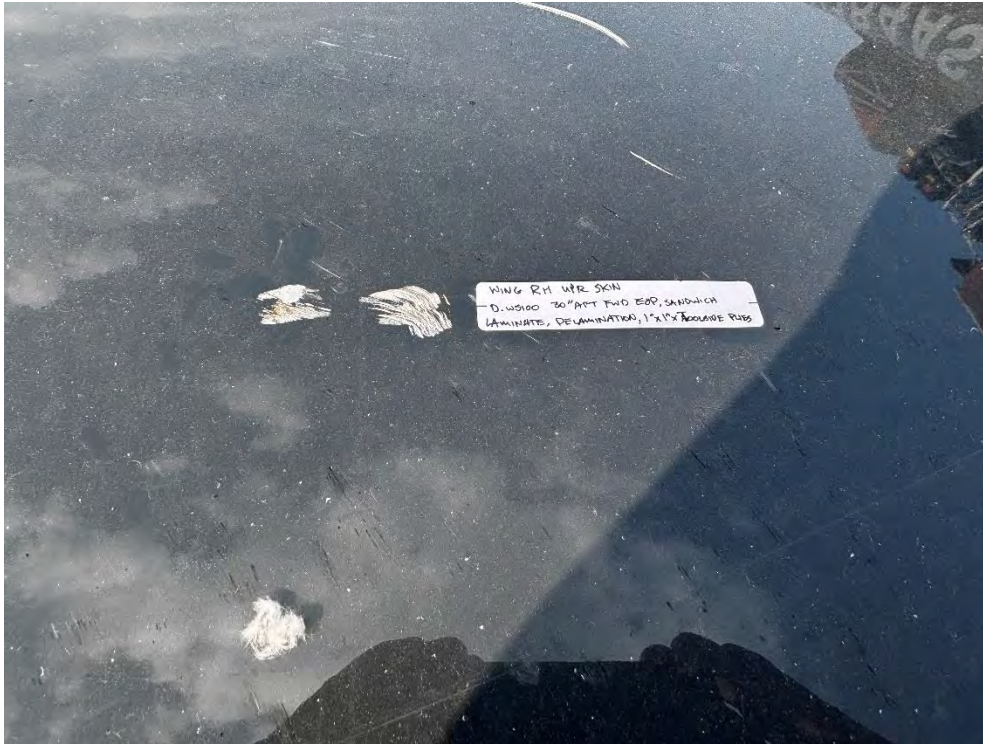
38. Wing - RH UPR Wing Skin, WS100, 30" Aft of LEOP, Toolside / Sandwich Structure - Laminate Only - Non-Penetrating - Delamination / 1" x 1", Toolside Plies Only.

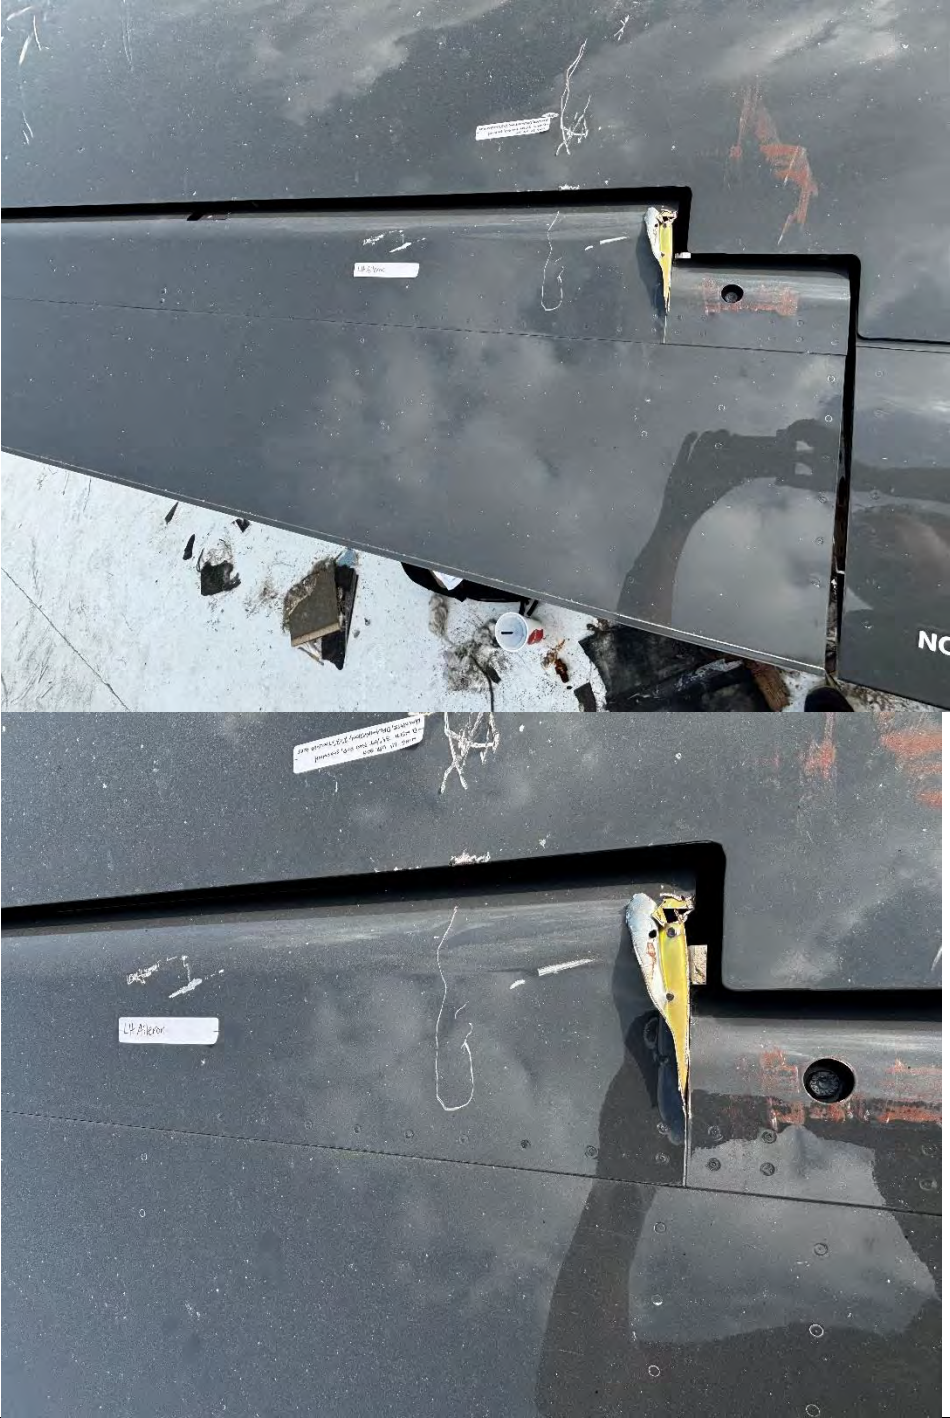
39. Component - LH Aileron / Component - Damage Beyond Repair

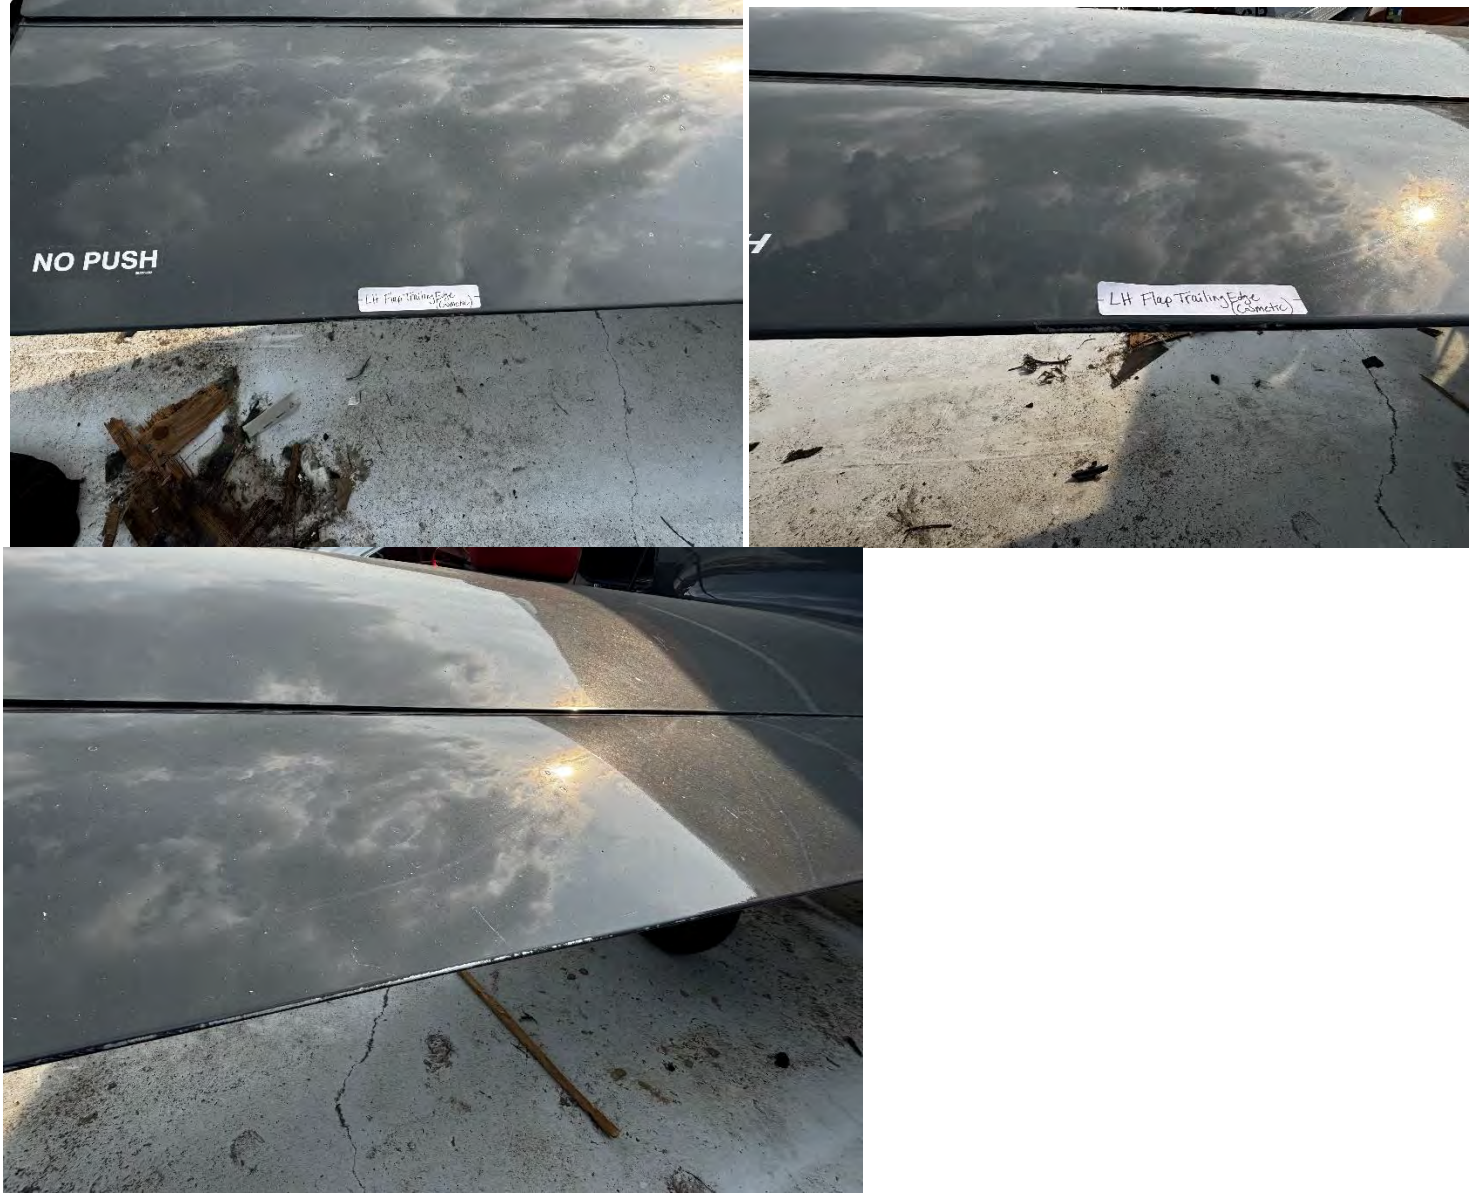
40. Component - LH Flap / Cosmetic (Scratching) / TE Gouging - Damage Beyond Repair.

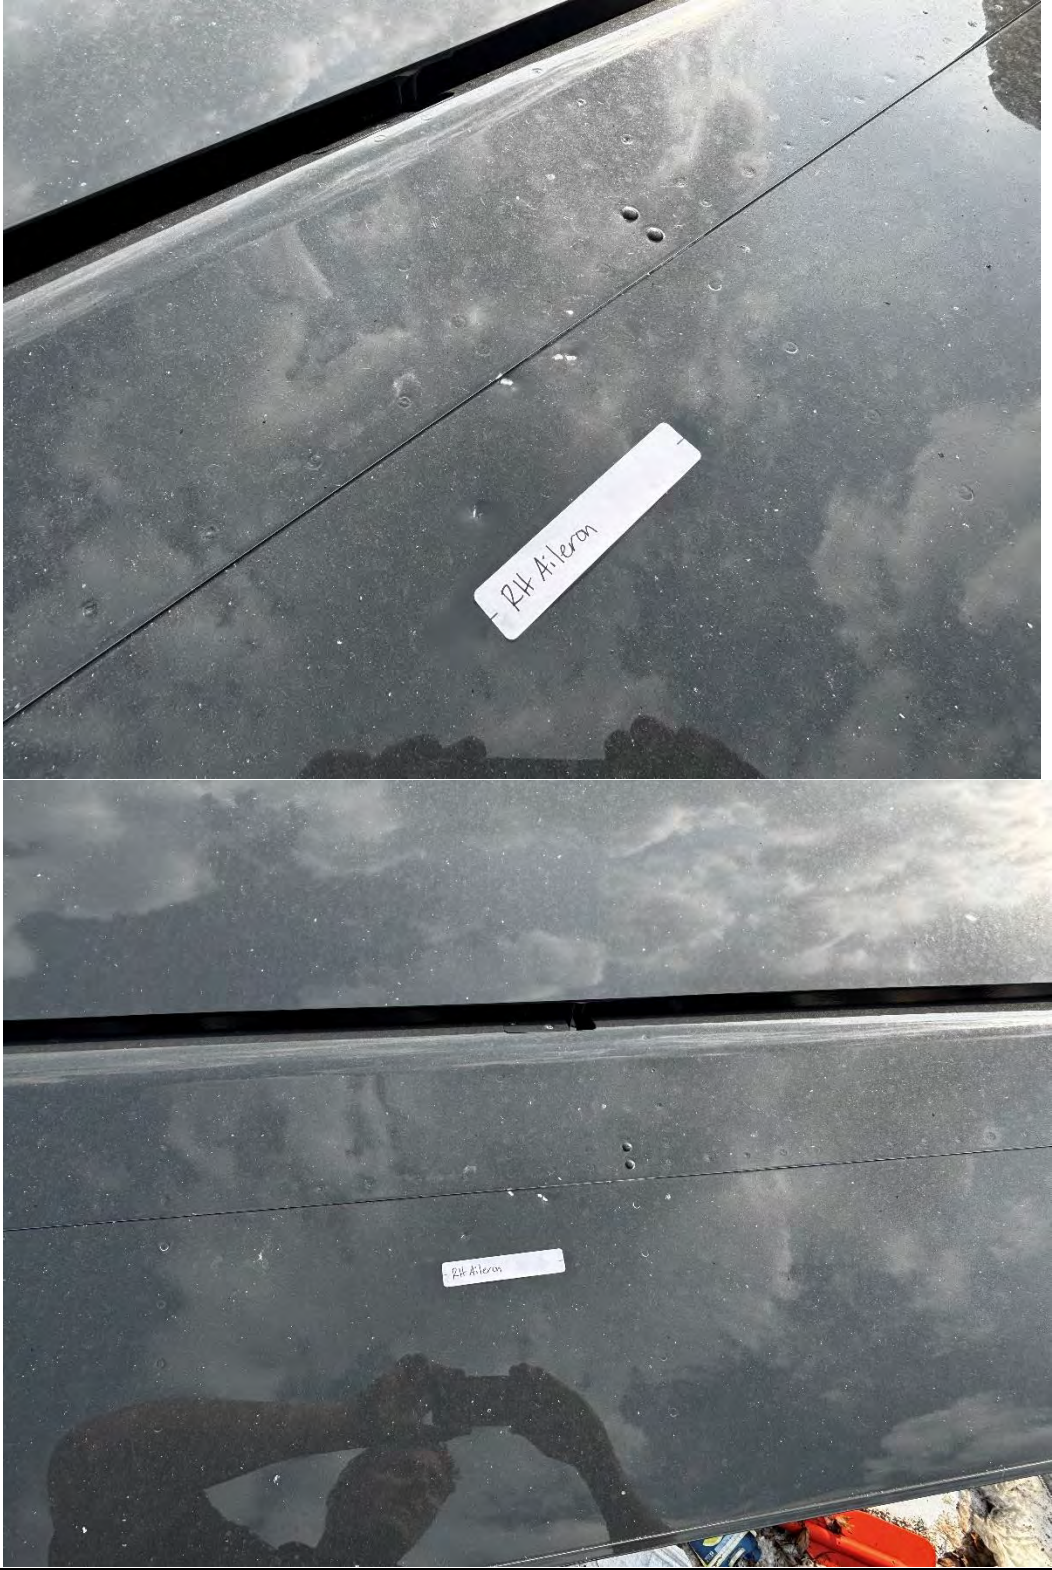
41. Component - RH Aileron / Component - Damage Beyond Repair

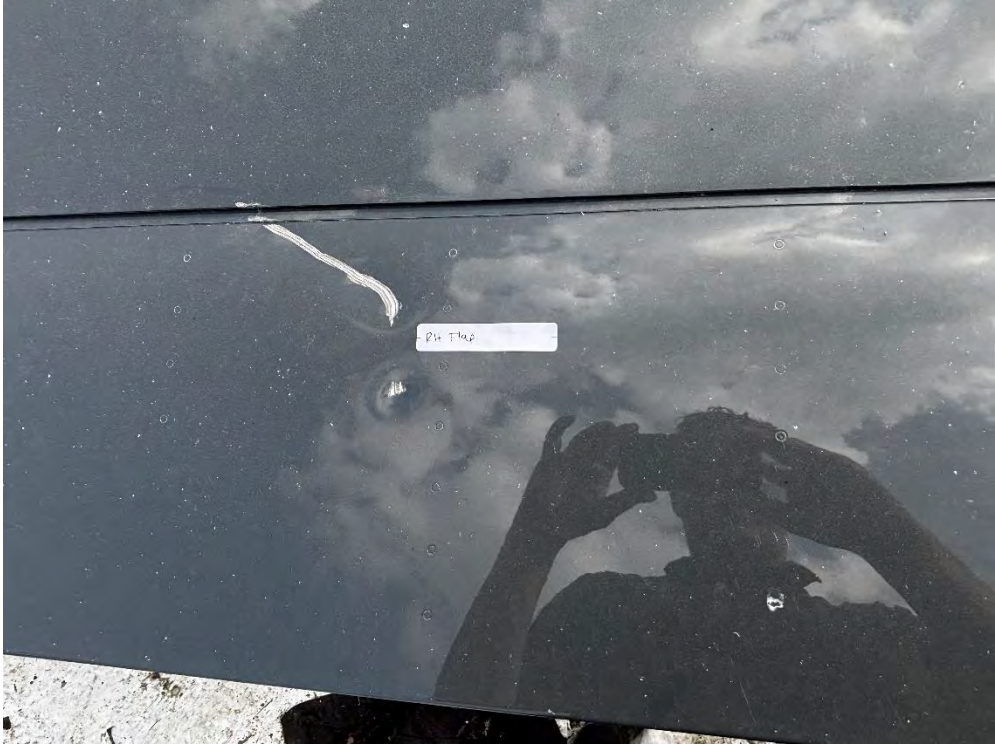
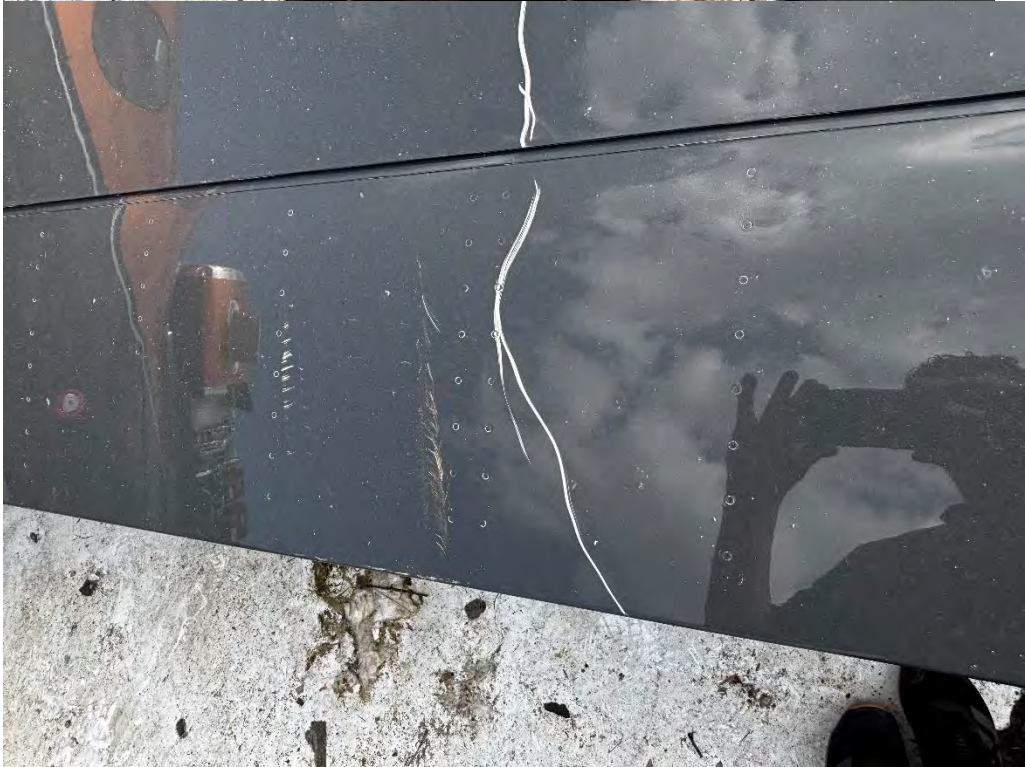
42. Component - RH Flap / Component - Damage Beyond Repair

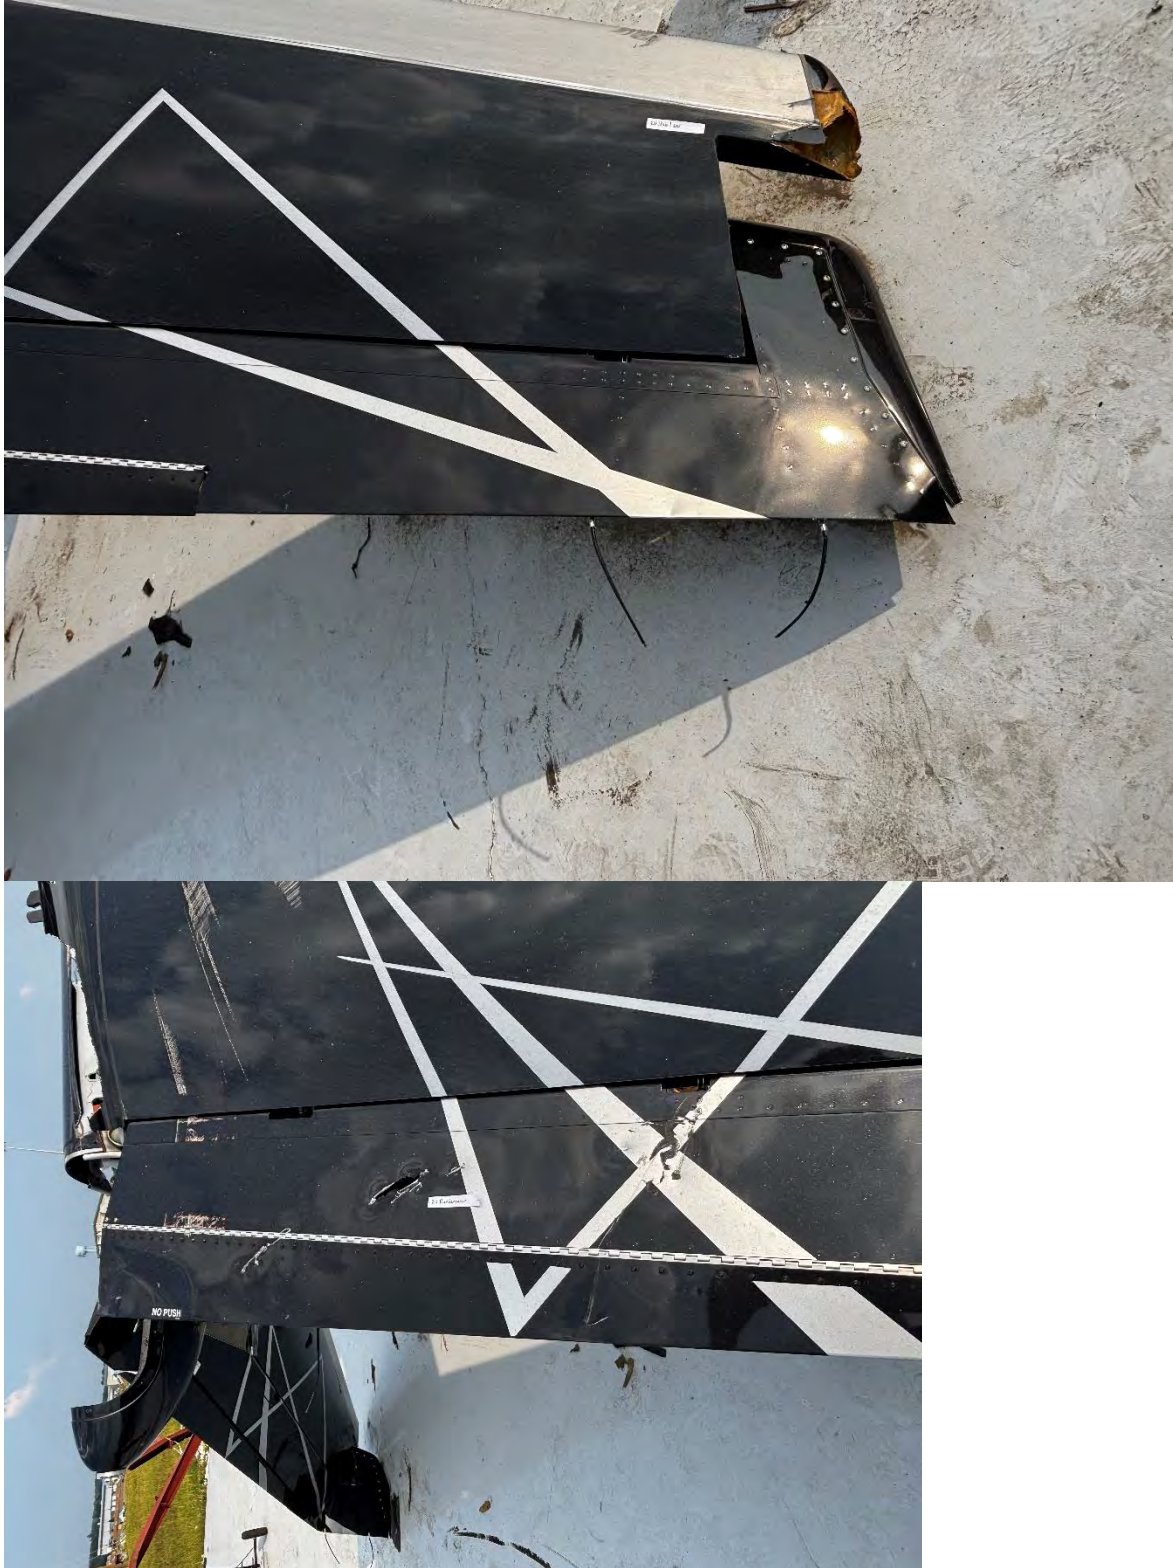
43. Component - RH Ruddervator / Component - Damage Beyond Repair
