AIRCRAFT DAMAGE ASSESSMENT REPORT

Model:	SF50	Registration:	N184AS	Serial:	0585	Hobbs:	114.1	Flight Hours:	95.4
Location:	KLOZ London, KY			A/C Operator:					
Work Order #:	DLH23637-06-2025			Date of Damage:	5/16/2025				
Cirrus Case #:	00449020			Report Completed:	6/9/2025				
Inspector:		Phone:		Email:					
DOM:		Phone:		Email:

Hangar Collapse Due to Tornado

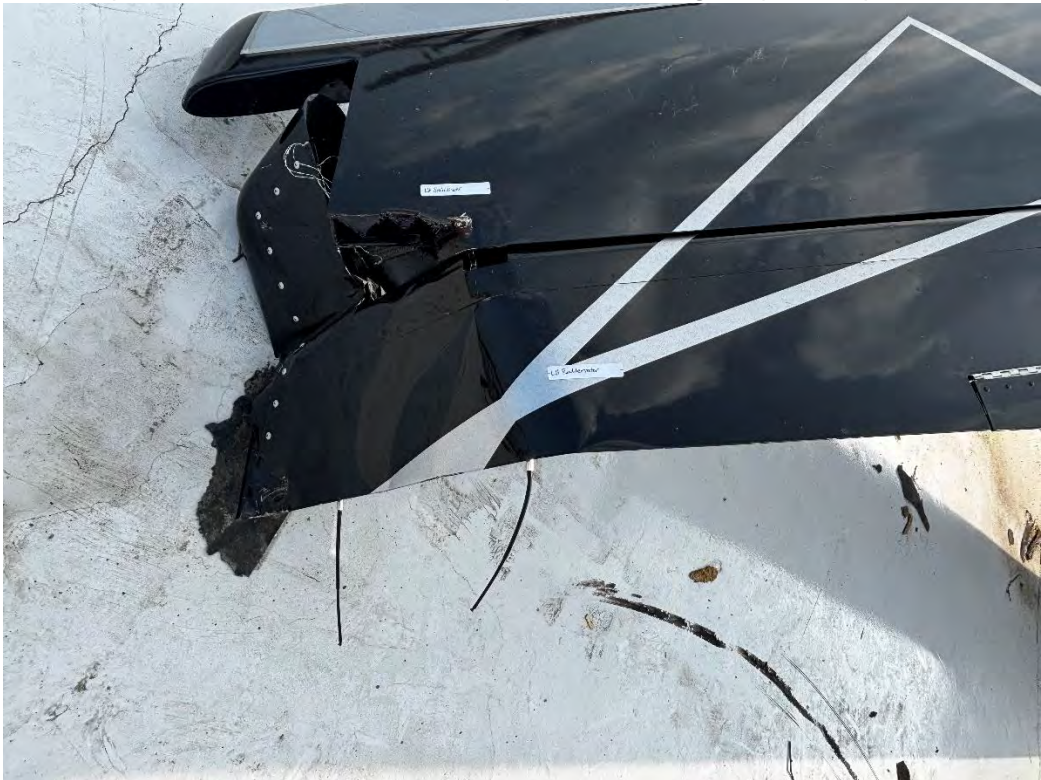
44. Component - LH Ruddervator / Component - Damage Beyond Repair

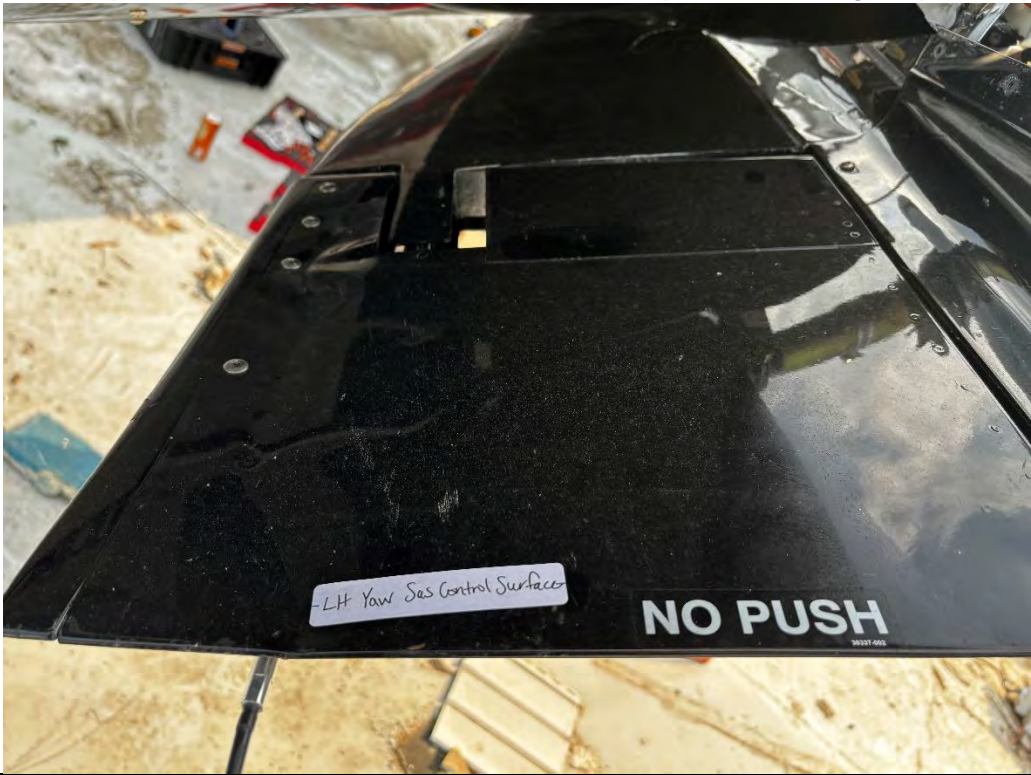
45. Component - LH Yaw SAS Control Surface / Component - Damage Beyond Repair

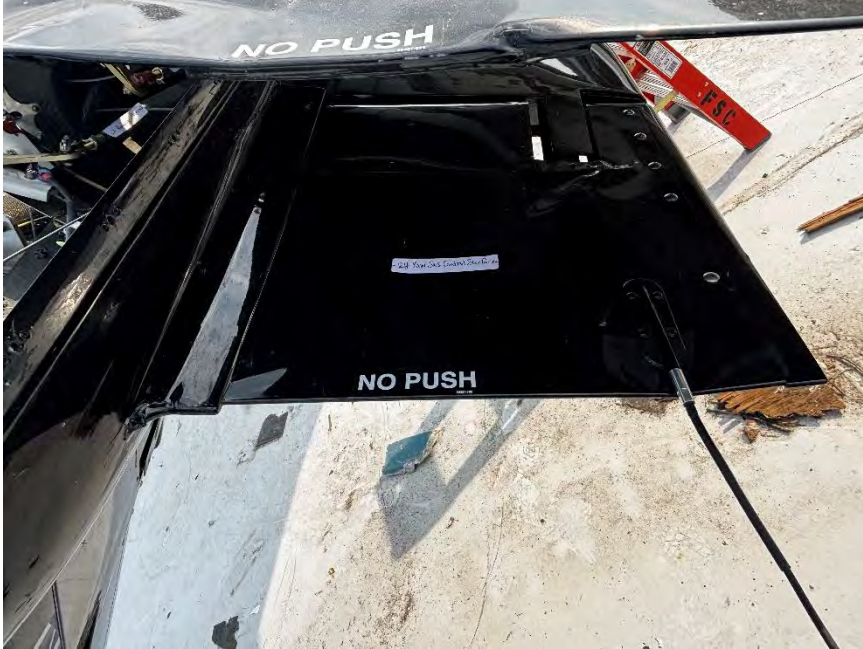
46. Component - RH Yaw SAS Control Surface / Component - Damage Beyond Repair

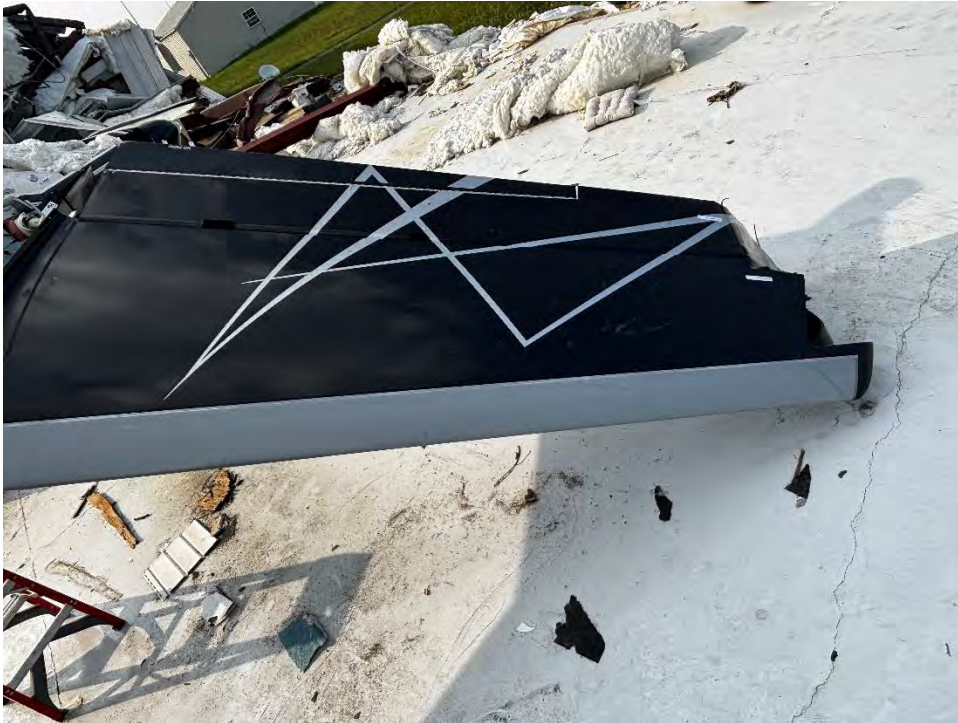
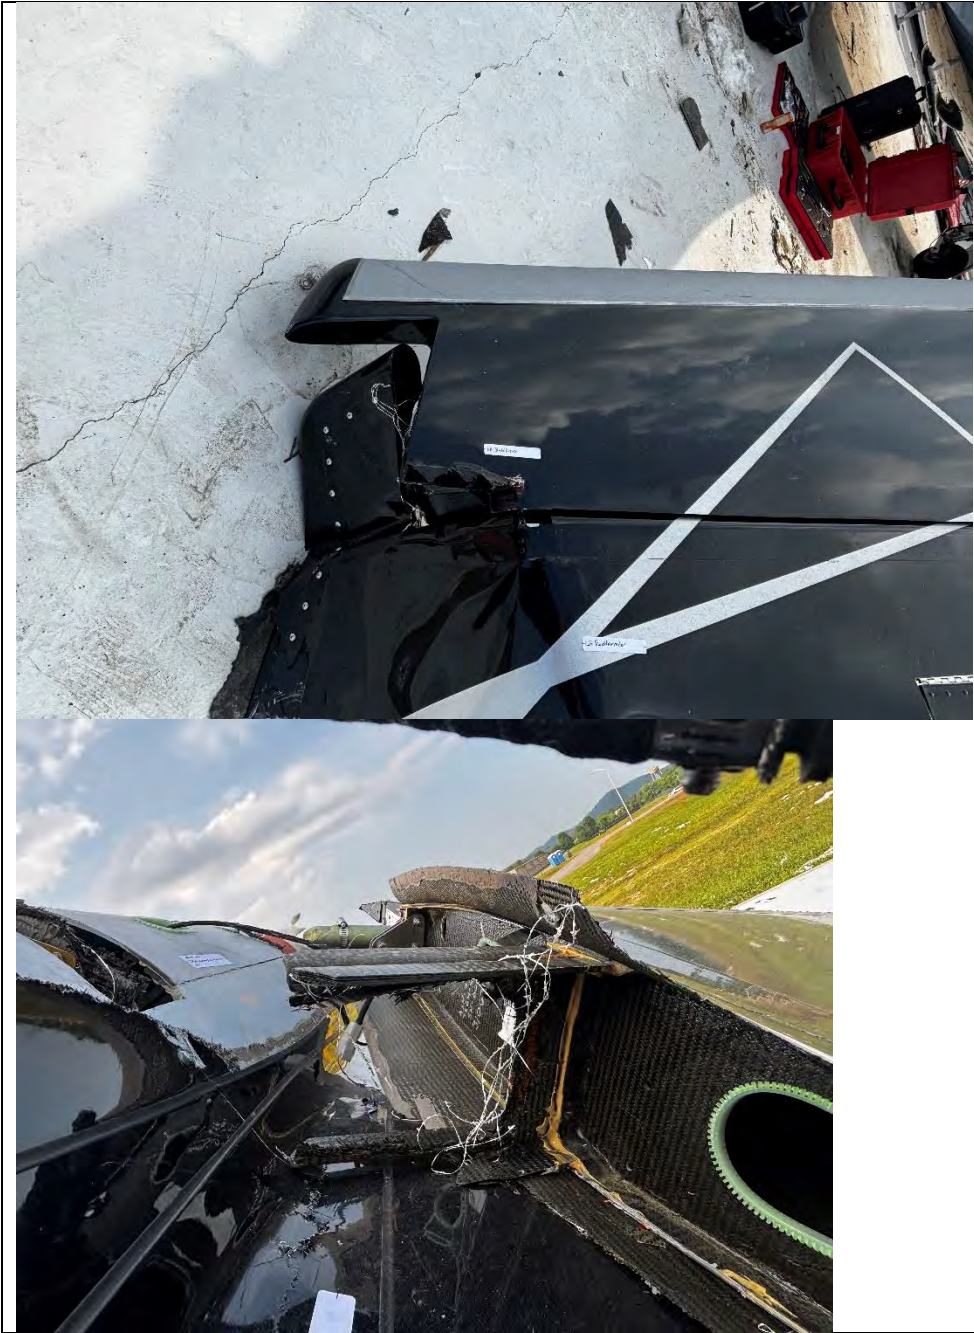
47. Component - LH Stabilizer / Component - Damage Beyond Repair

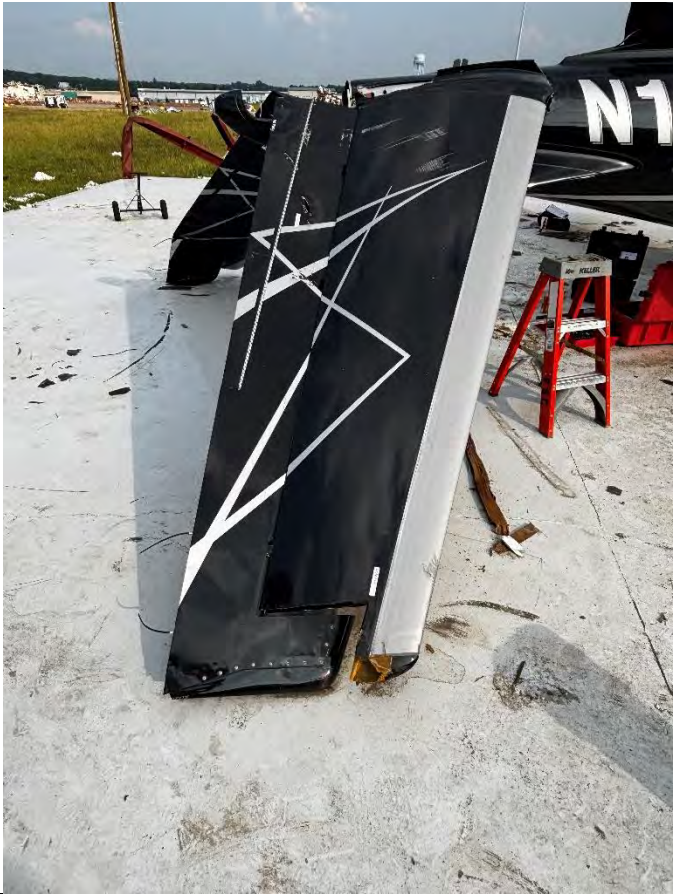
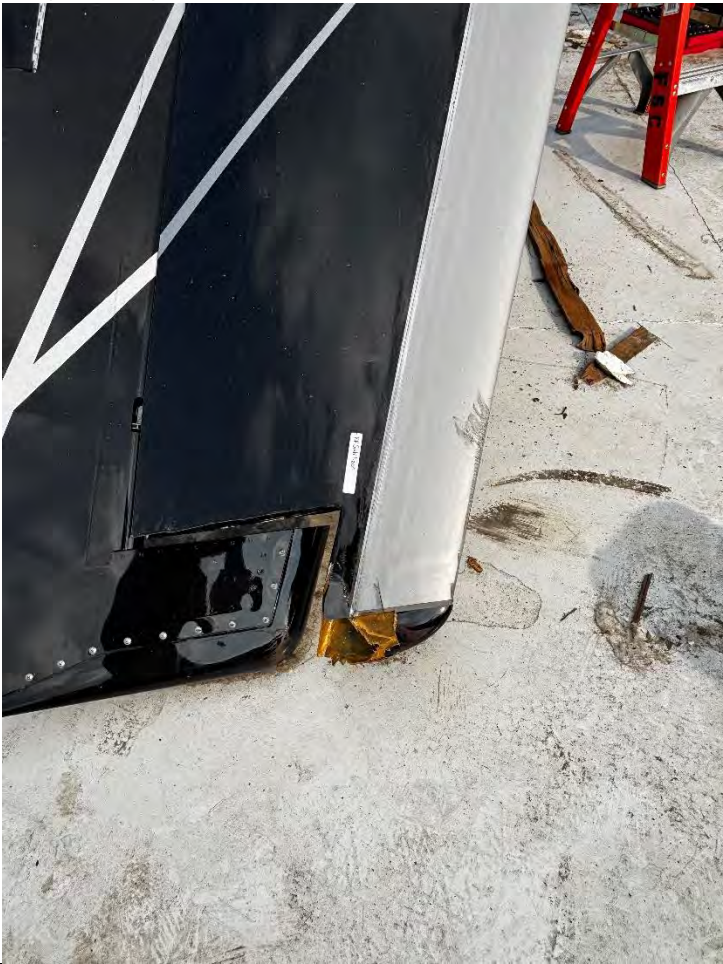
48. Component - RH Stabilizer / Component - Damage Beyond Repair

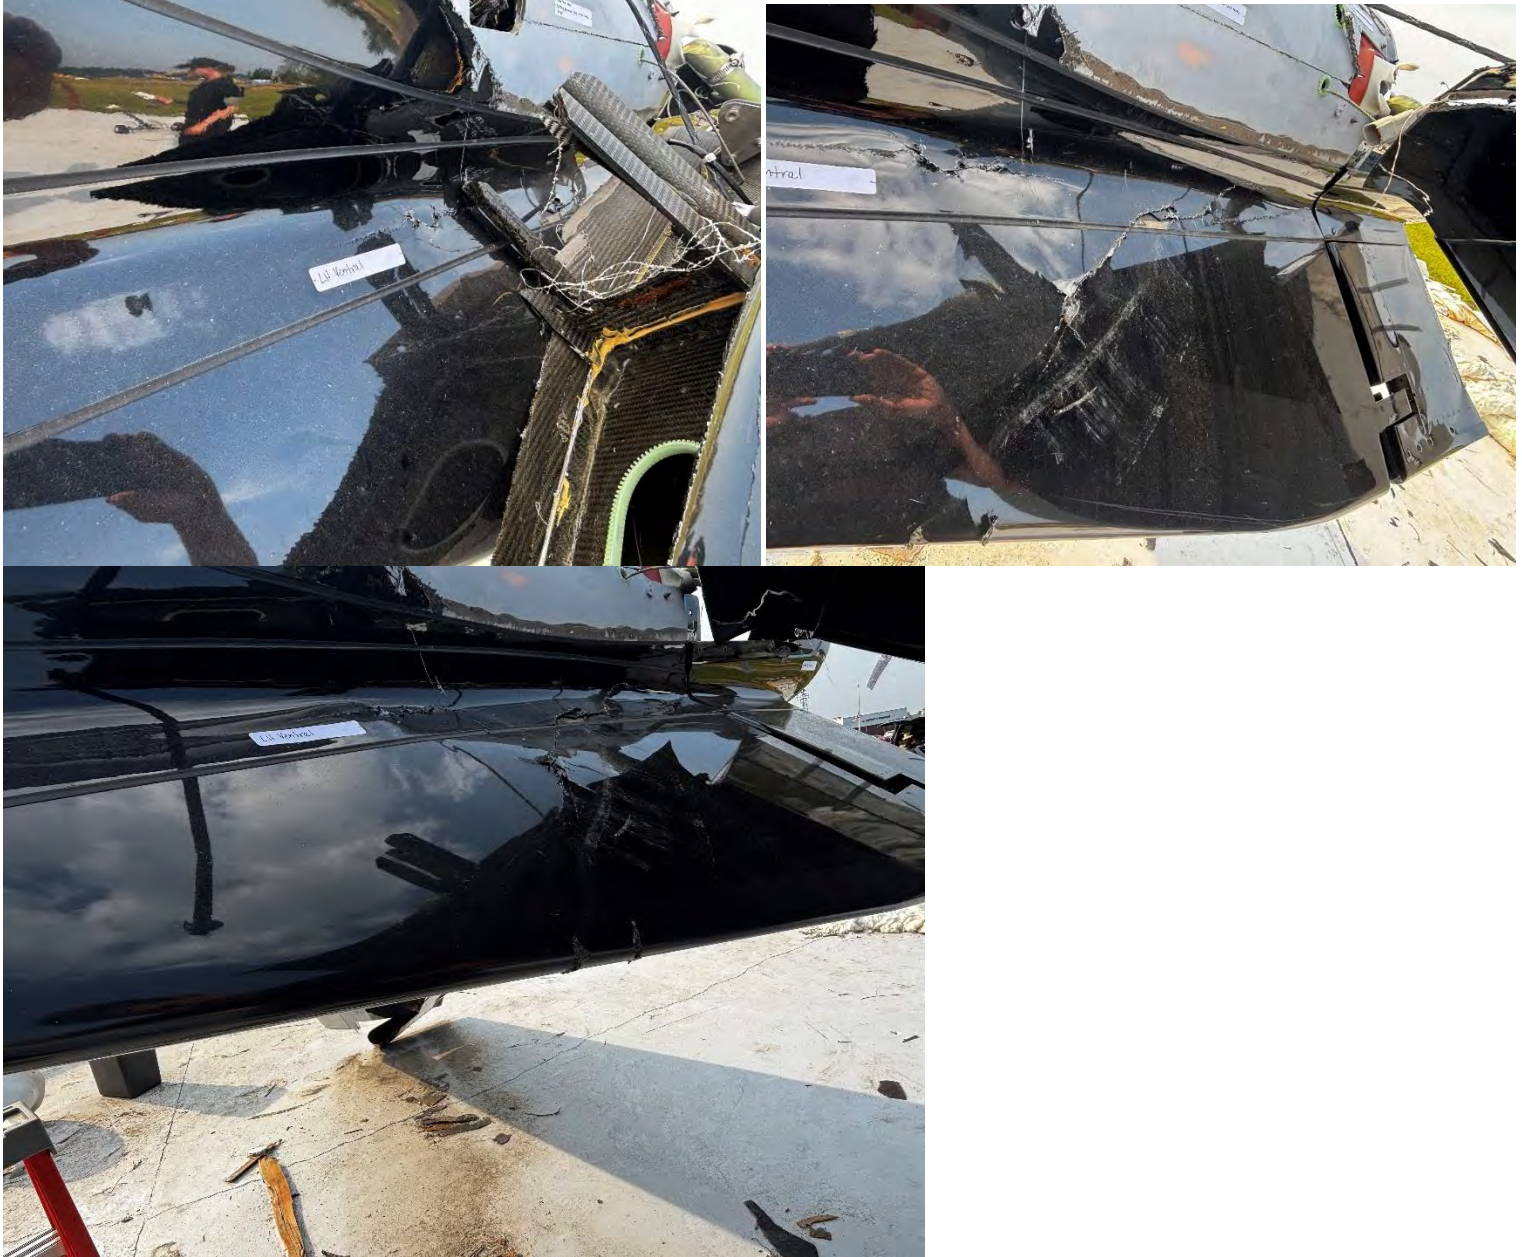
49. Composite Detail Part - LH Ventral / Component - Damage Beyond Repair

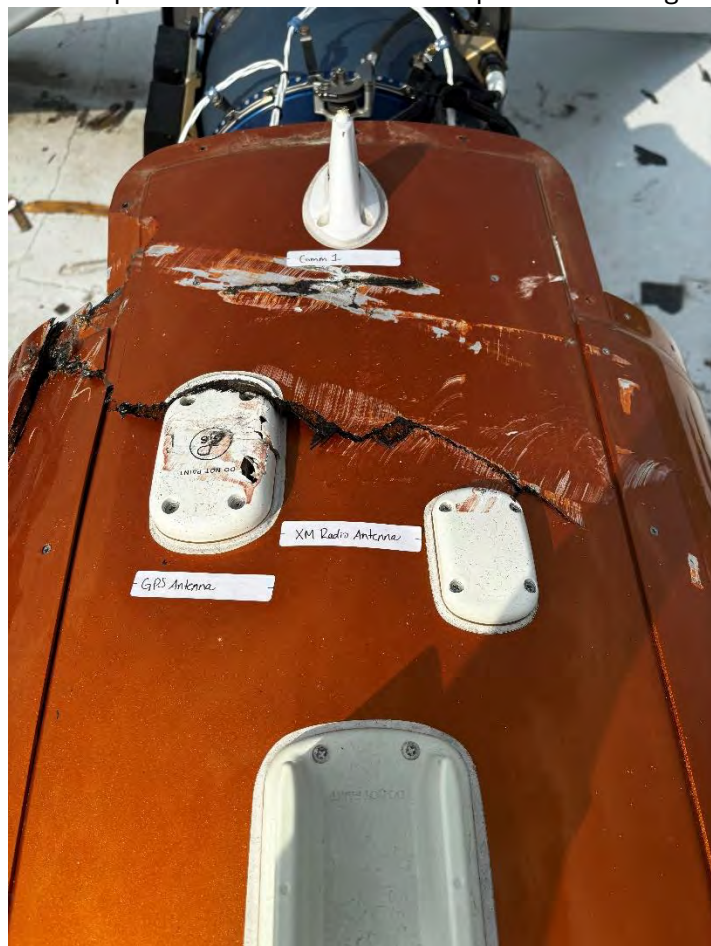
51. Component - GPS Antenna / Component - Damage Beyond Repair

52. Component - XM Radio Antenna / Component - Damage Beyond Repair (**Photo Above**)

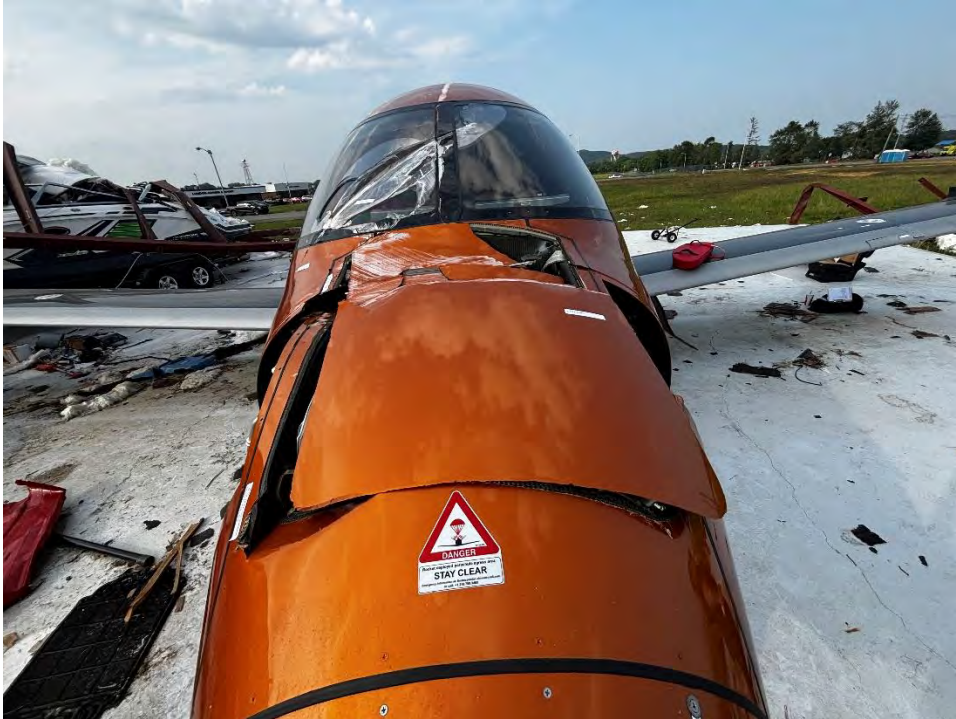
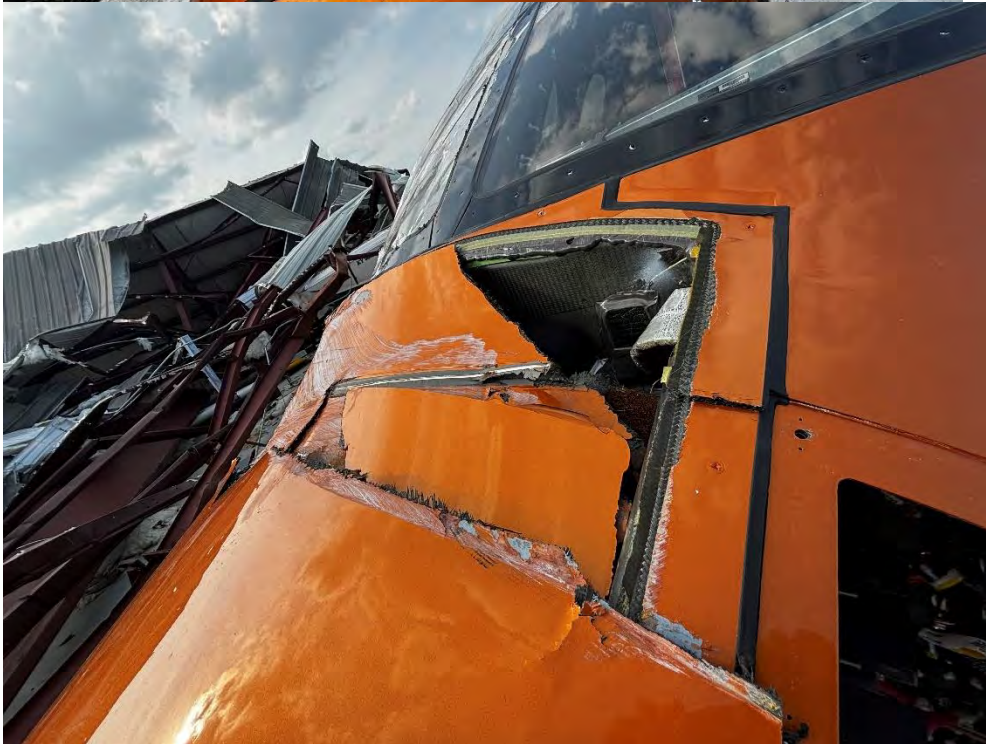
55. Composite Detail Part - CAPS Cover / Component - Damage Beyond Repair

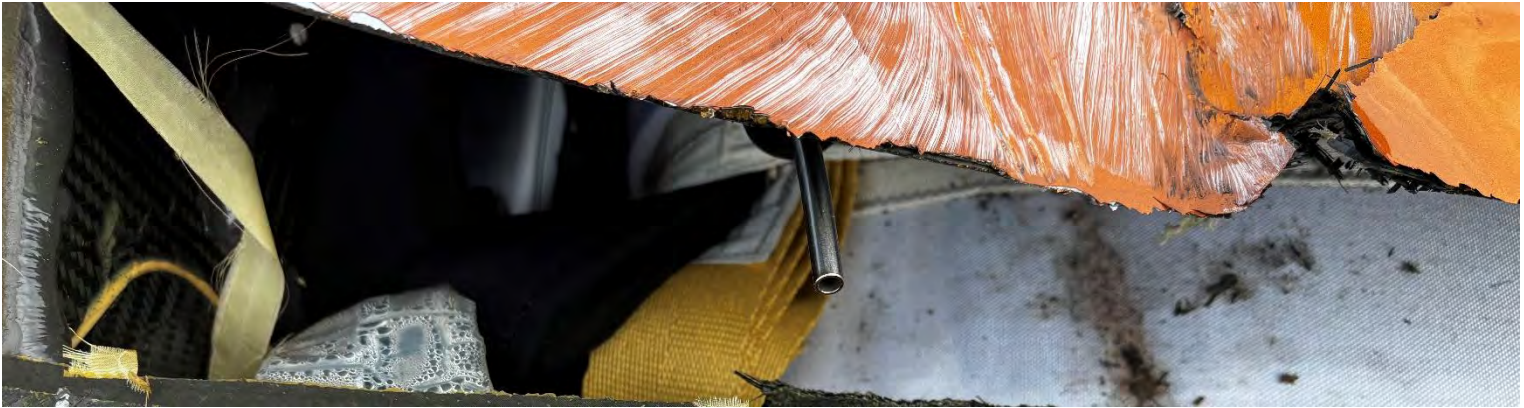
56. Component - Windscreen Spraybar / Component - Damage Beyond Repair

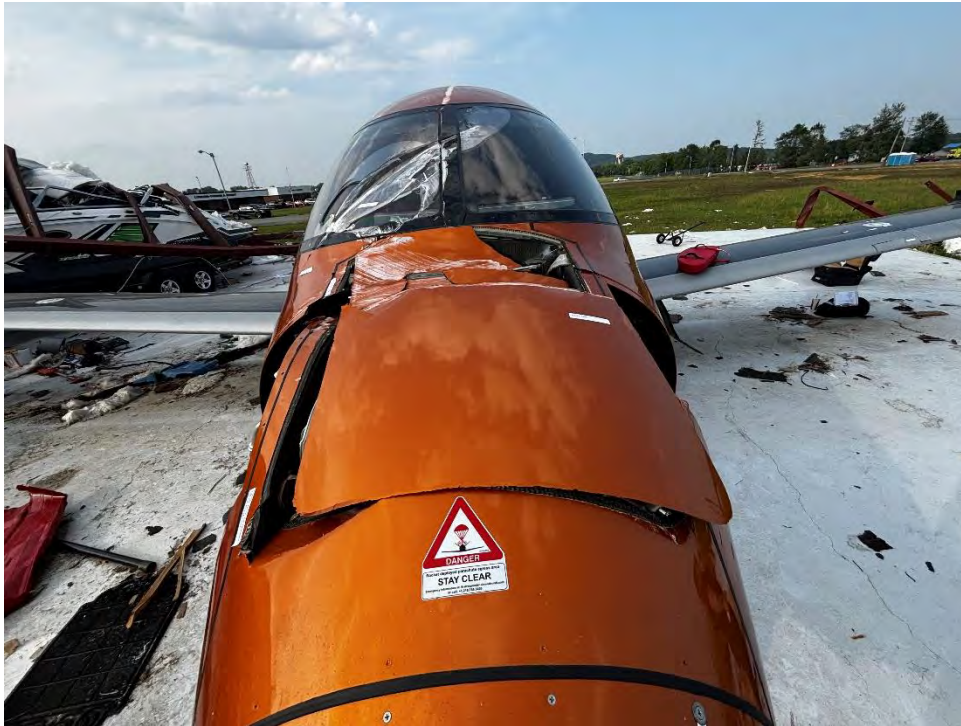
57. Component - CAPS System / Component – Moisture/Damage Beyond Repair

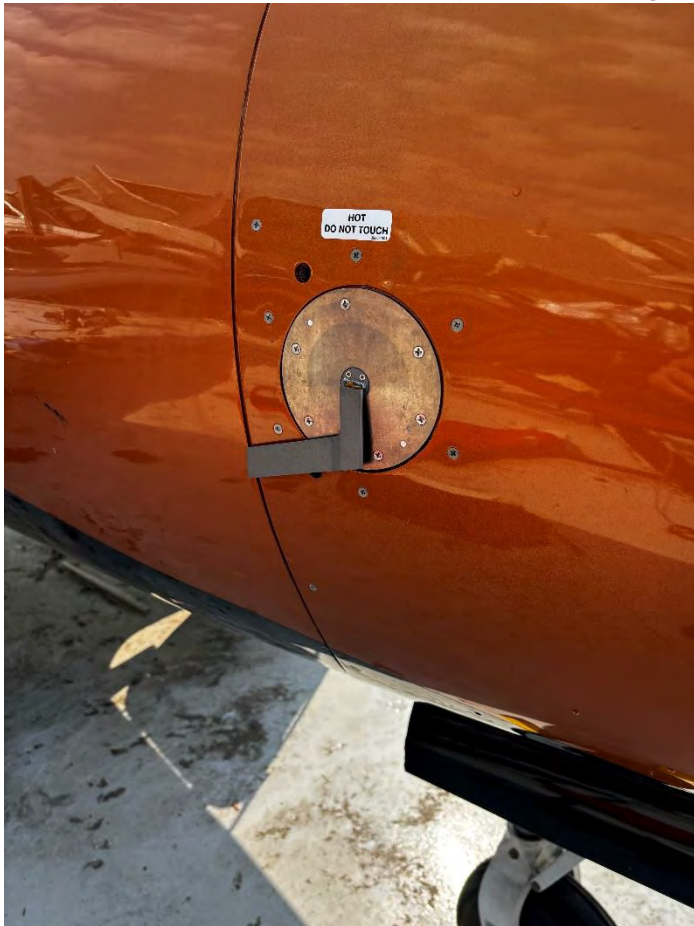
58. Component - AOA Sensor / Component - Damage Beyond Repair

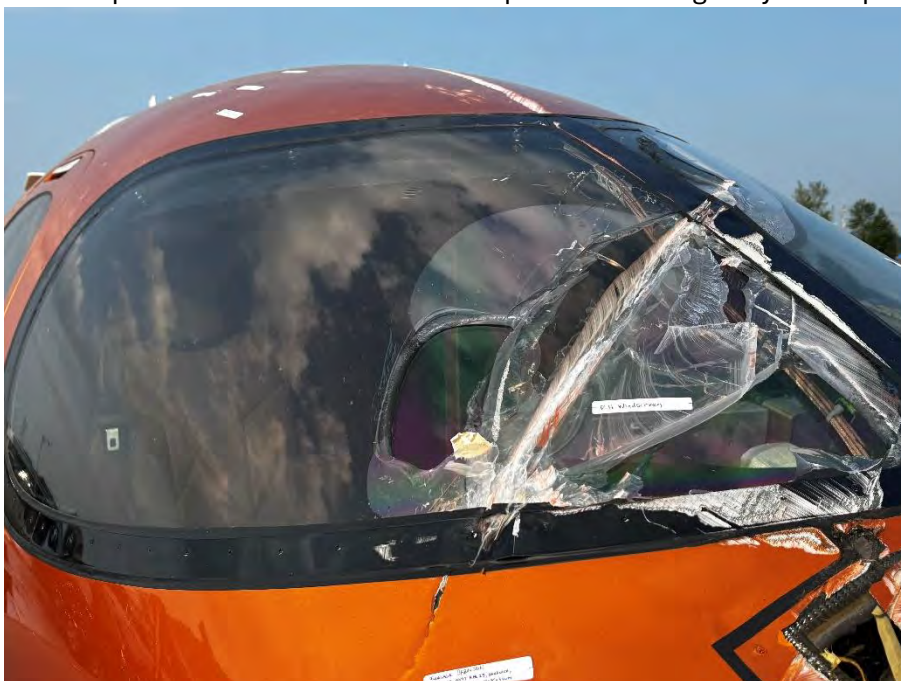
59. Component - RH Windscreen / Component - Damage Beyond Repair

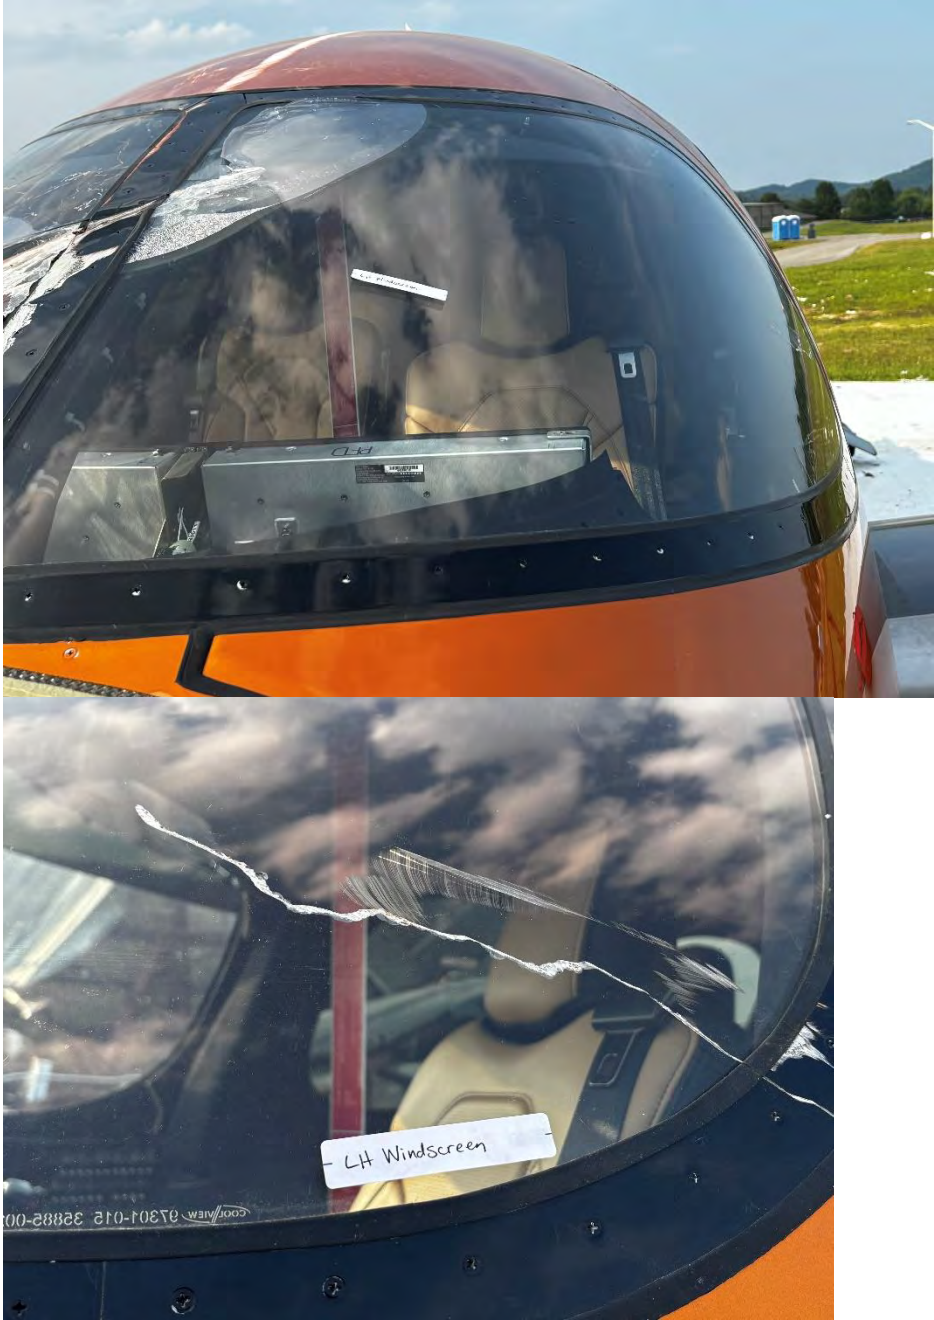
60. Component - LH Windscreen / Component - Damage Beyond Repair

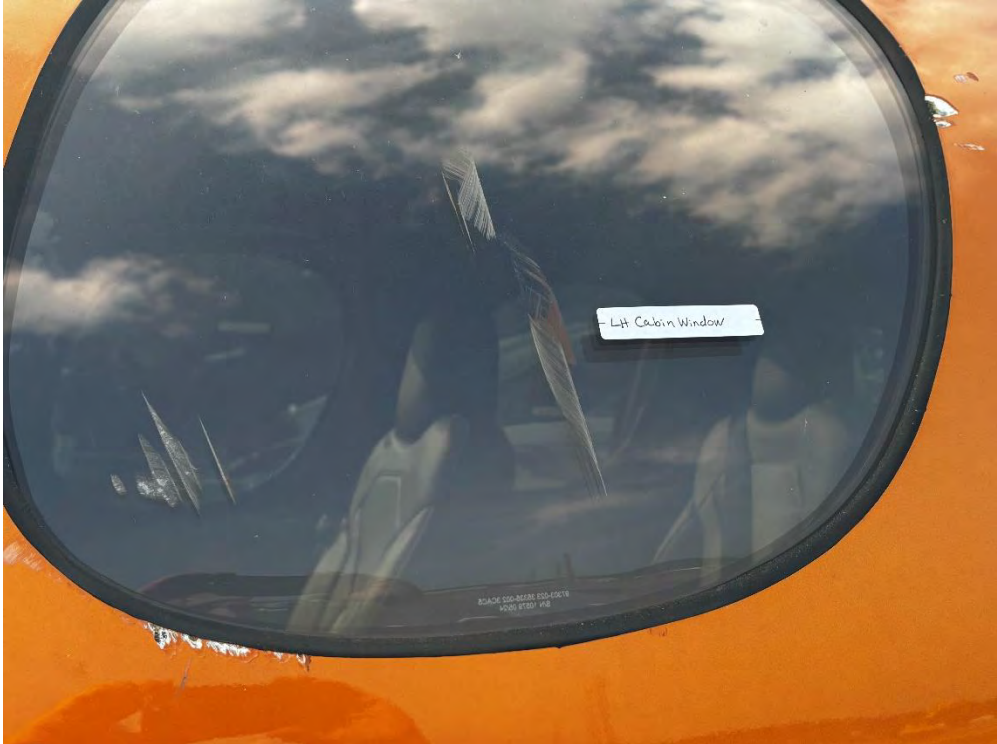
61. Component - LH Cabin Window / Component - Damage Beyond Repair

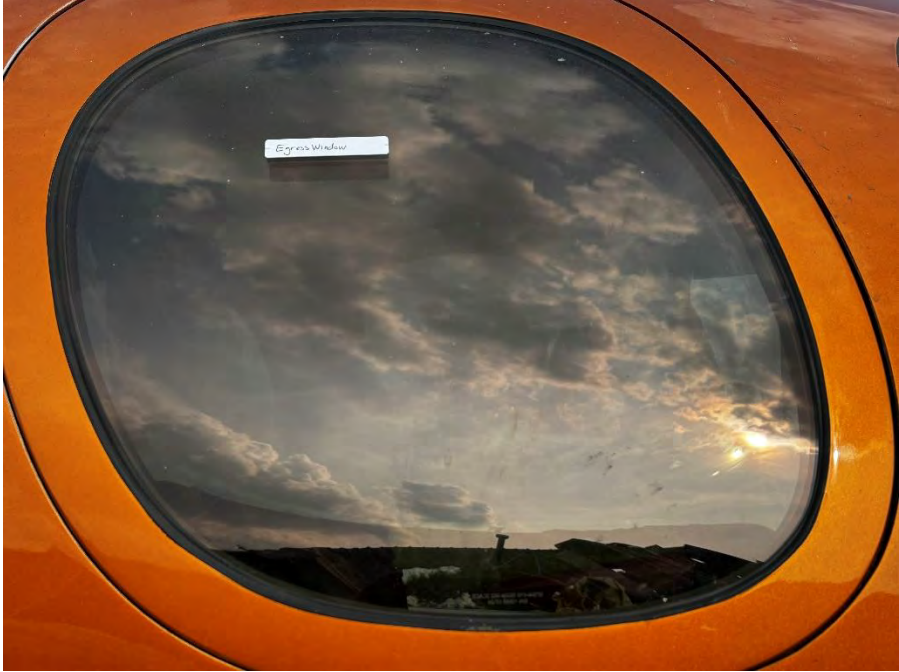
62. Component - Egress Window / Component - Damage Beyond Repair

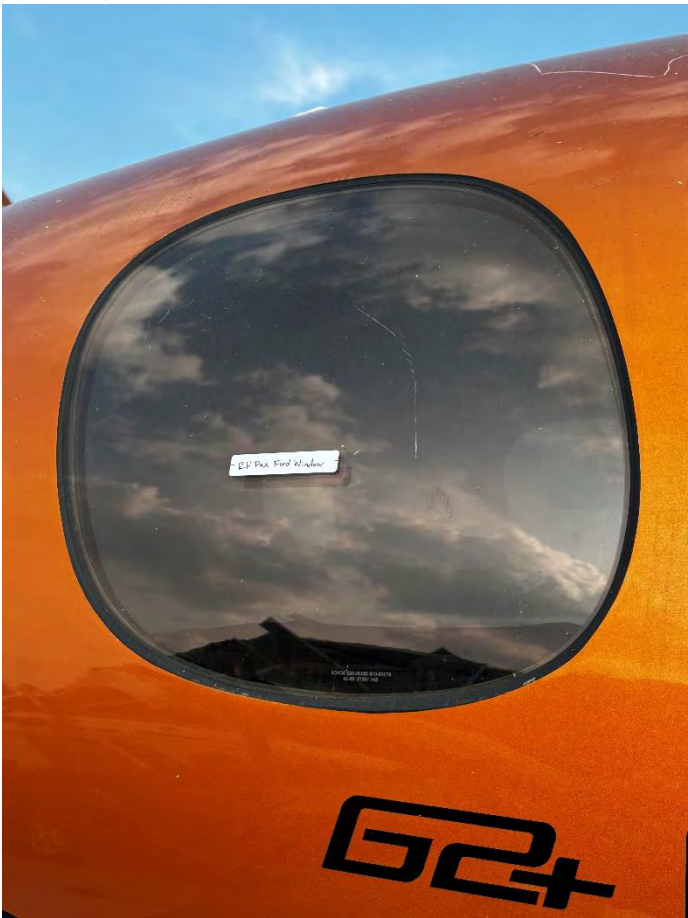
63. Component - RH Pax Fwd Window / Component - Damage Beyond Repair

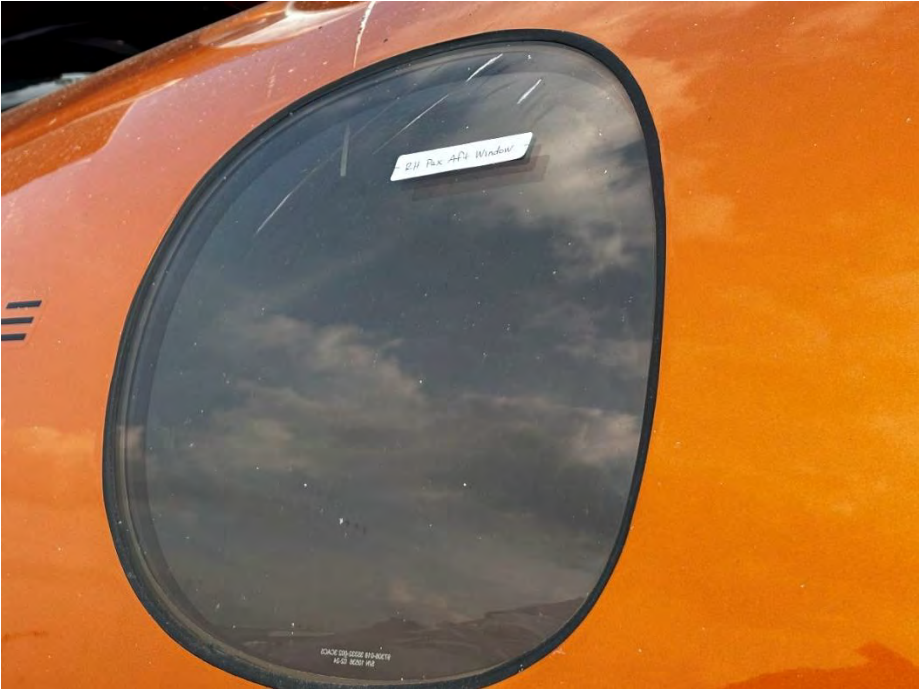
64. Component - RH Pax Aft Window / Component - Damage Beyond Repair

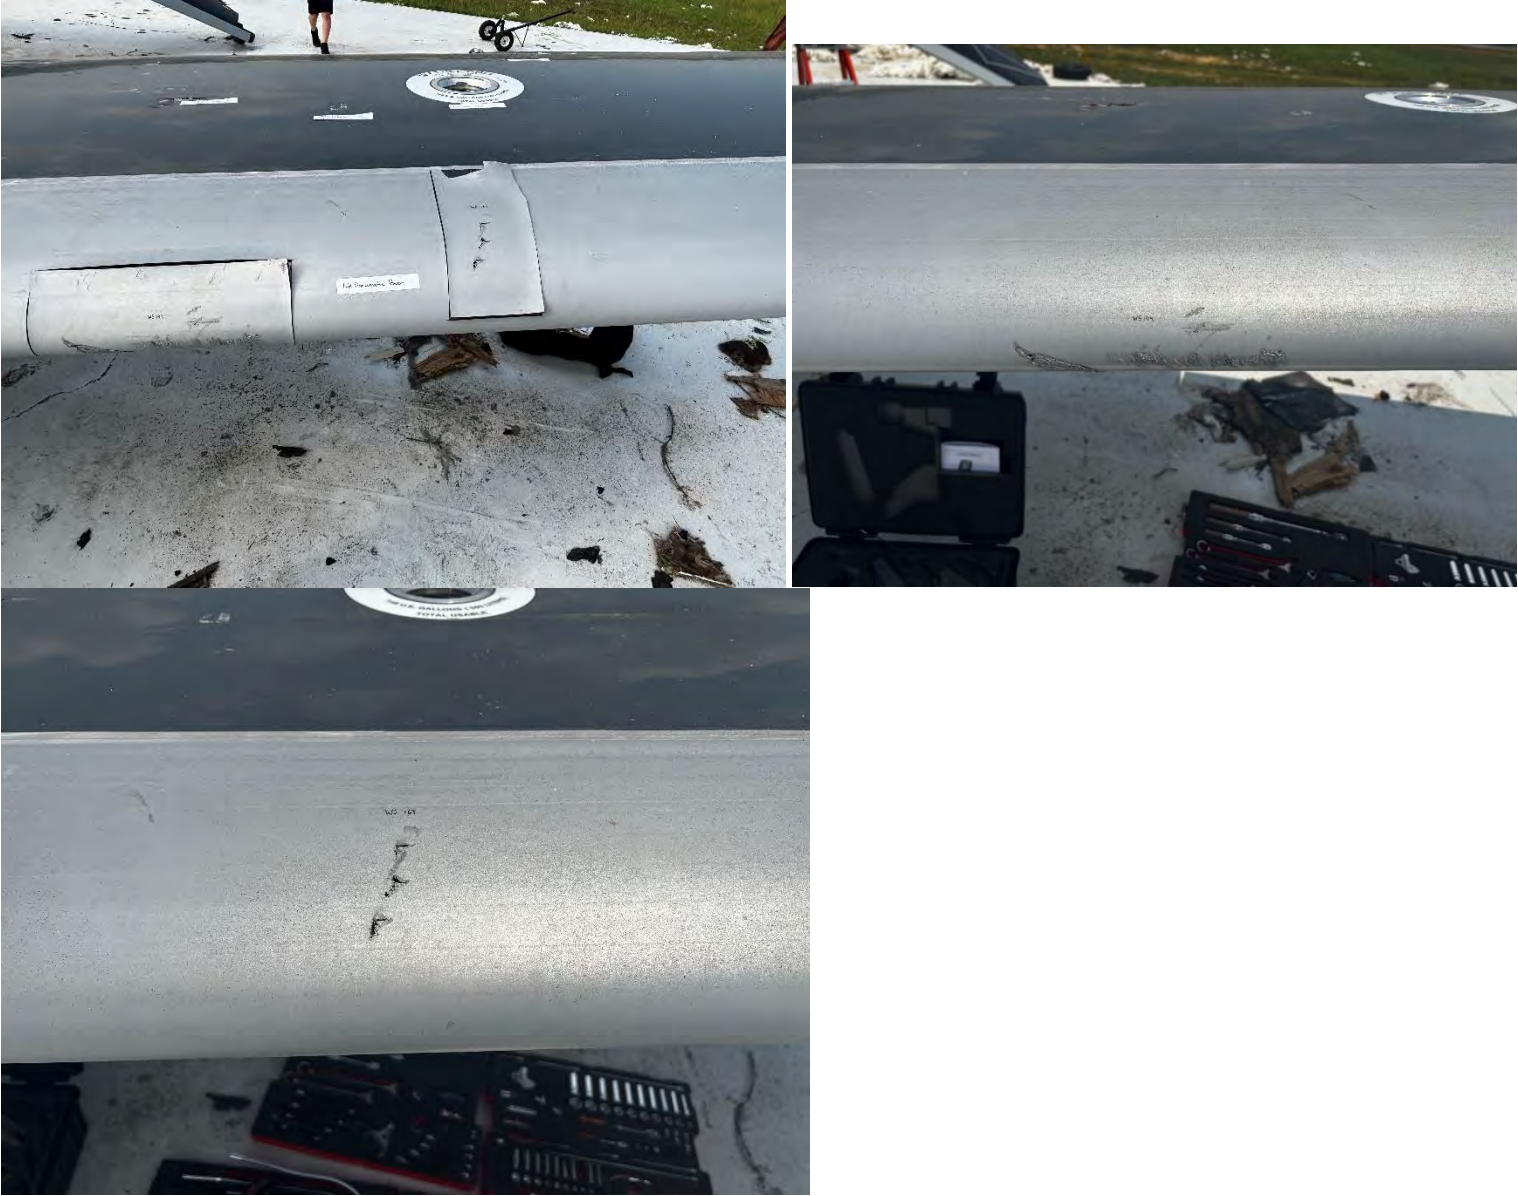
65. Component - LH Pneumatic De-Ice Boot / Component - Damage Beyond Repair

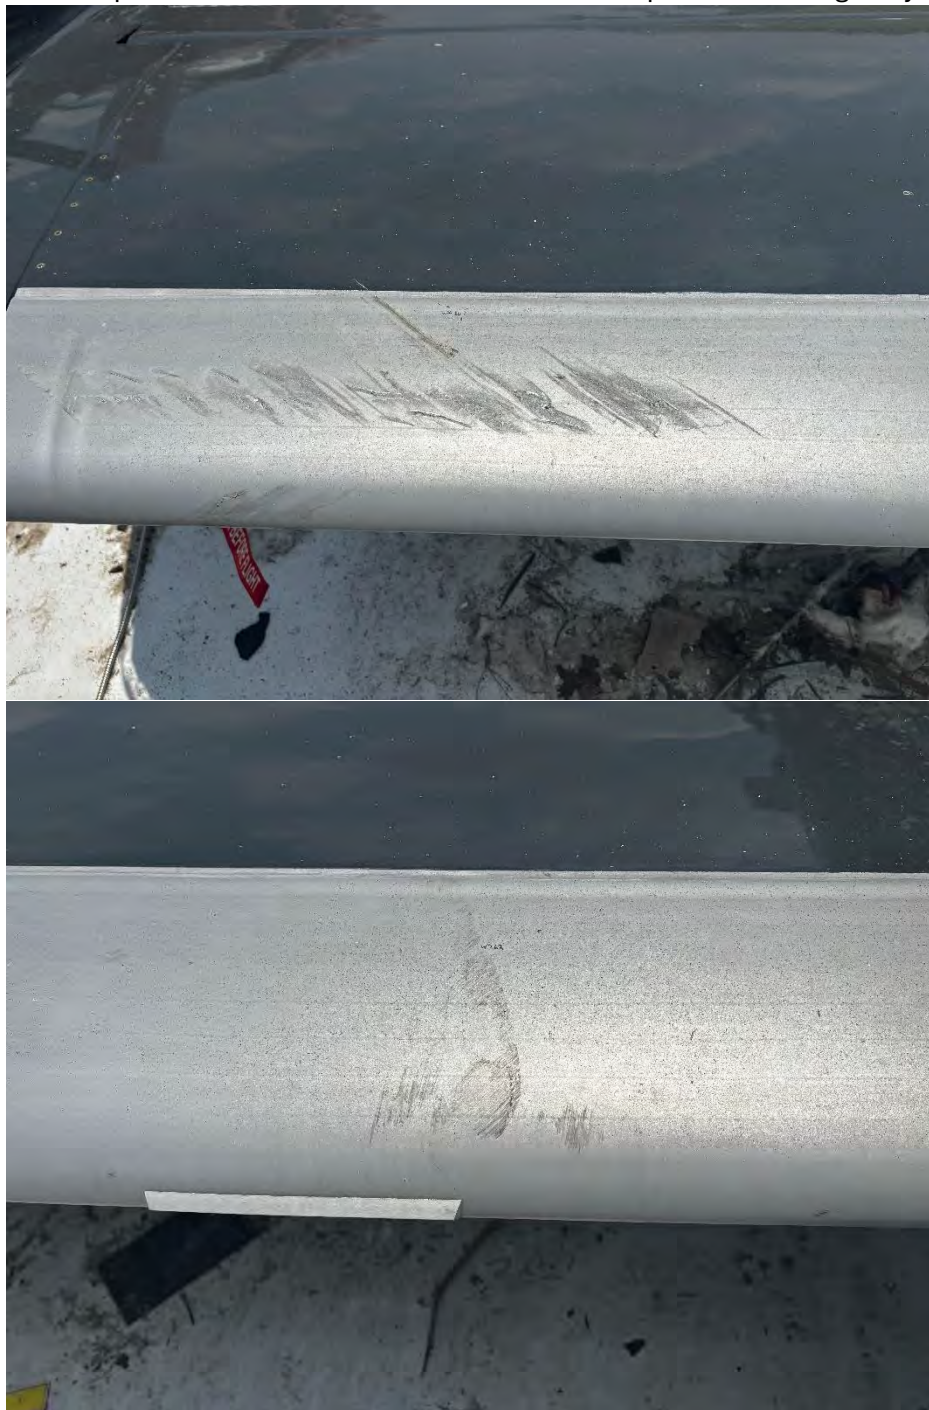
66. Component - RH Pneumatic De-Ice Boot / Component - Damage Beyond Repair

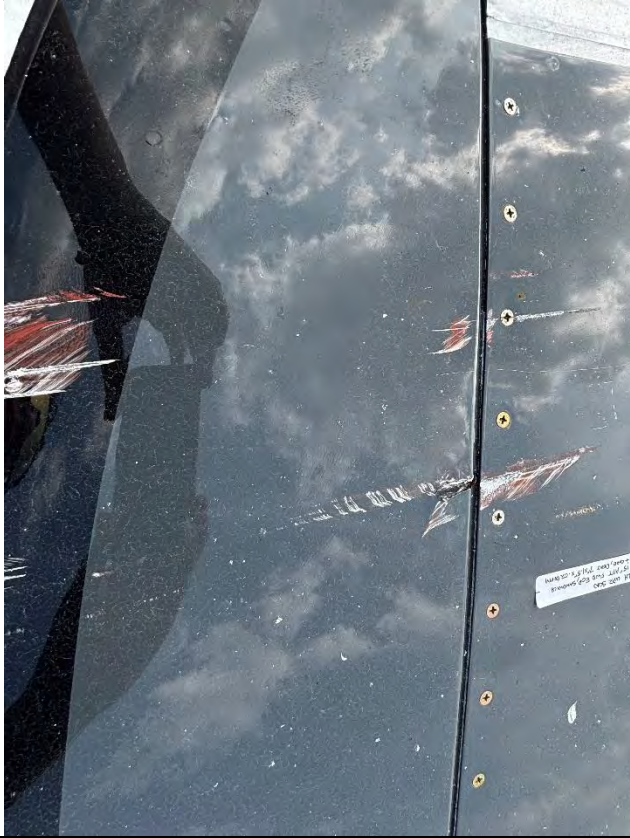
68. Composite Detail Part- LH Wingtip / Component - Damage Beyond Repair

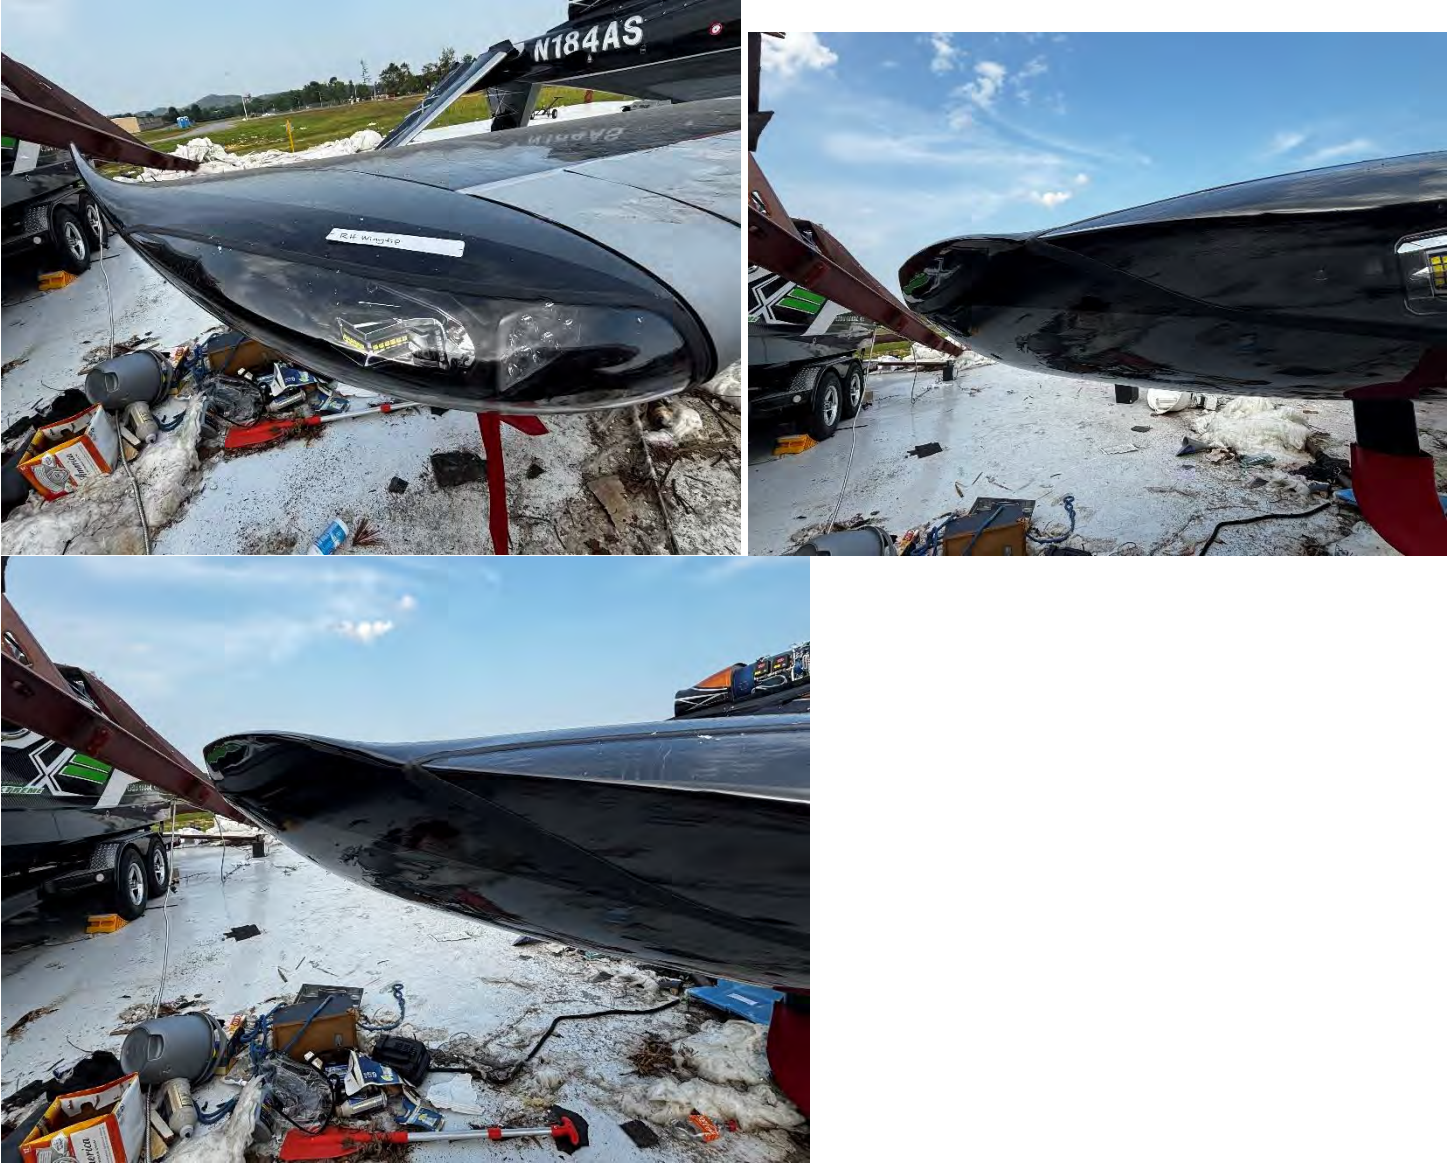
69. Composite Detail Part - RH Wingtip / Component - Damage Beyond Repair

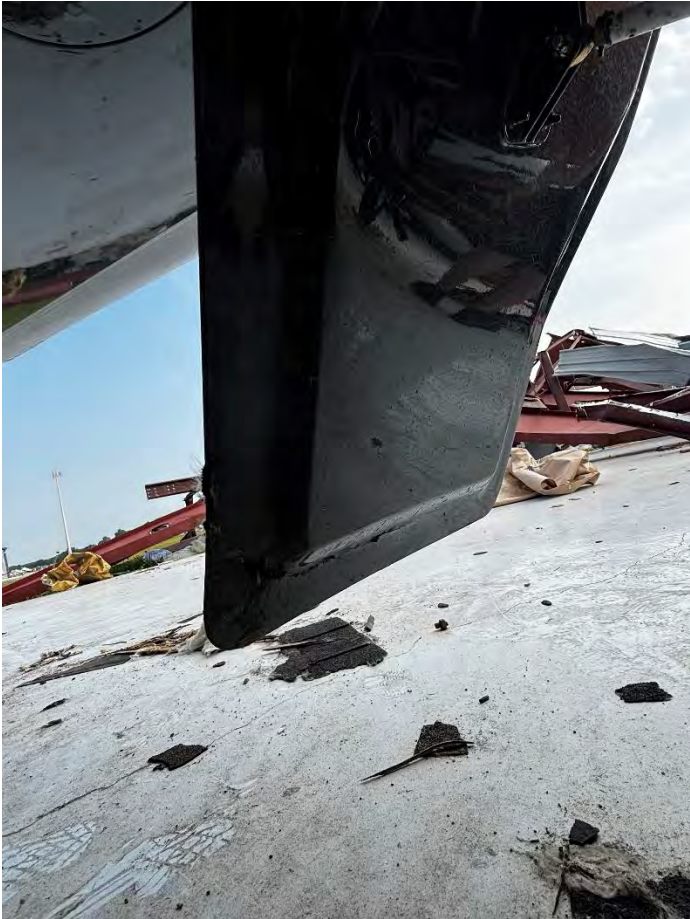
70. Composite Detail Part - LH MLG Door / Component - Damage Beyond Repair

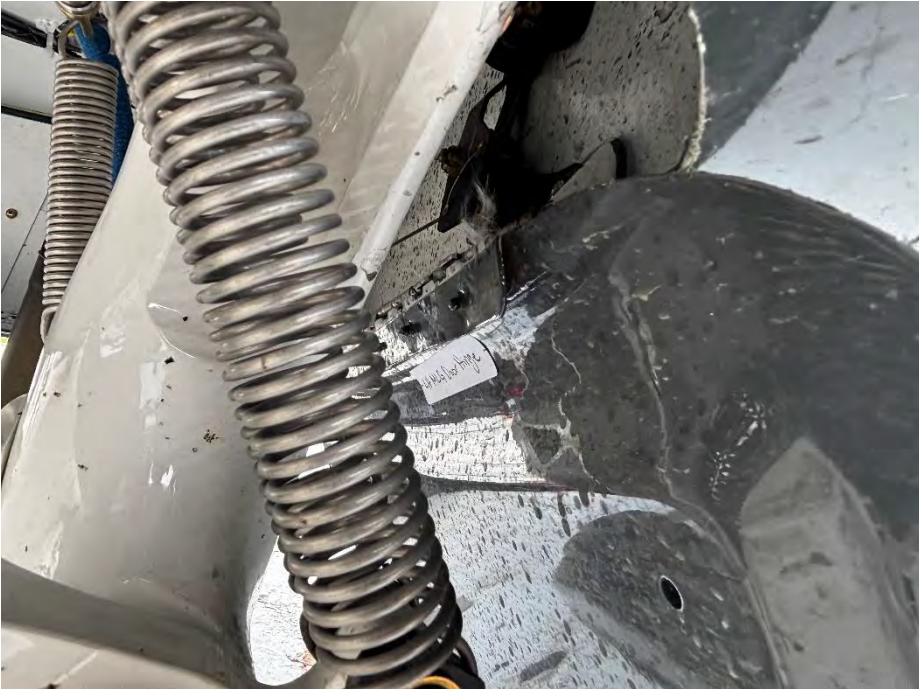
71. Component - LH MLG Door Hinge / Component - Damage Beyond Repair
