AIRCRAFT DAMAGE ASSESSMENT REPORT

Model:	SF50	Registration:	N184AS	Serial:	0585	Hobbs:	114.1	Flight Hours:	95.4
Location:	KLOZ London, KY			A/C Operator:					
Work Order #:	DLH23637-06-2025			Date of Damage:	5/16/2025				
Cirrus Case #:	00449020			Report Completed:	6/9/2025				
Inspector:		Phone:		Email:					
DOM:		Phone:		Email:

Hangar Collapse Due to Tornado

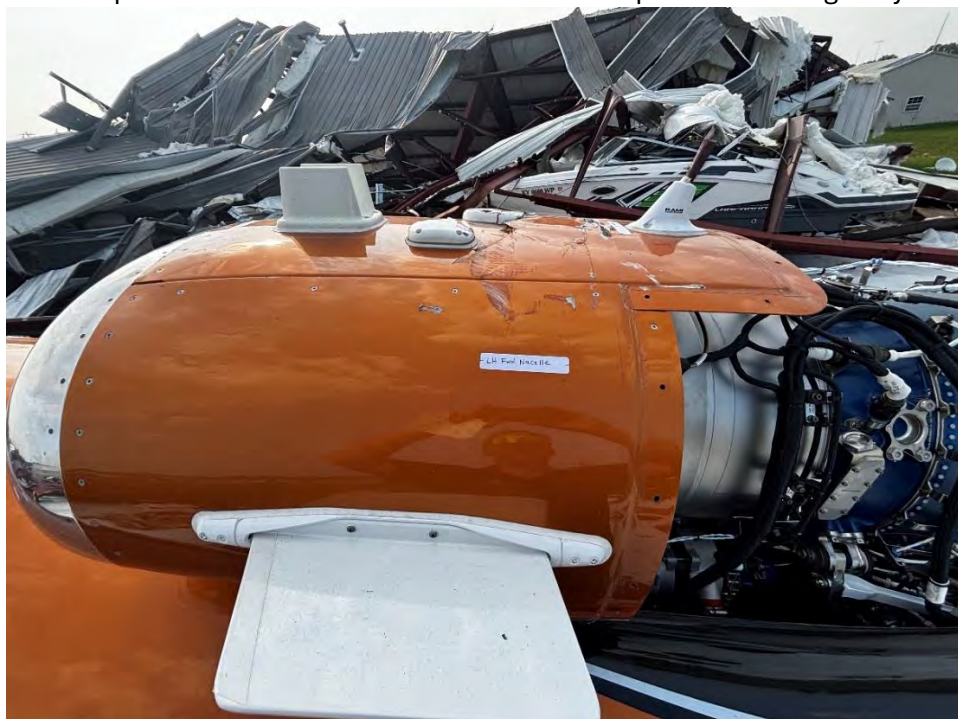
72. Composite Detail Part - LH Fwd Nacelle / Component - Damage Beyond Repair

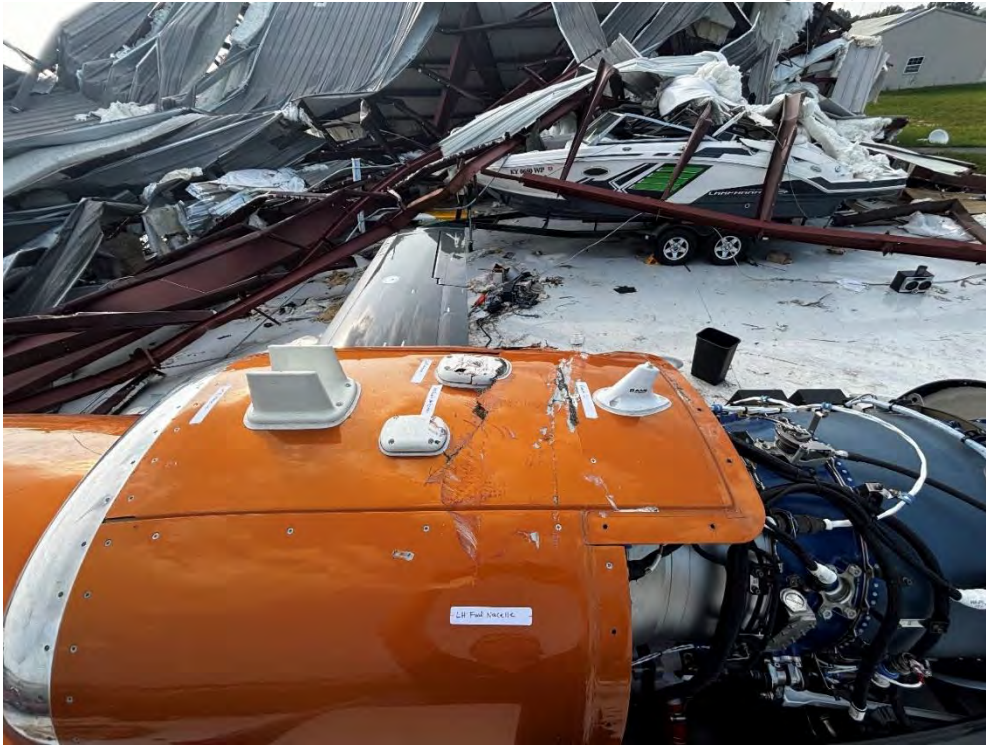
74. Composite Detail Part - UPR Nacelle / Component - Damage Beyond Repair

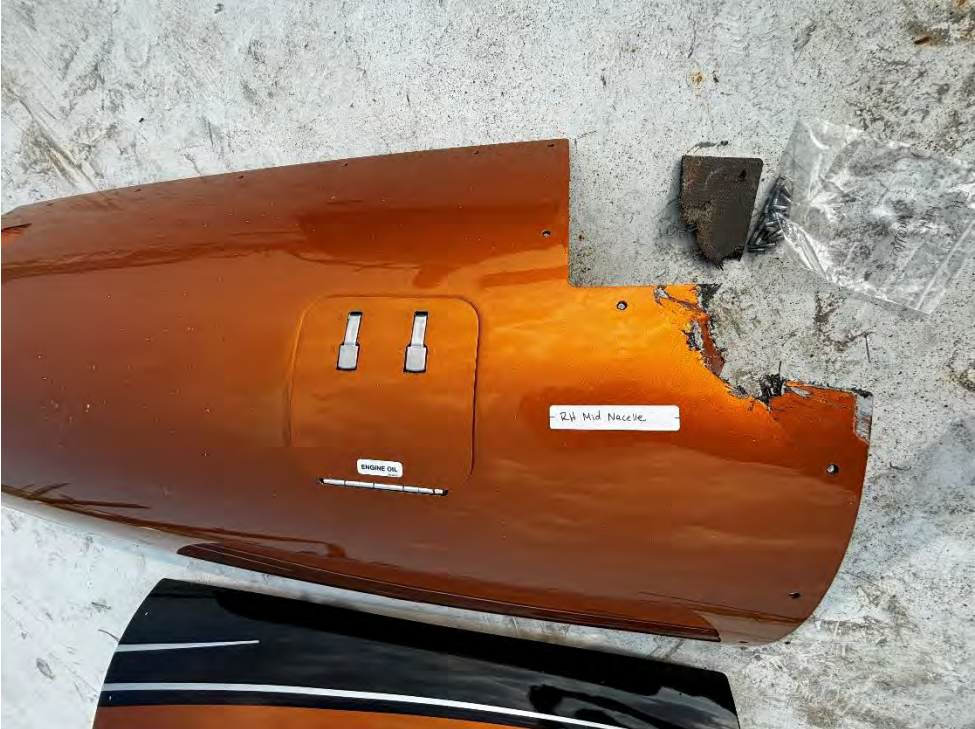
75. Composite Detail Part - RH Mid Nacelle / Component - Damage Beyond Repair

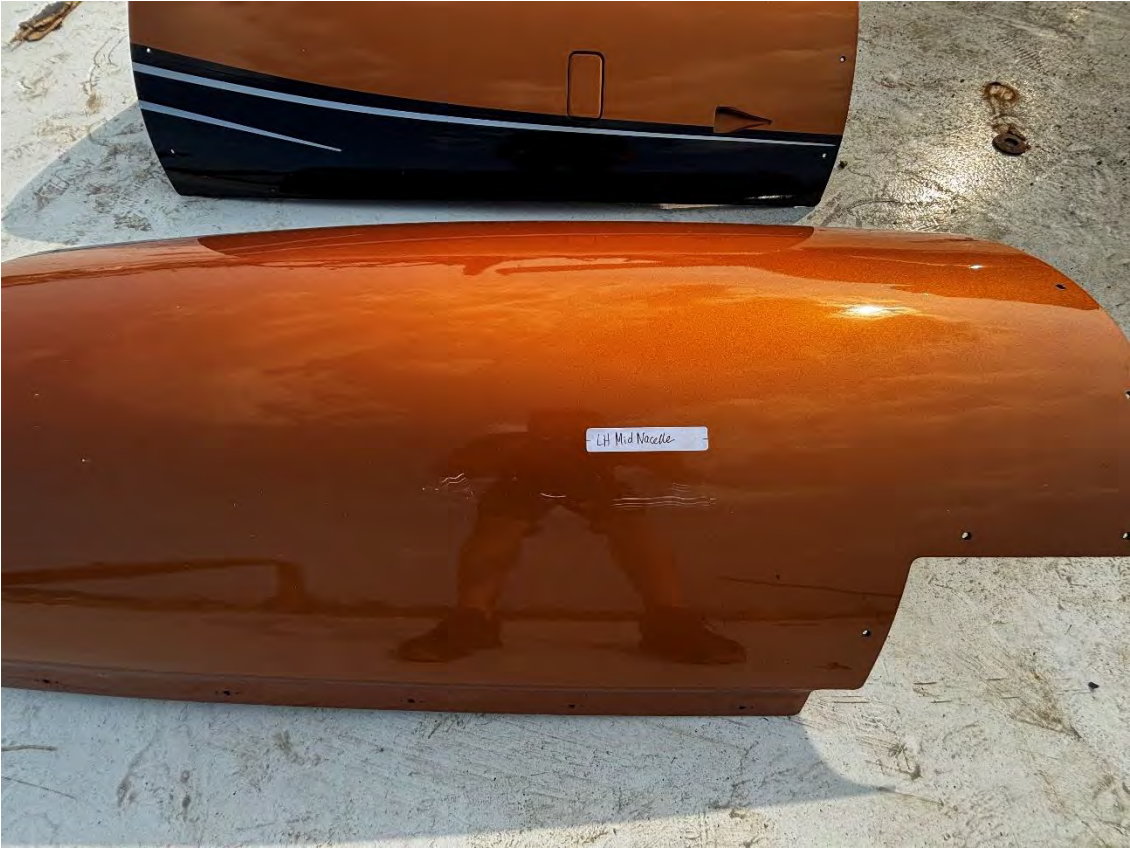
76. Composite Detail Part – LH Mid Nacelle / Component - Cosmetic / Scratches

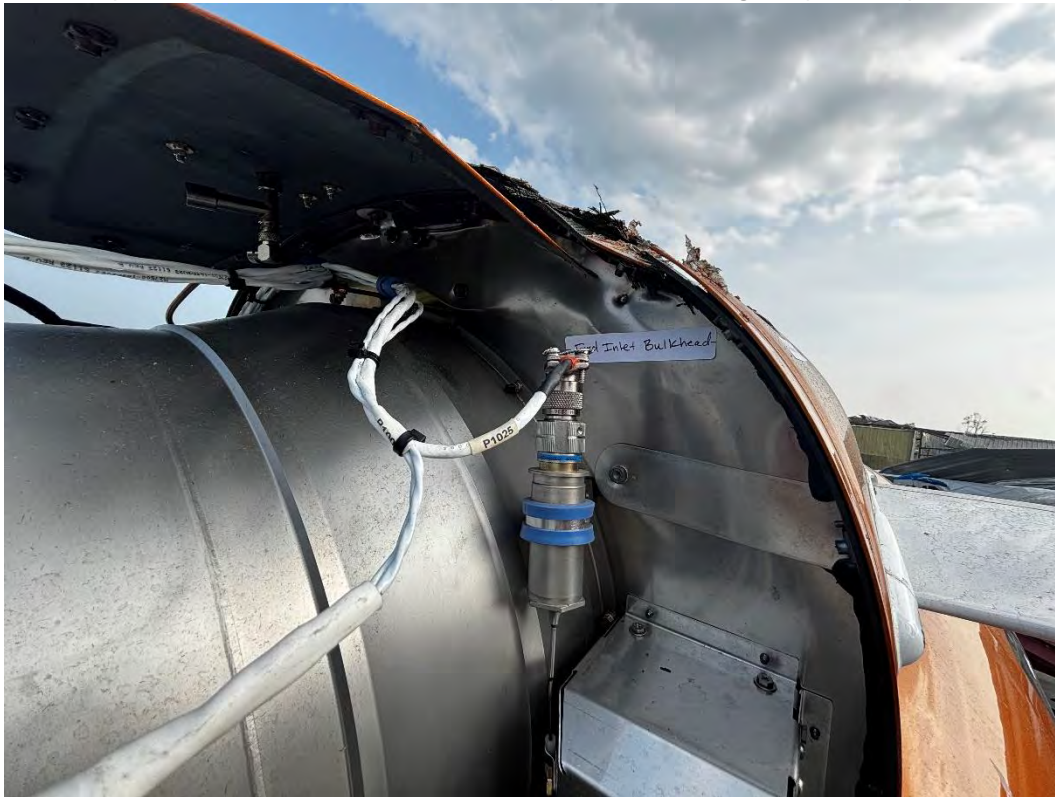
77. Component - Fwd Inlet Bulkhead / Component - Damage Beyond Repair

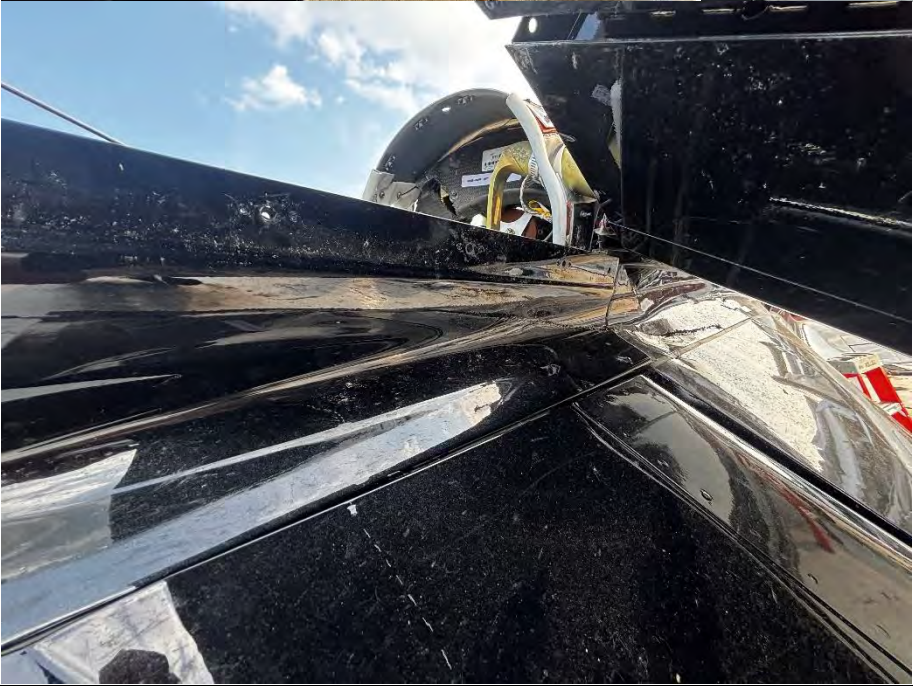
79. Composite Detail Part - LWR Tailcone / Component - Damage Beyond Repair

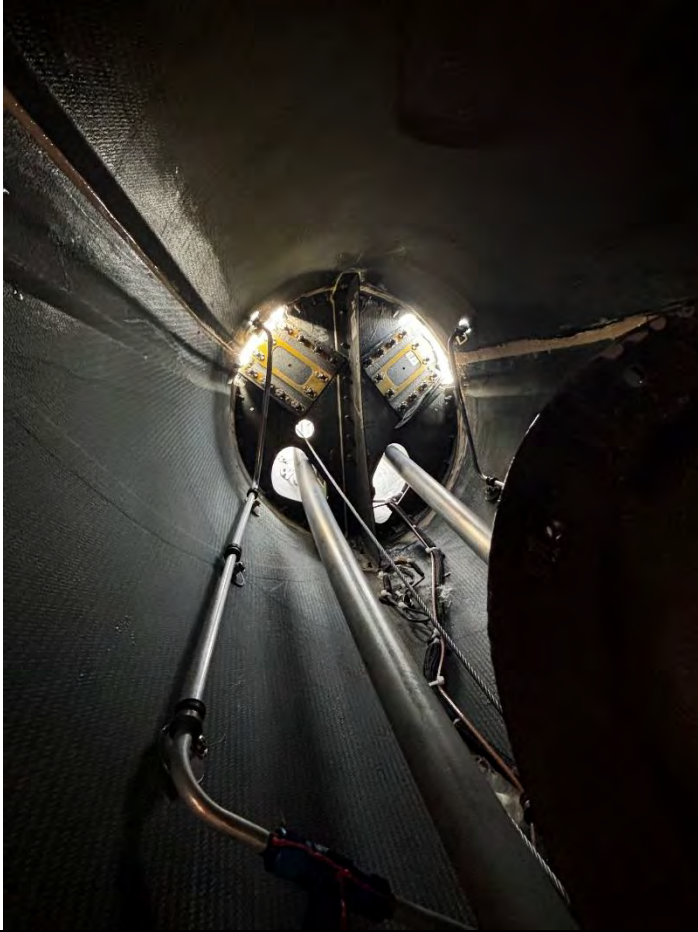
80. Component - LH Ruddervator Pushrod / Component – Bent / Damage Beyond Repair

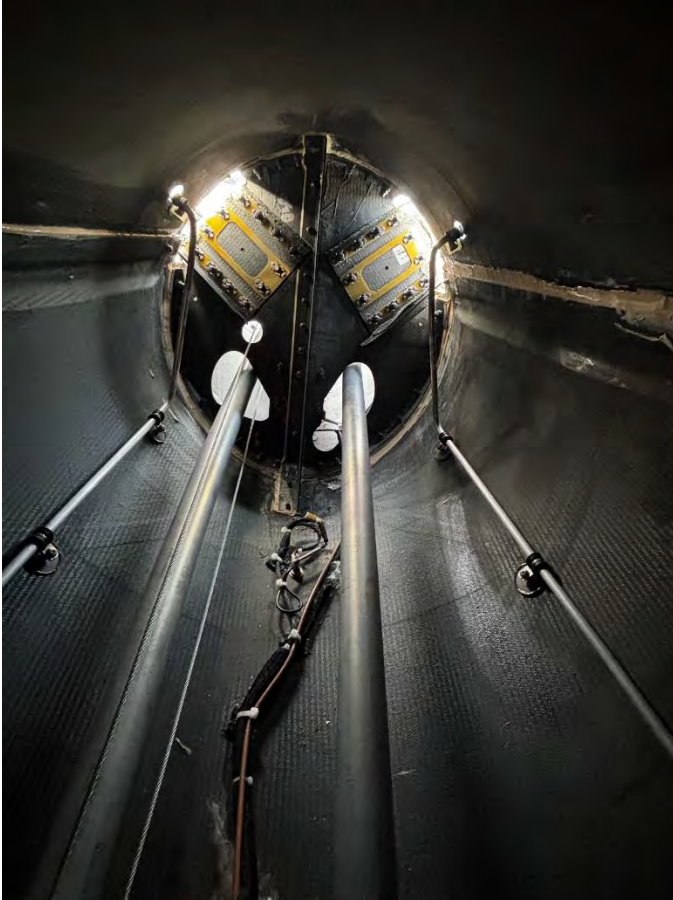
81. Component - RH Ruddervator Pushrod / Component - Bent / Damage Beyond Repair

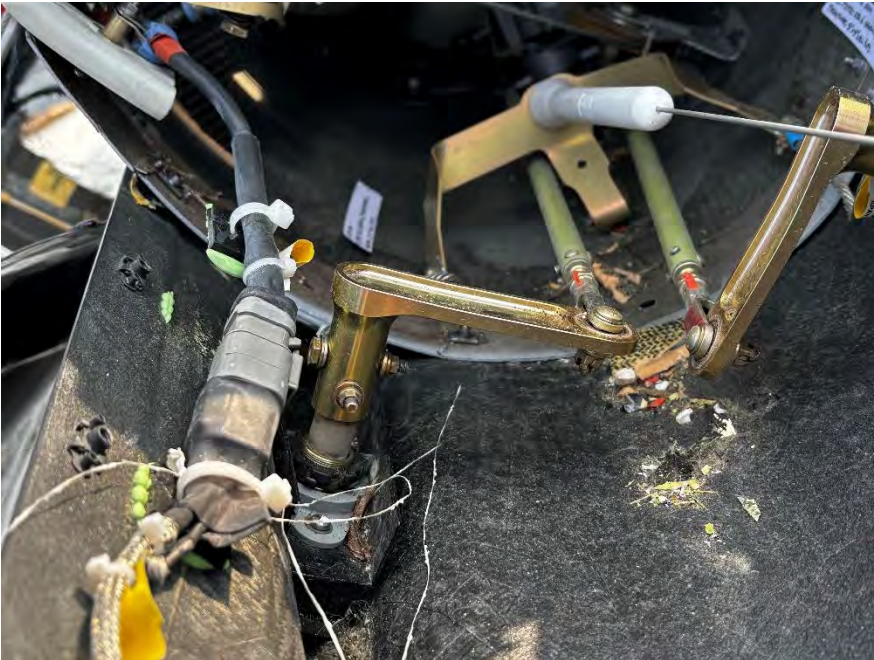
82. Component - LH Yaw SAS Pushrods / Component - Damage Beyond Repair

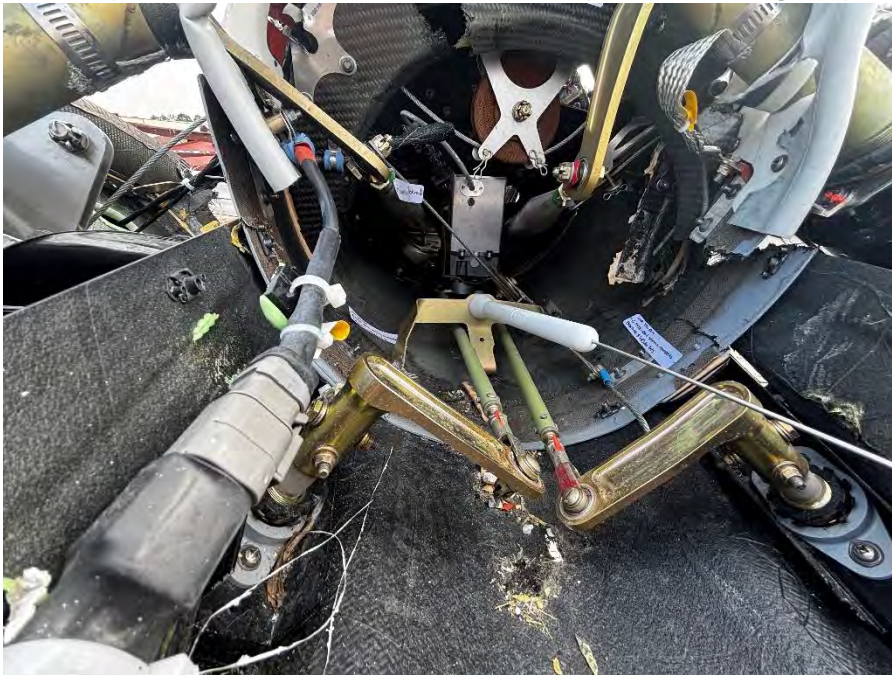
83. Component - RH Yaw SAS Pushrods / Component - Damage Beyond Repair

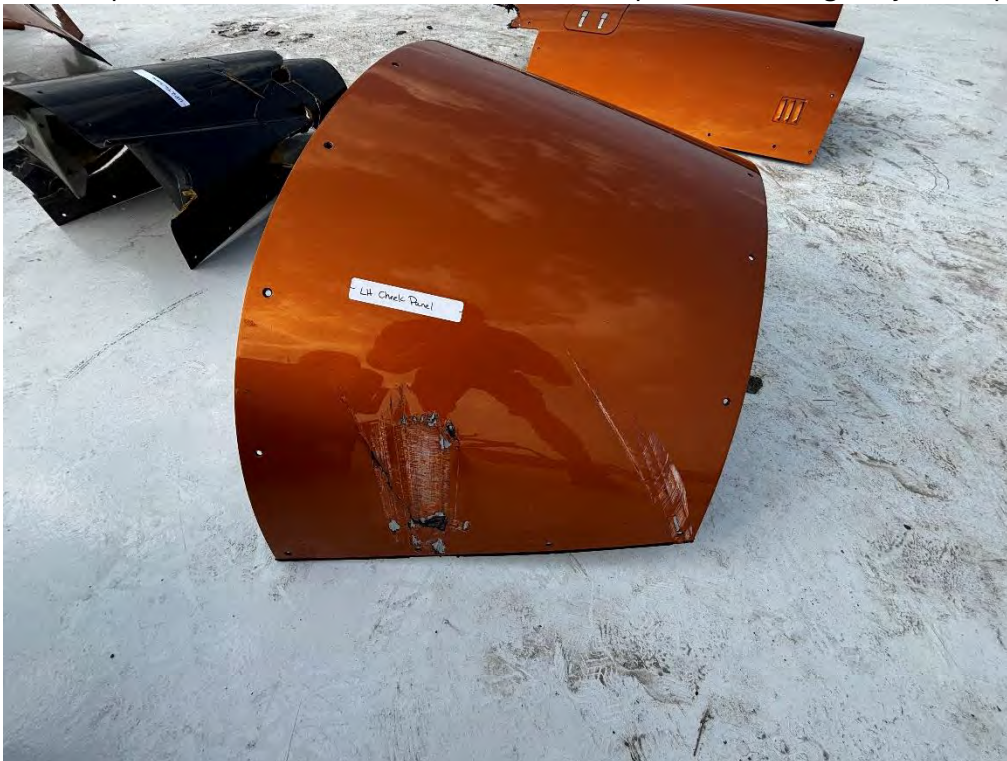
84. Composite Detail Part - LH Cheek Panel / Component - Damage Beyond Repair

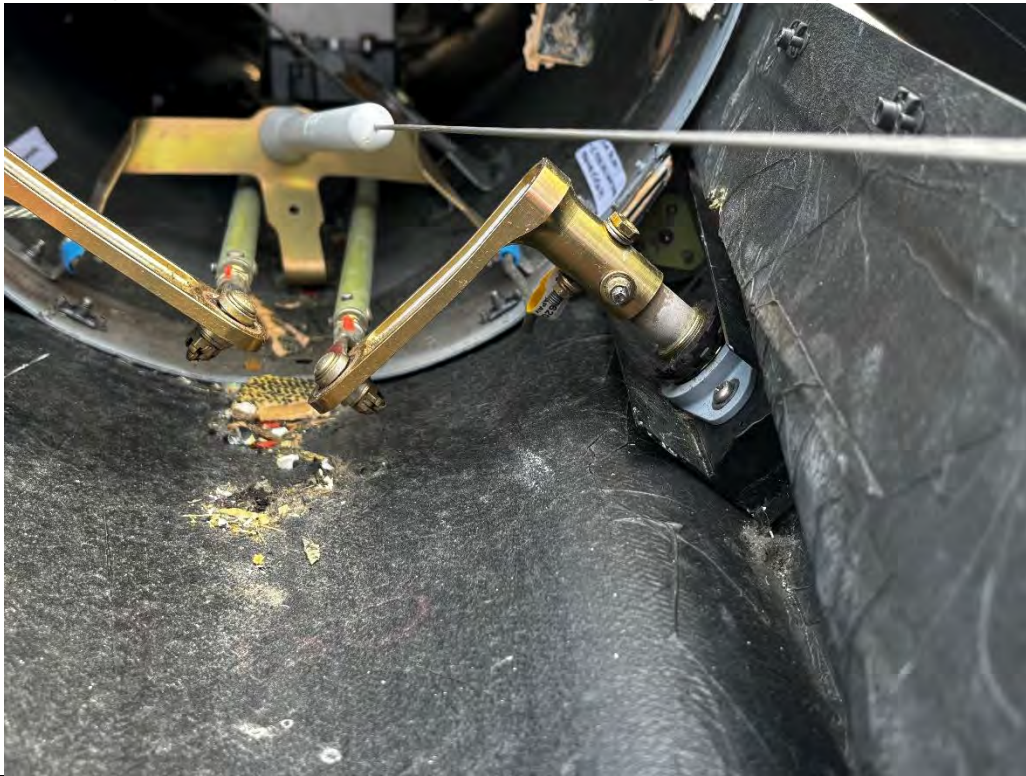
86. Component - ELT Bracket / Component - Damage Beyond Repair

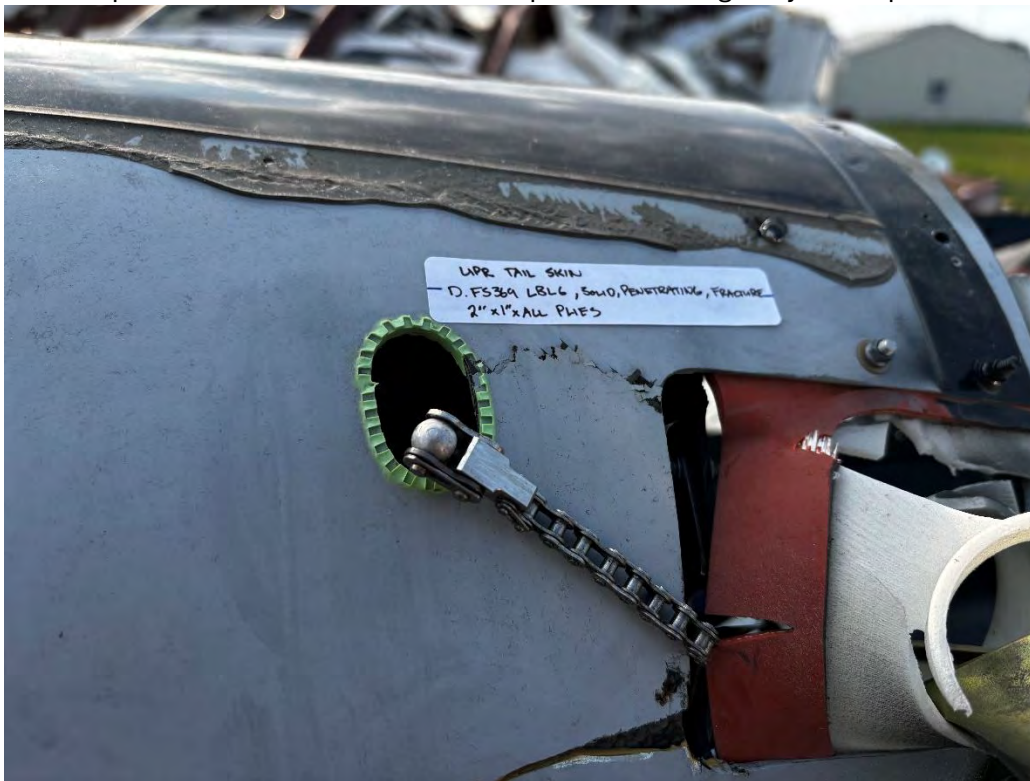
87. Component - Pitch Trim Cables / Component - Damage Beyond Repair

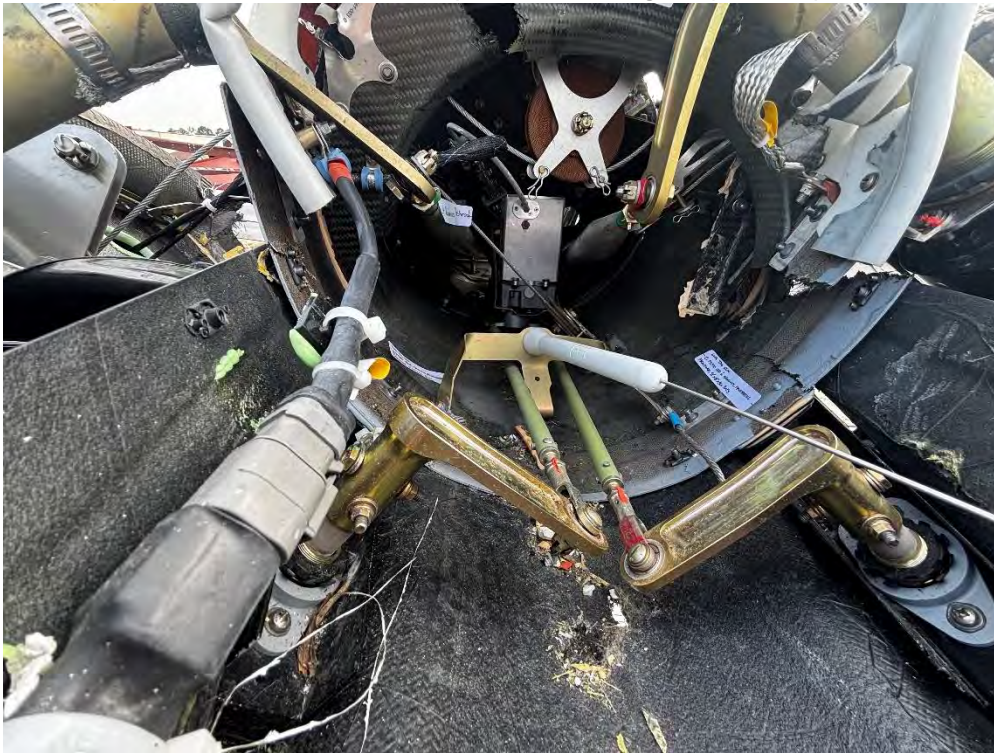
88. Component - Yaw Cables / Component - Damage Beyond Repair

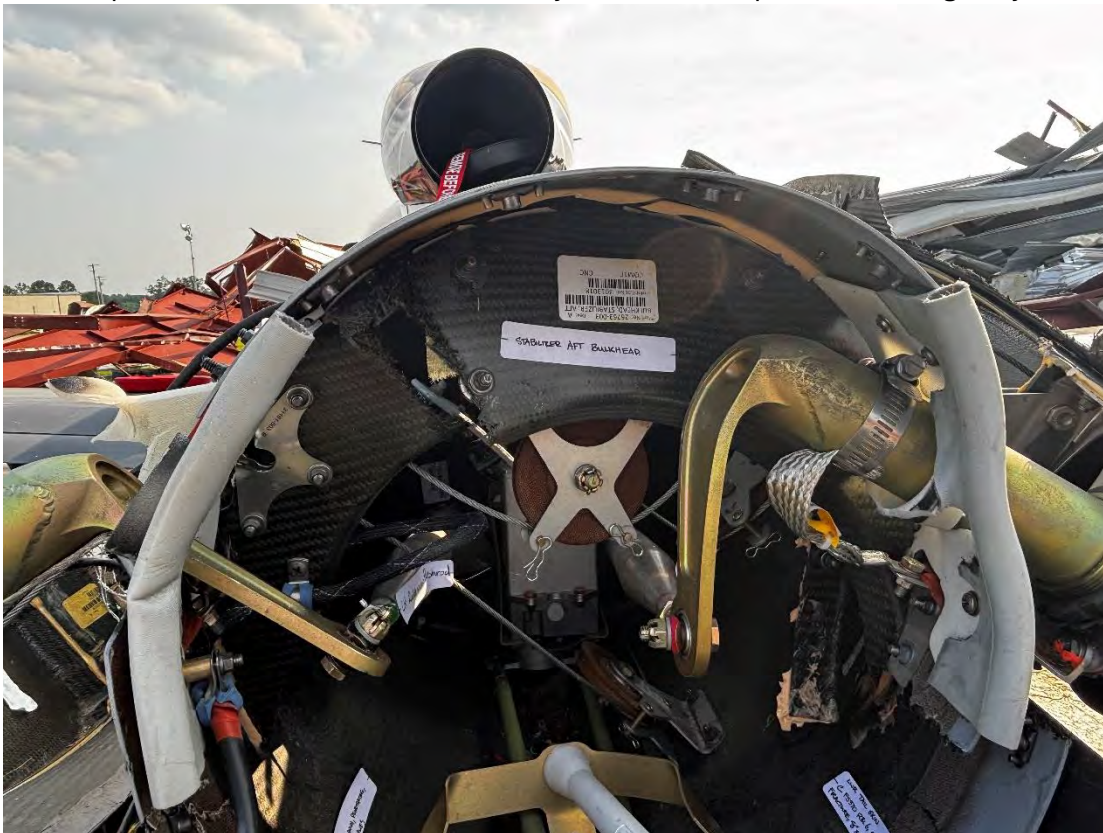
89. Component - Pitch Trim Aft Center Pulley Bracket / Component - Damage Beyond Repair

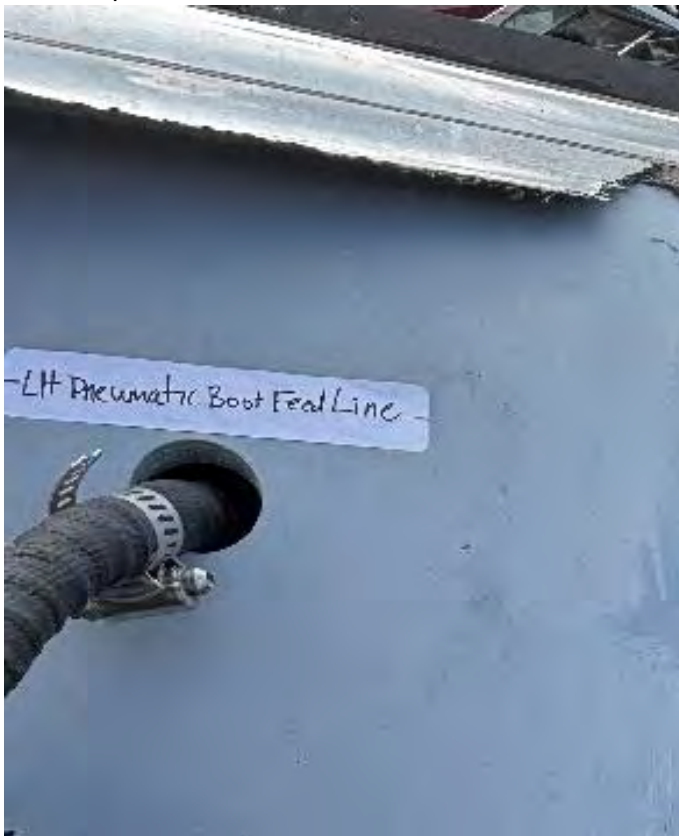
92. Component - LH Pneumatic Boot Feed Line / Component - Damage Beyond Repair

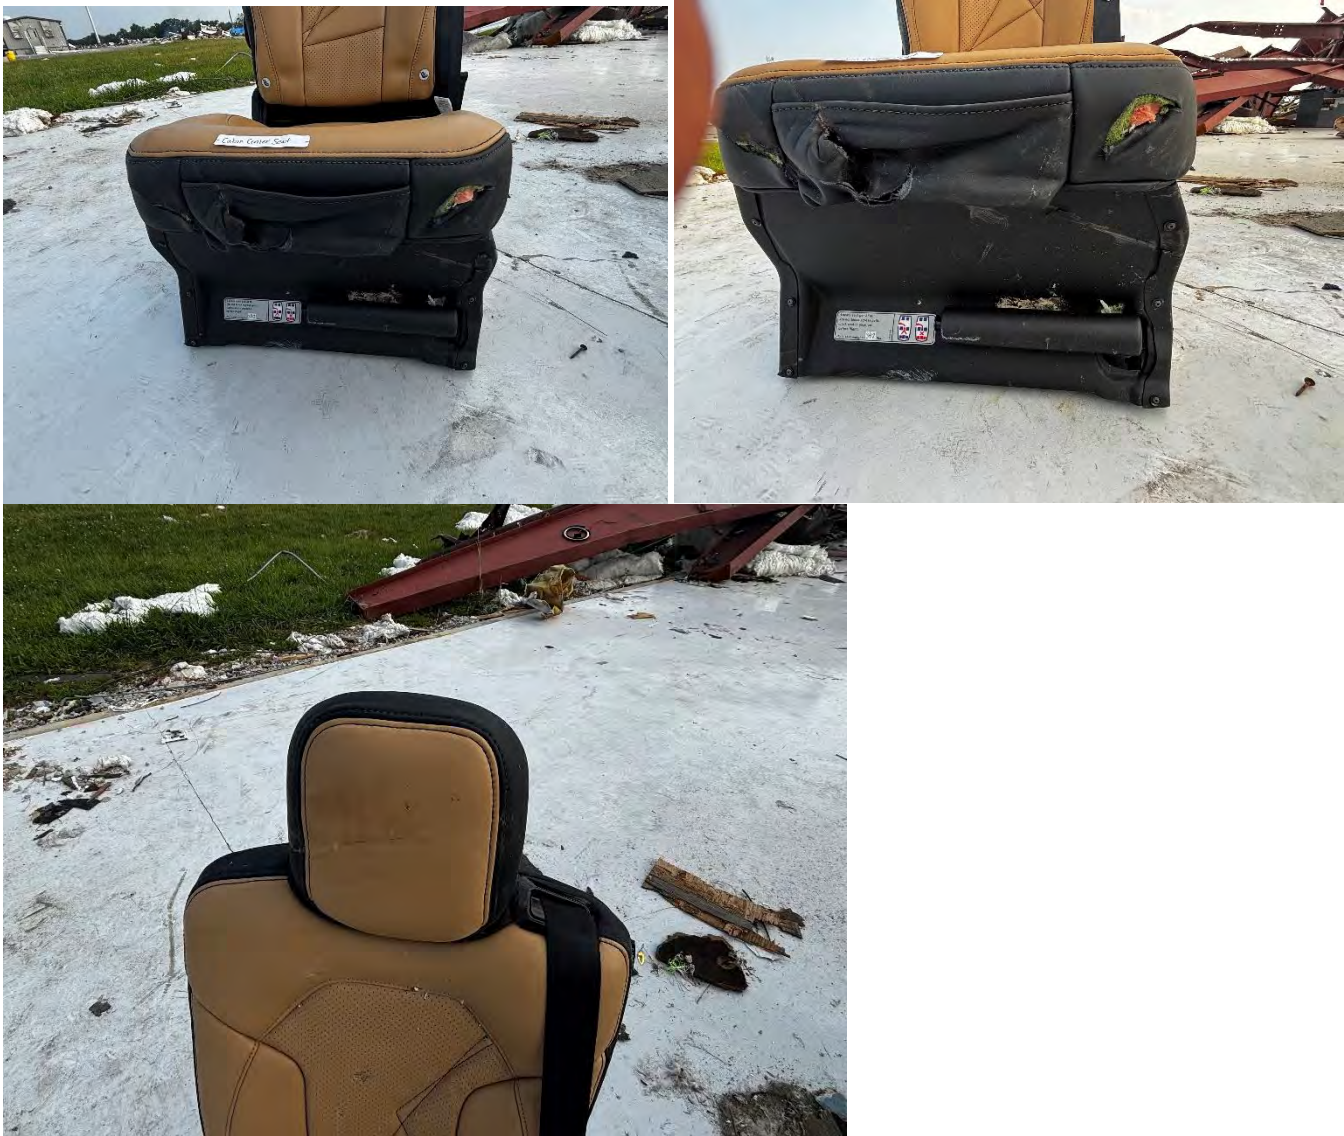
93. Component - Cabin Center Seat / Component - Damage Beyond Repair

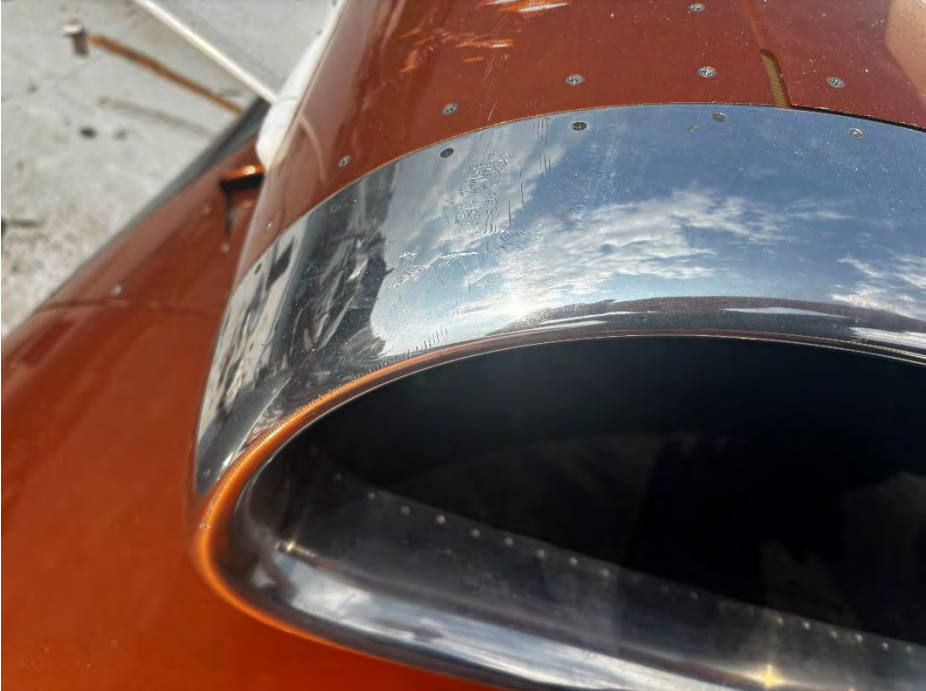
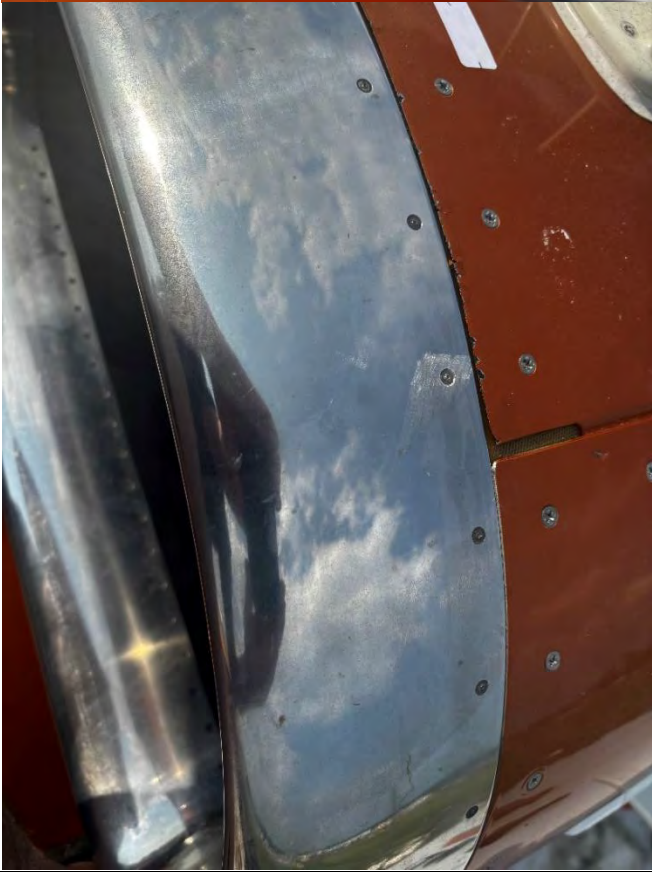
94. Component – Engine Inlet - Gouging / Component – Damage Beyond Repair
