Airframe Entry - Aircraft SN: 145421

Package / Inspection

RECEIVED LH MAIN KANDING GEAR DUE FOR OVERHAUL. NO MAJOR DAMAGE EXTERNALLY NOTED.  
UNIT WILL BE OVERHAULED IN ACCORDANCE WITH LIEBHERR CMM 32-10-01

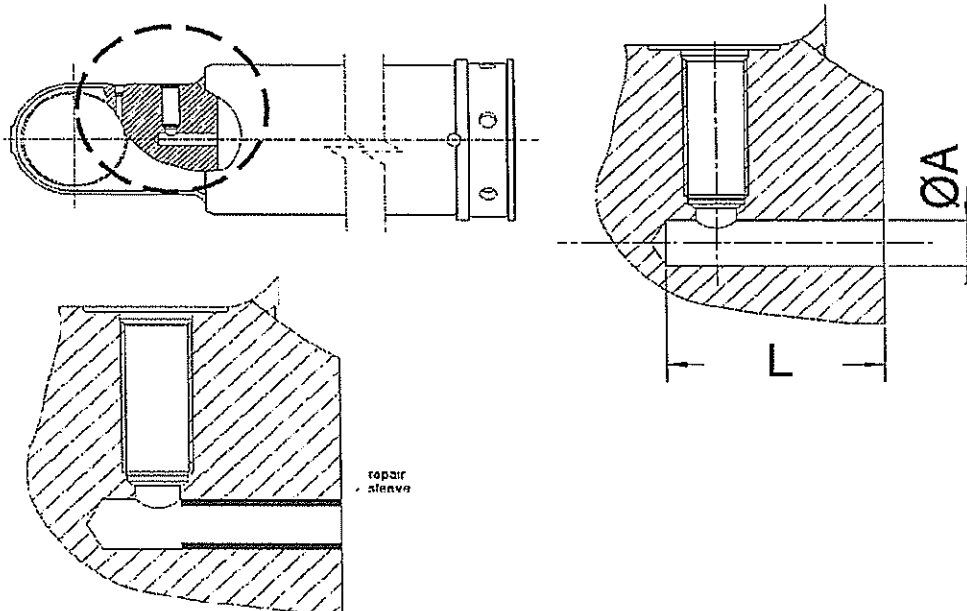
| REFERENCE # | ØA | L |
|---|---|---|
| | 0.3951 | 1.7322 |
| As Received/<br>Post Rework | 0.4660 | 1.8500 |

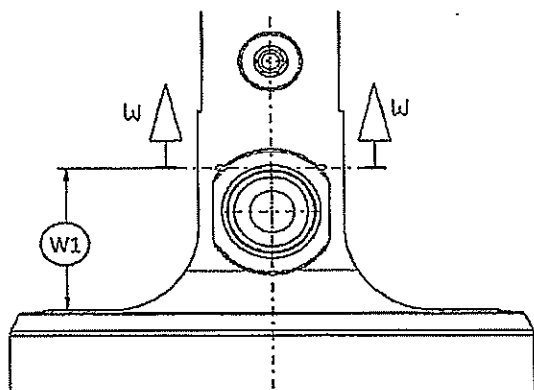
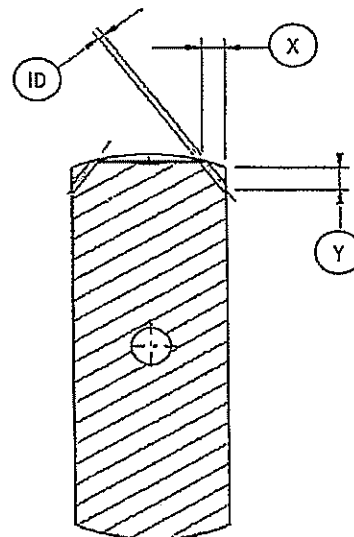
Section view W-W

| REFERENCE # | W1 | ID | X | Y |
|---|---|---|---|---|
| Repair Limit | NOT<br>APPLICABLE | NOT<br>AVAILABLE | NOT<br>AVAILABLE | NOT<br>AVAILABLE |
| As Received/<br>Post Rework | 1.3400 | 0.0680 | 0.200 | 0.1970 |

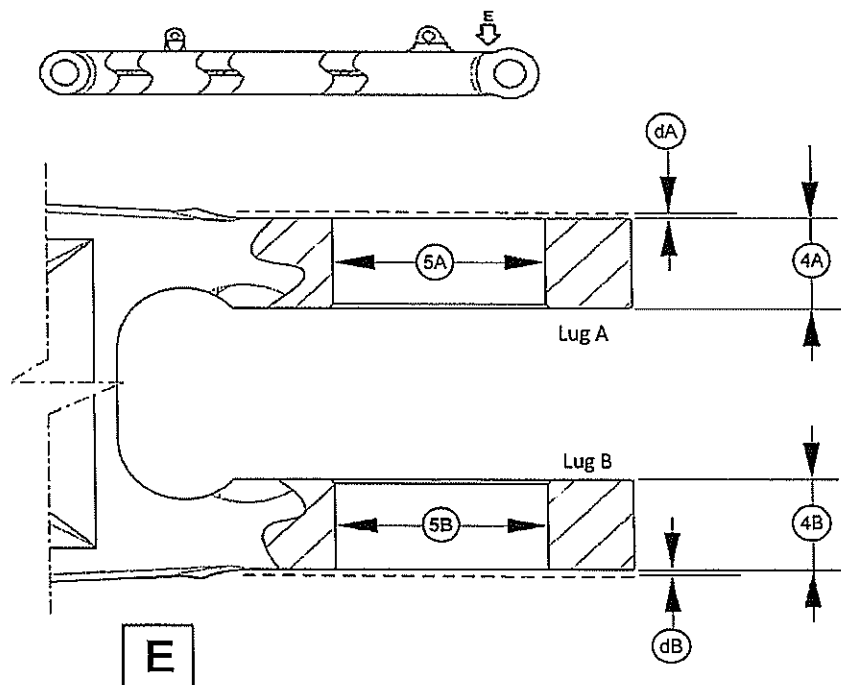
| REFERENCE # | 4A | 4B | 5A | 5B | dA (removed) | dB (removed) |
|---|---|---|---|---|---|---|
| Repair Limit | MIN<br>0.8167 | MIN<br>0.8167 | 1.9379 | 1.9379 | 0.0314<br>MAX | 0.0314<br>MAX |
| As Received/<br>Post Rework | 0.8300 | 0.8830 | 1.9890 | 1.8903 | 0.0443 | N/A |

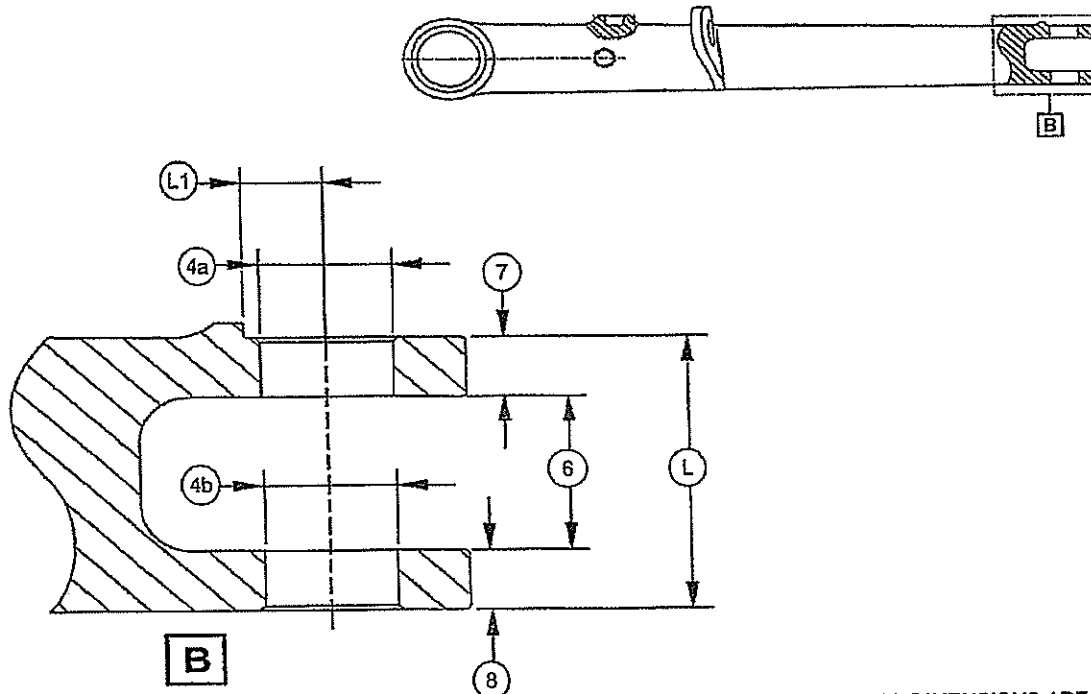
| REFERENCE # | 4a | 4b | L1 | 5 | 7 | 8 | L |
|---|---|---|---|---|---|---|---|
| Repair Limit | 0.5905 | 0.5905 | NOT PROVIDED | 0.7795 *<br>0.7953 * | 0.2362 MIN<br>0.2280 (IDR) | 0.2362 MIN<br>0.2280 (IDR) | NOT PROVIDED |
| As Received/<br>Post Rework | 0.5773 | 0.5773 | 0.3520 | 0.7760 | 0.2270 | 0.2440 | 1.2460 |
