National Transportation Safety Board

CEN22LA430

Group Chair's Factual Report

Helicopter: Leonardo AW139, registration N811TA

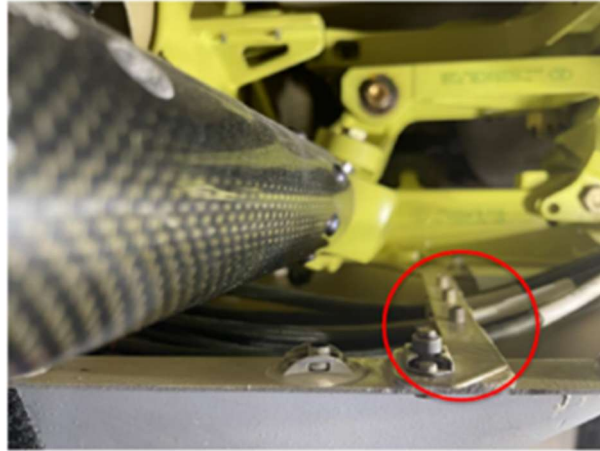
Retaining clips for the wire bundles to the overhead circuit breaker panel are meant to route the wire bundles under the support strip at C3 as required by the engineering drawings (Photo 9).

Wires **below** metal support

Photo 9: Wire Correctly Routed Below the Support Strip (Courtesy of Leonardo Helicopter)

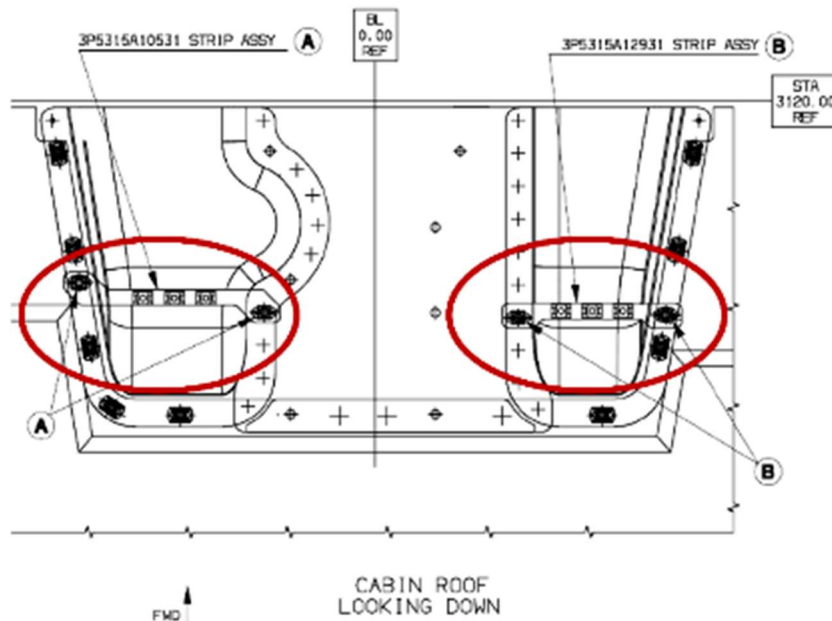
Figure 3: Page 3 of Version 8 of the 3NB Pax Ceiling Panel Closeout Job Card (Red Highlights Modified by NTSB)

The page following the diagrams stated: "ENSURE THAT THE MOVING PARTS OF THE FLIGHT CONTROL RODS IN THE AREA HAS ATLEAST 0.5 INCH CLEARANCE FROM THE SURROUNDING FIXED PARTS." No mention, or specific instructions for inspection, of wiring was called for in these cards.

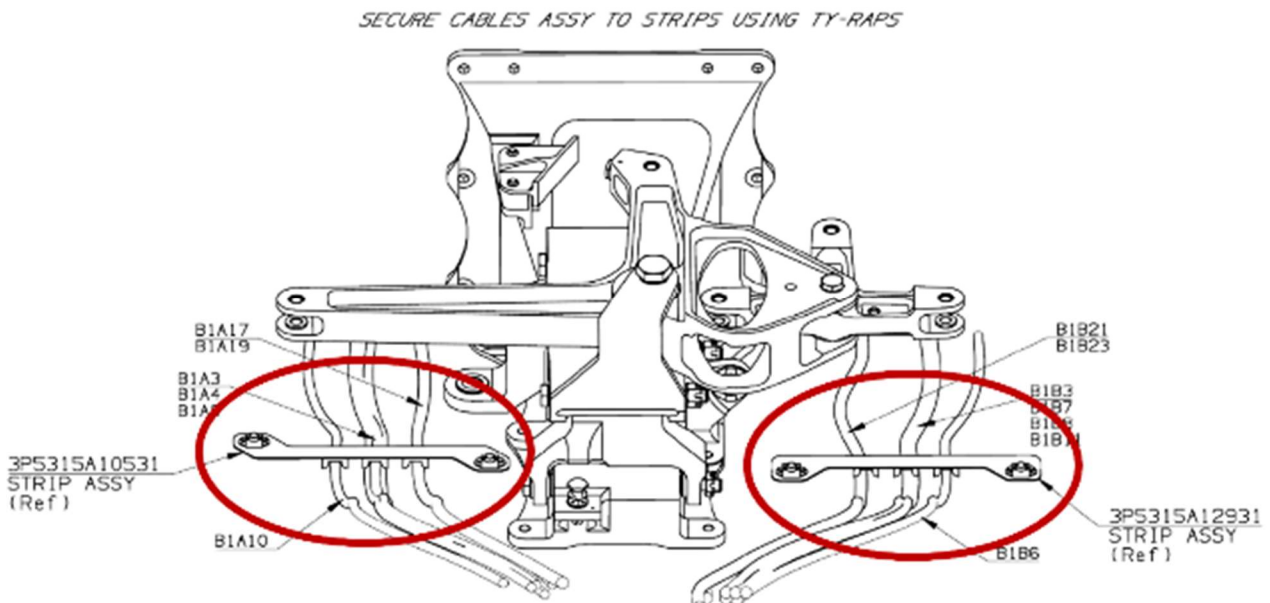
Figure 4: Page 4 of Version 8 of the 3NB Pax Ceiling Panel Closeout Job Card (Red Highlights Modified by NTSB)

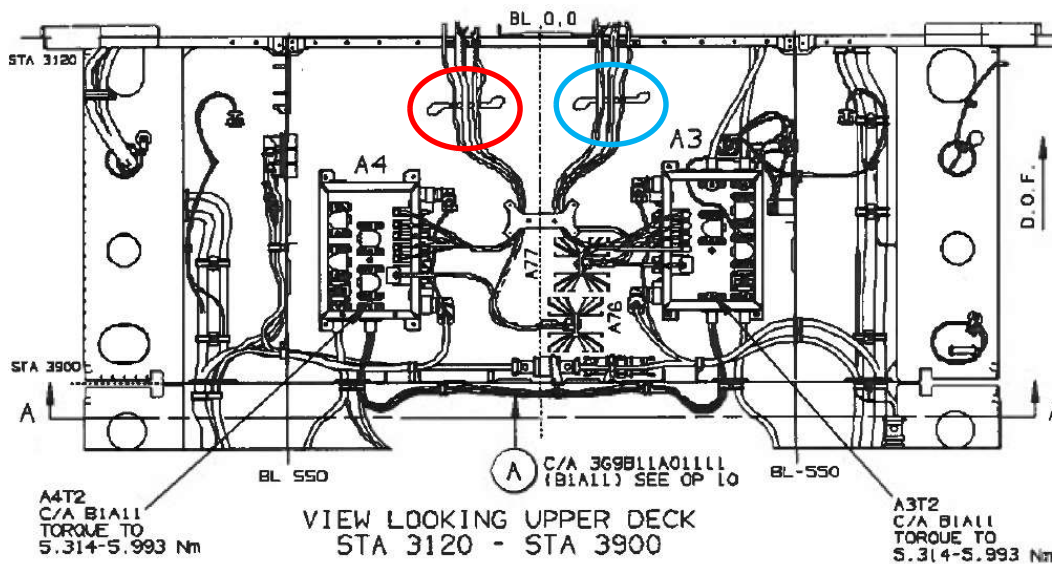
Figure 5. An excerpt from the "Completion and Finishing of Power C/A Card" showing the power cable routing on the roof thru the right strip assembly (red circle) and the left strip assembly (blue circle). This view is looking up to the roof with aircraft forward at the top of the image. (Courtesy of Leonardo, modified by NTSB)

The assembly cards contained views of the left and right strip assemblies installed with power cables routed through them. In the views looking upwards (from within the cabin), the power cables were solid lines with the strip assemblies as solid lines behind them, inferring that routing of the power cables were under the strip assemblies (Figures 6 and 7). Additionally, the shape of the right strip assembly was identical to the left strip assembly in these views, even though the right strip assembly is of a different shape than the left strip assembly. There was no specific instruction to verify that the power cables were routed underneath the strip assembly.

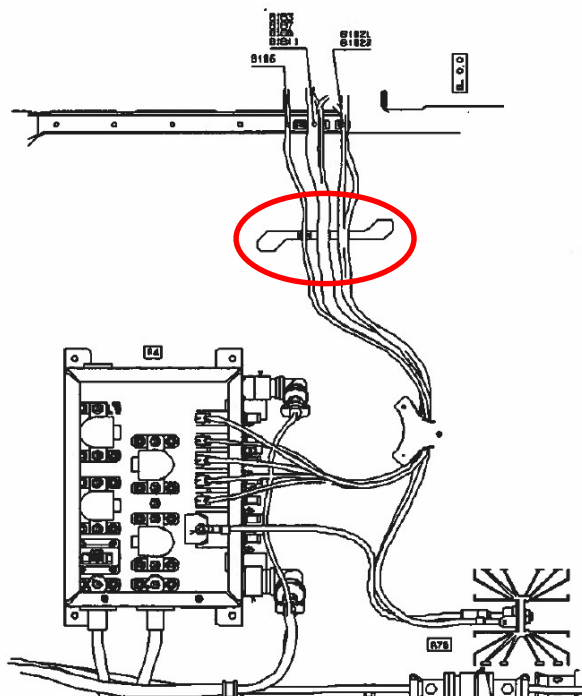
Figure 6. A detail excerpt from the "Completion and Finishing of Power C/A Card" showing the power cable routing on the right strip assembly (red circle). (Courtesy of Leonardo, modified by NTSB)

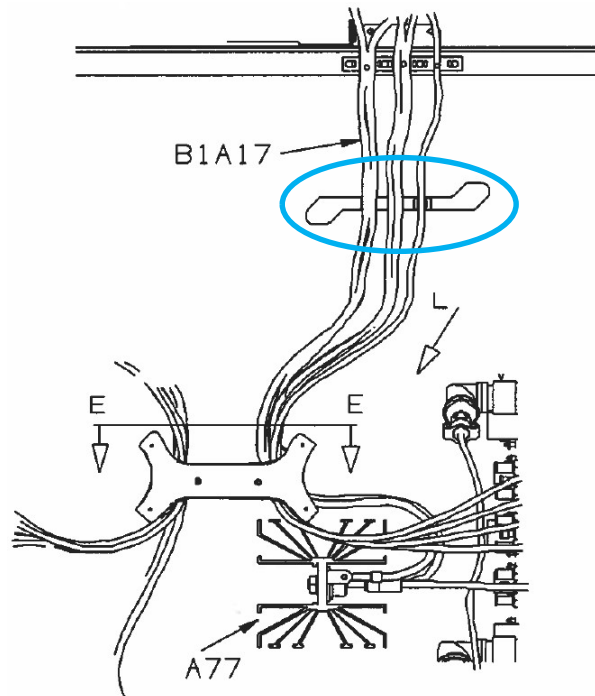
Figure 7. A detail excerpt from the "Completion and Finishing of Power C/A Card" showing the power cable routing on the left strip assembly (blue circle). (Courtesy of Leonardo, modified by NTSB)
