AIRCRAFT DAMAGE ASSESSMENT REPORT

Model:	SF50	Registration:	N184AS	Serial:	0585	Hobbs:	114.1	Flight Hours:	95.4
Location:	KLOZ London, KY			A/C Operator:					
Work Order #:	DLH23637-06-2025			Date of Damage:	5/16/2025				
Cirrus Case #:	00449020			Report Completed:	6/9/2025				
Inspector:		Phone:		Email:					
DOM:		Phone:		Email:

Hangar Collapse Due to Tornado

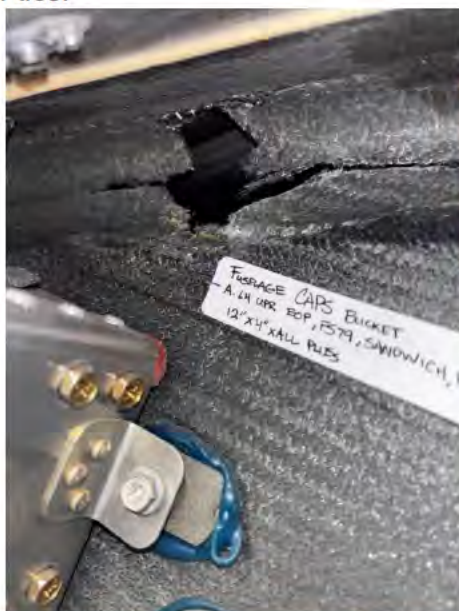
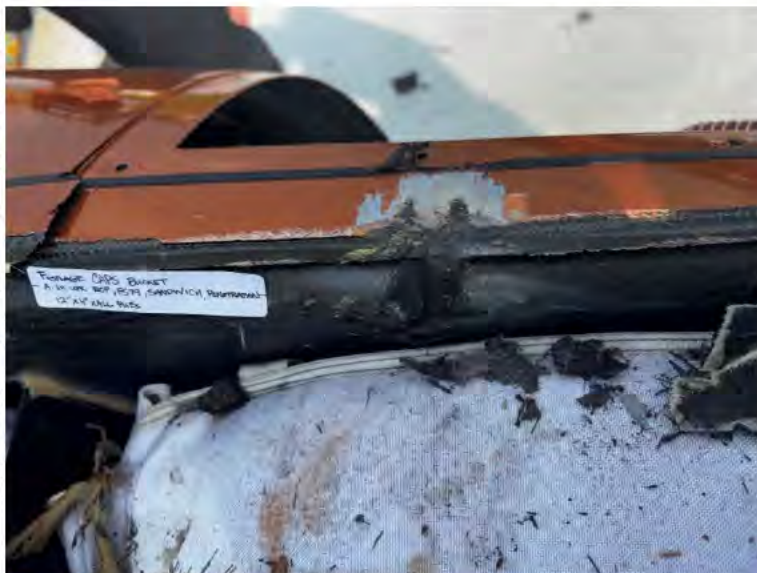
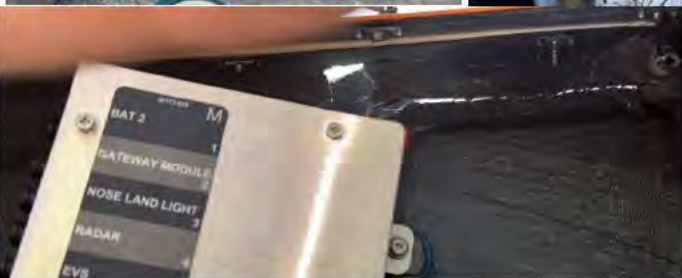
1. Fuselage - CAPS Bucket, LH UPR EOP, FS79 / Sandwich Structure - Laminate Only - Penetrating - Fracture / 12" x 4", All Plies.

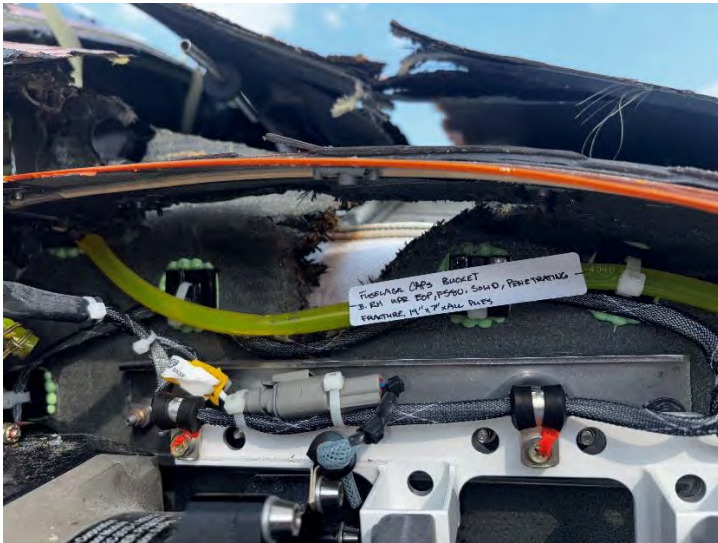
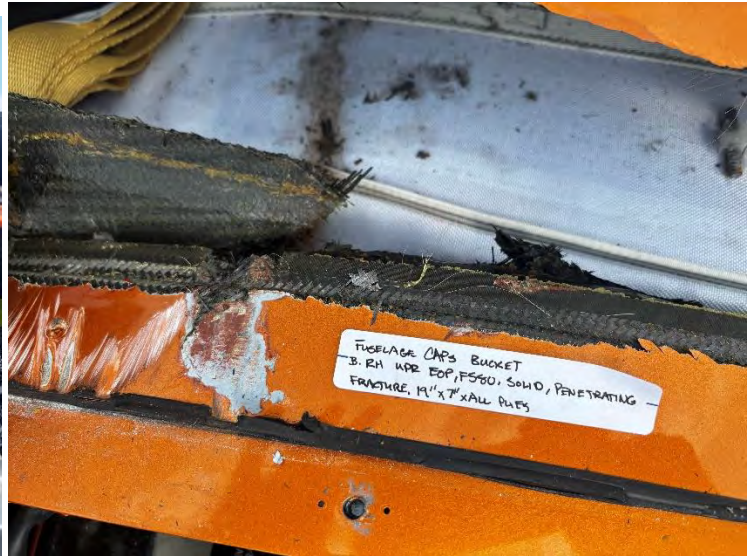
2. Fuselage - CAPS Bucket, RH UPR EOP, FS80 / Sandwich Structure - Laminate Only - Penetrating - Fracture / 19" x 7", All Plies.

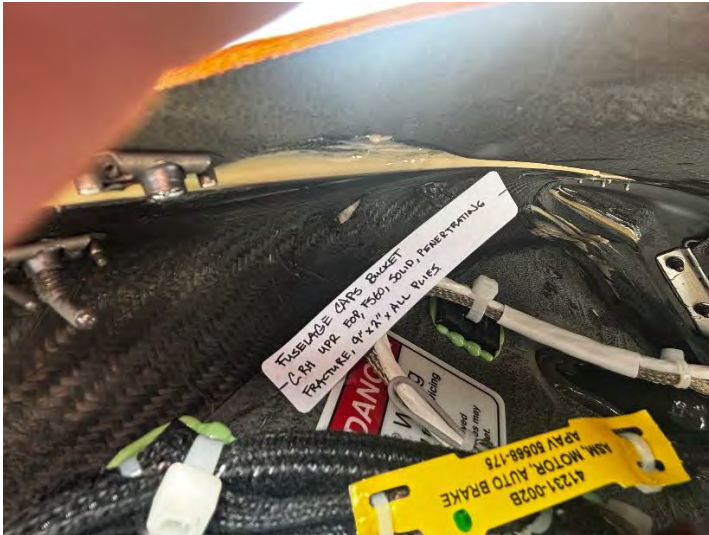
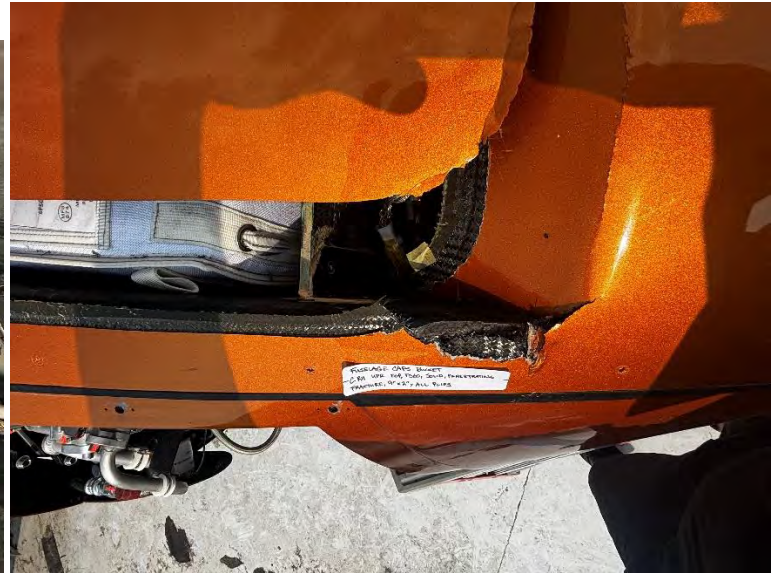
3. Fuselage - CAPS Bucket, RH UPR EOP, FS60 / Sandwich Structure - Laminate Only - Penetrating - Fracture / 9" x 2", All Plies.

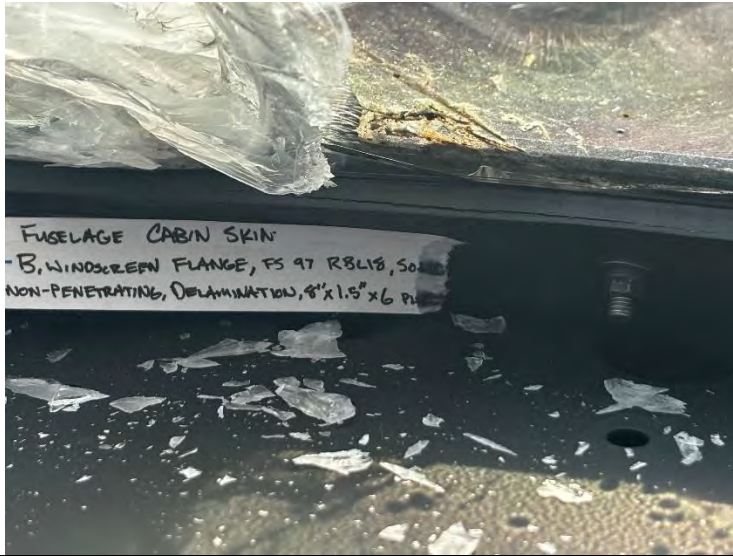
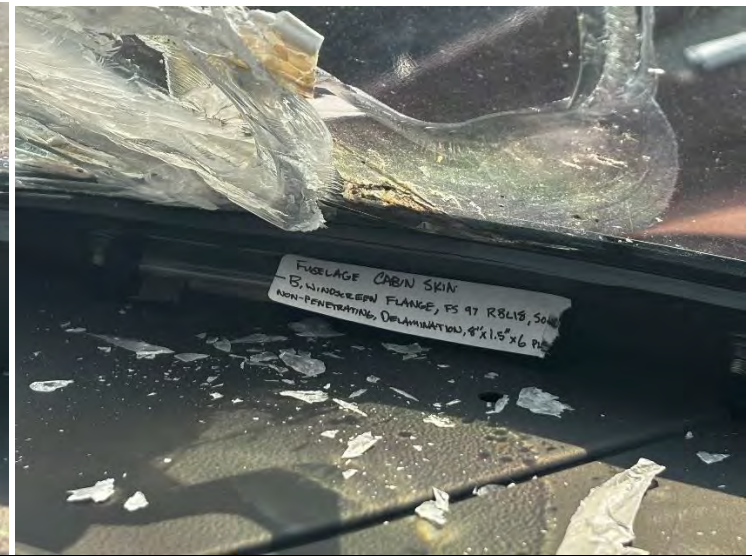
5. Fuselage - Cabin Skin, Windscreen Flange, FS97 RBL18 / Solid Laminate - Non-Penetrating - Delamination / 8" x 1.5", 6 Plies.

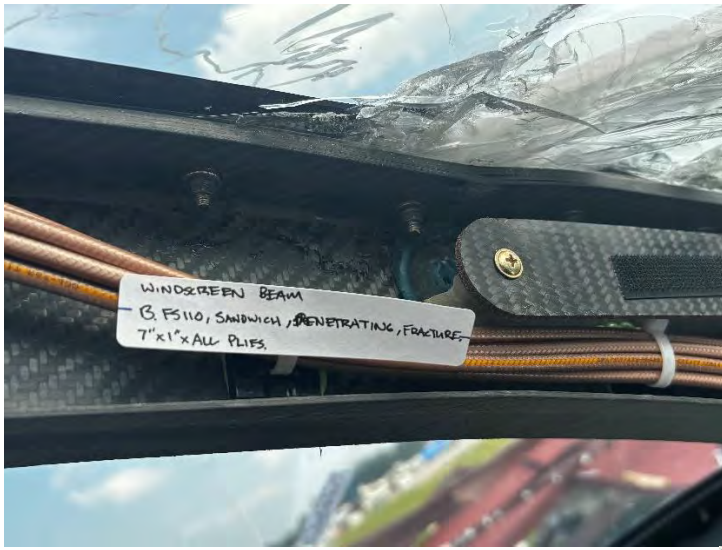
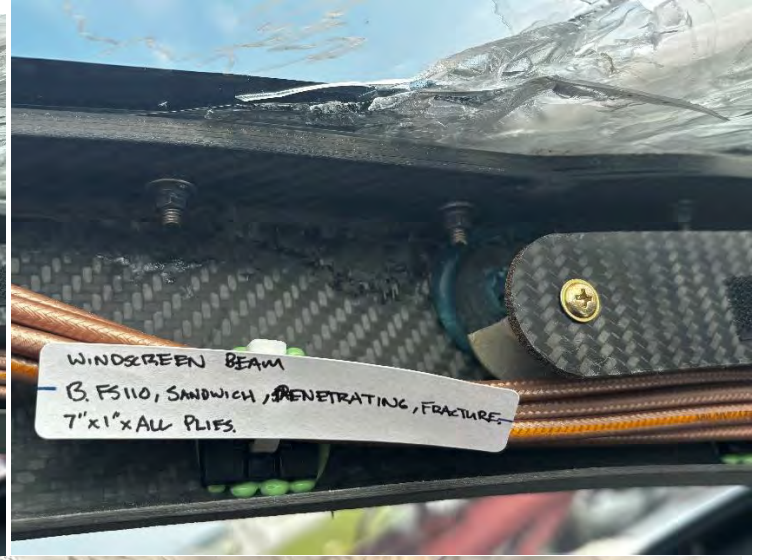
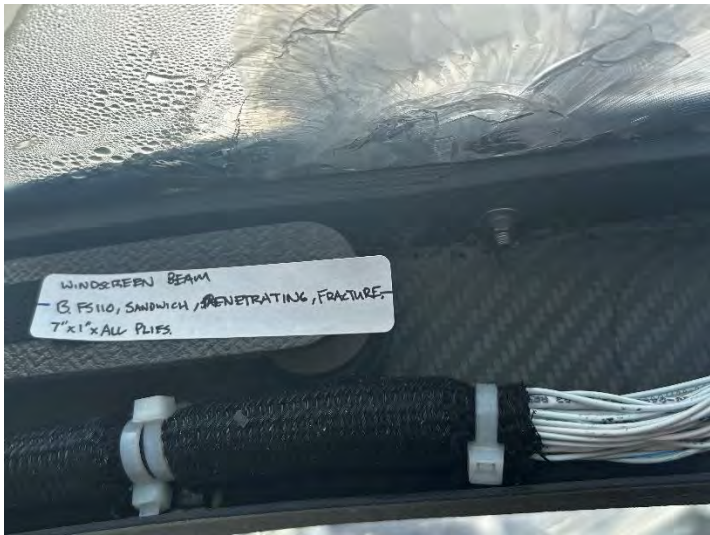
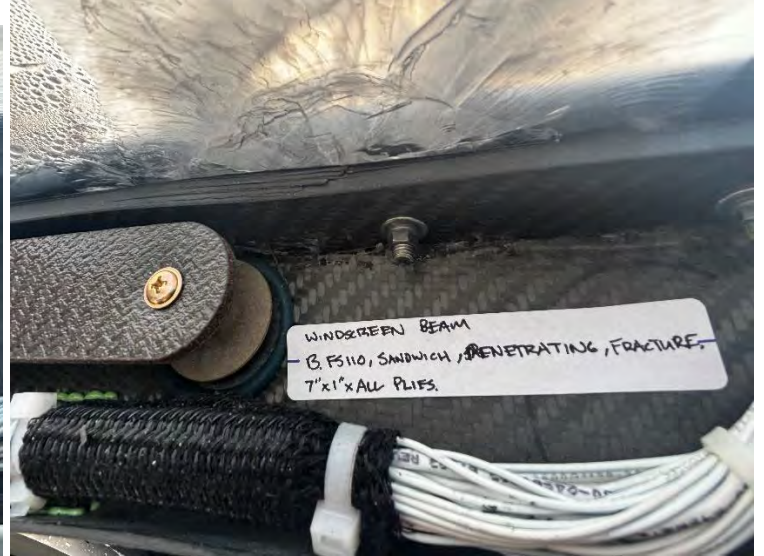
7. Fuselage - Windscreen Beam, FS110 / Sandwich Structure - Laminate Only - Penetrating - Fracture / 7" x 1", All Plies.

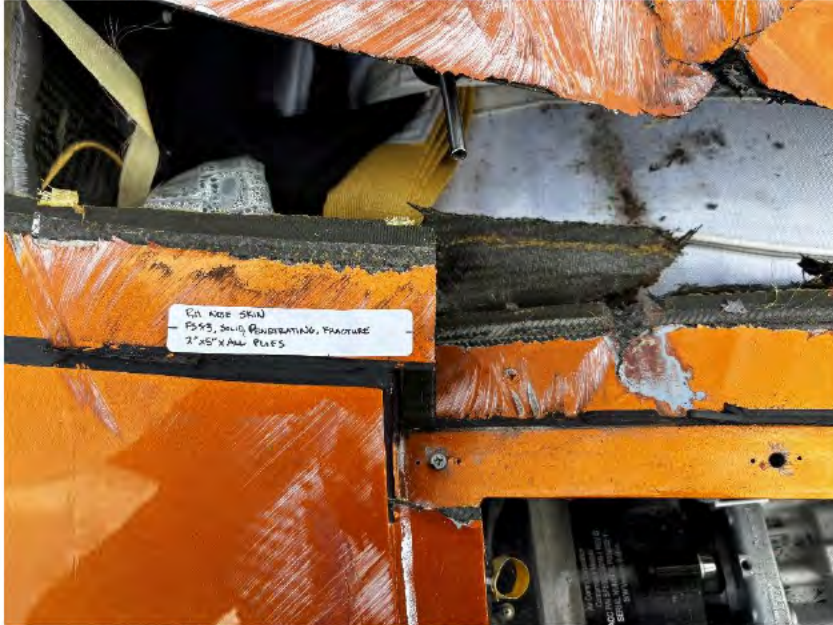
8. Fuselage - RH Nose Skin, FS38 / Solid Laminate - Penetrating - Fracture / 2" x 5", All Plies.

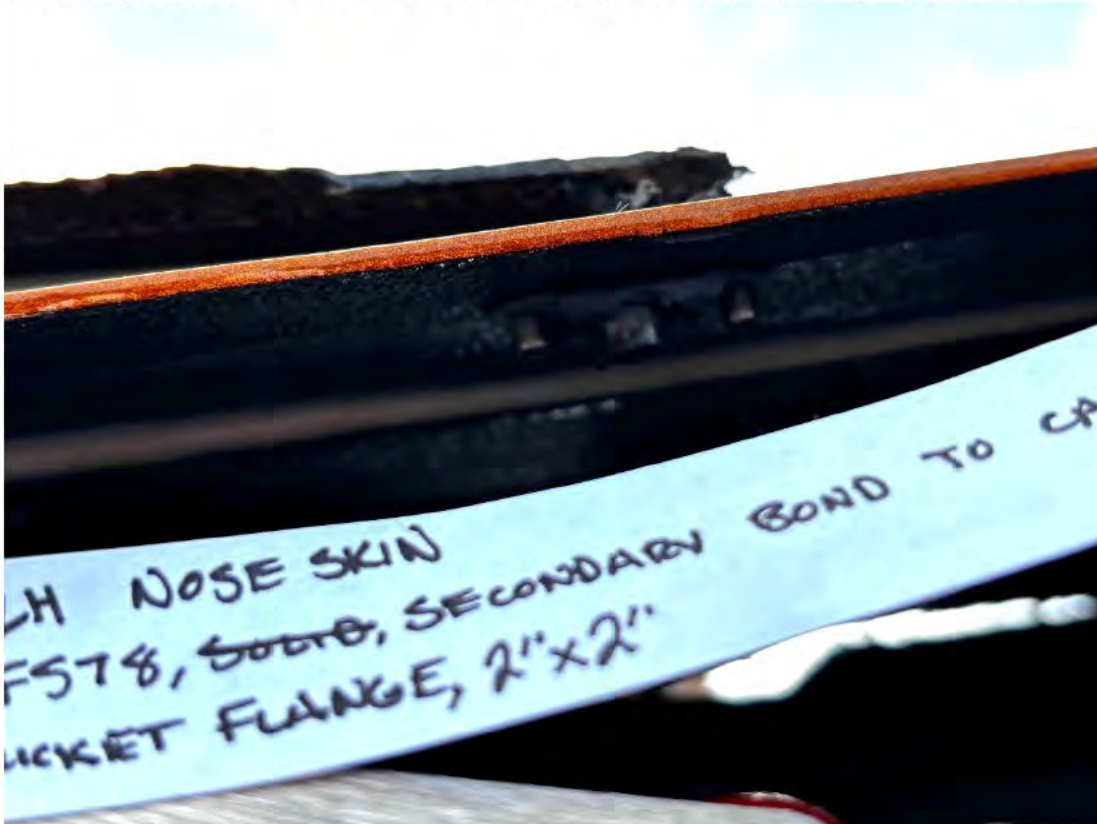
9. Fuselage - LH Nose Skin to CAPS Bucket Flange, FS78 / Secondary Bond / 2" x 2".

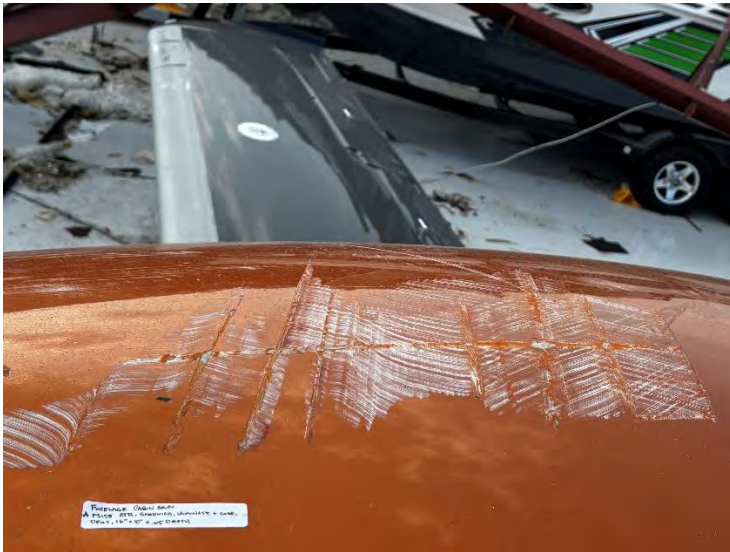
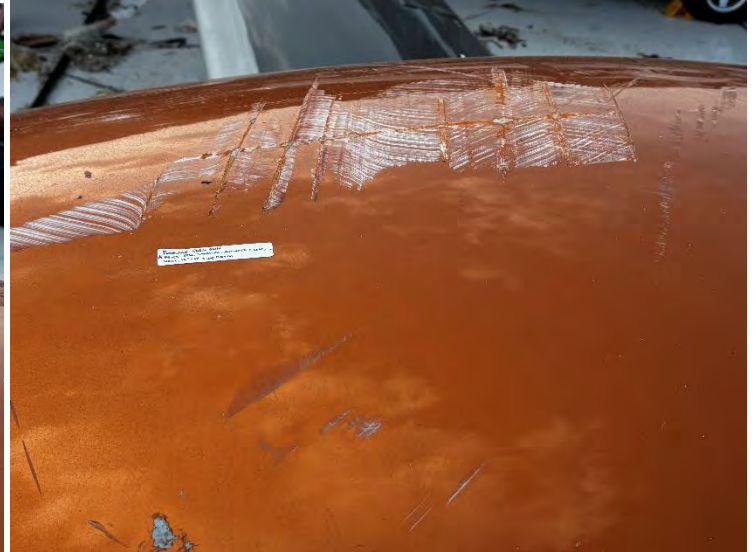
10. Fuselage - Cabin Skin, FS155, Toolside / Sandwich Structure - Laminate and Core / 16" x 10" x .05", Core Compression.

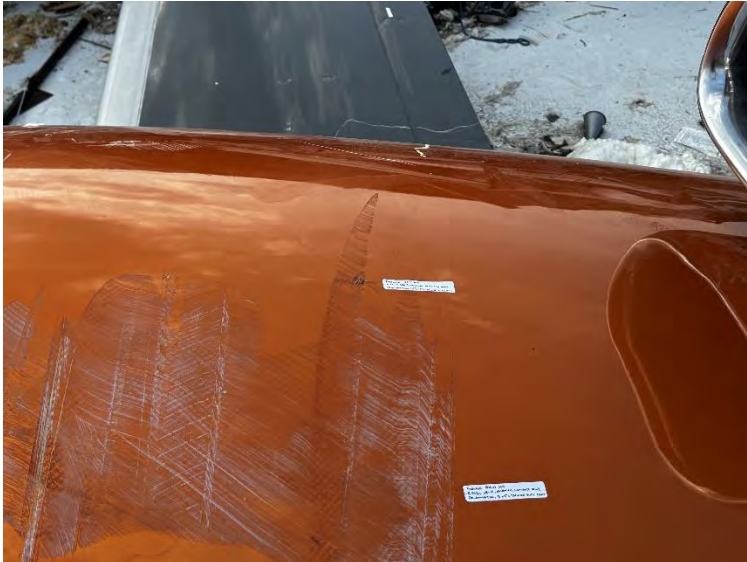
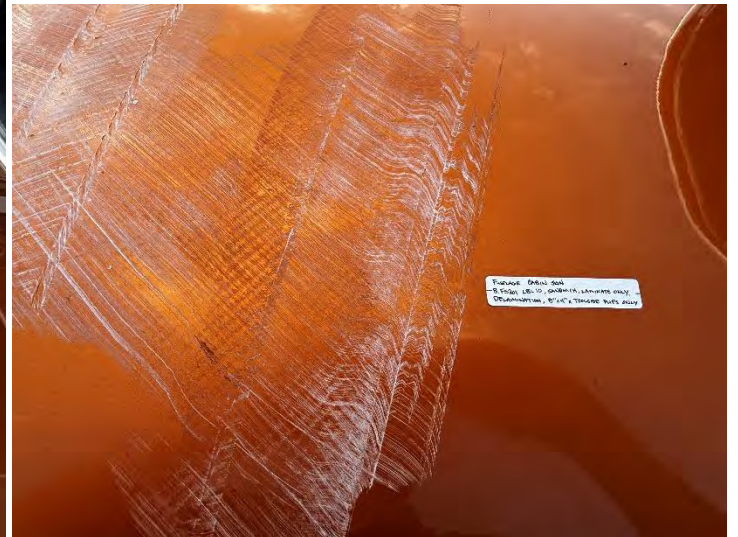
11. Fuselage - Cabin Skin, FS201 LBL10, Toolside / Sandwich Structure - Laminate Only - Non-Penetrating - Delamination / 8" x 4", Toolside Plies Only.

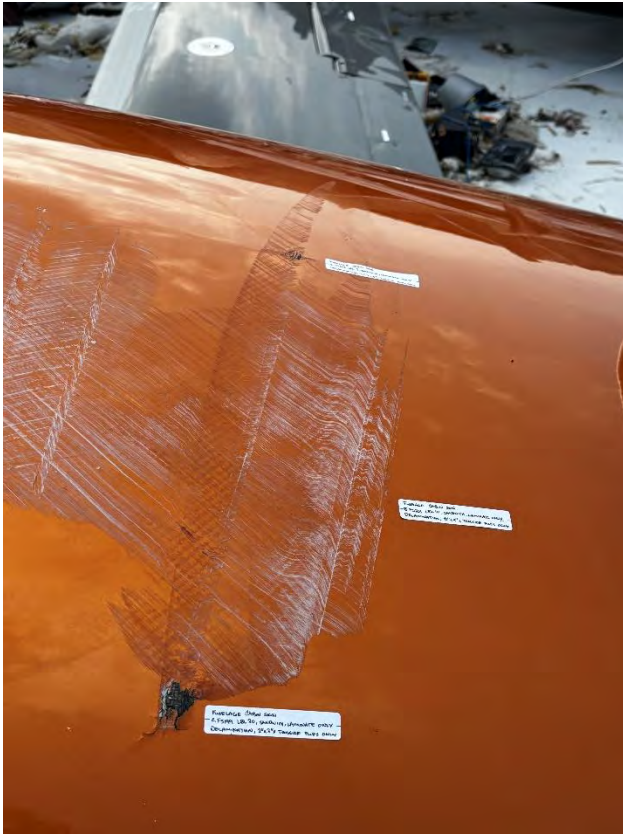
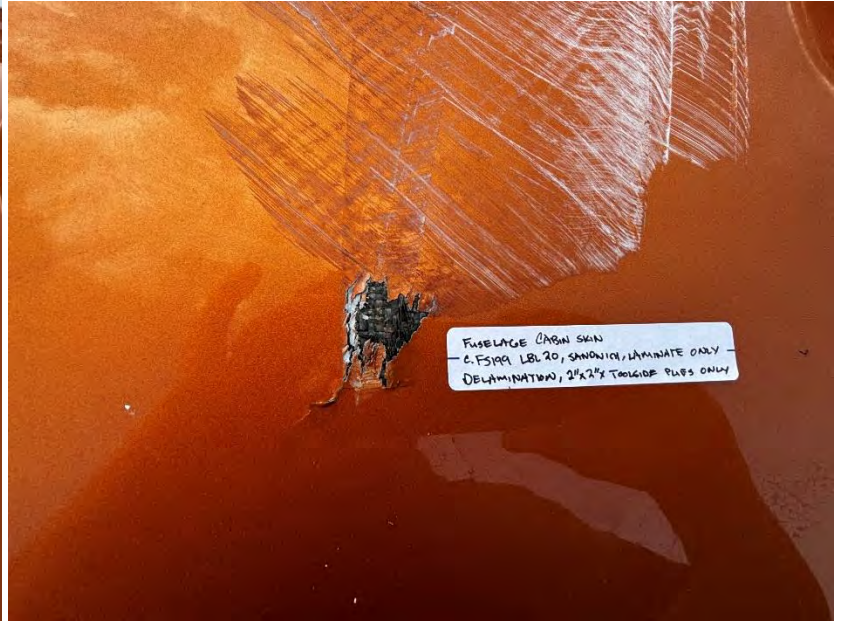
12. Fuselage - Cabin Skin, FS199 LBL20, Toolside / Sandwich Structure - Laminate Only - Non-Penetrating - Delamination / 2" x 2", Toolside Plies Only.

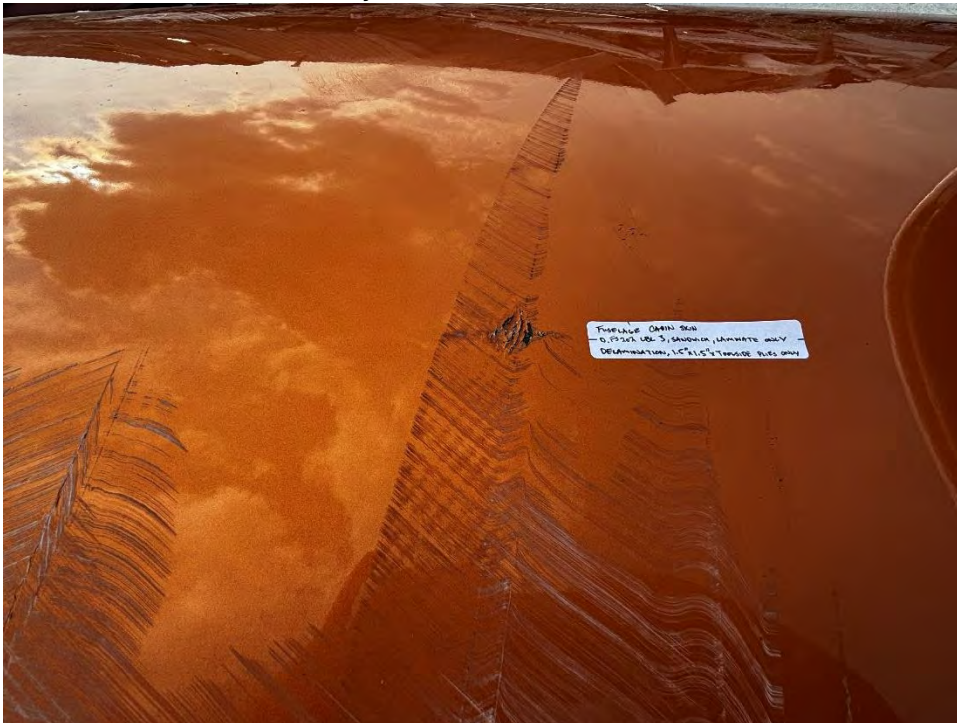
13. Fuselage - Cabin Skin, FS202 LBL3, Toolside / Sandwich Structure - Laminate Only - Non-Penetrating - Delamination / 1.5" x 1.5", Toolside Plies Only.

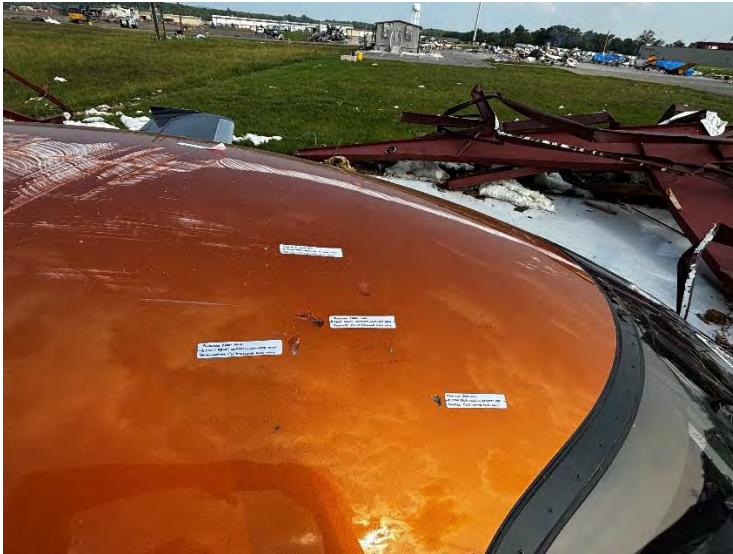
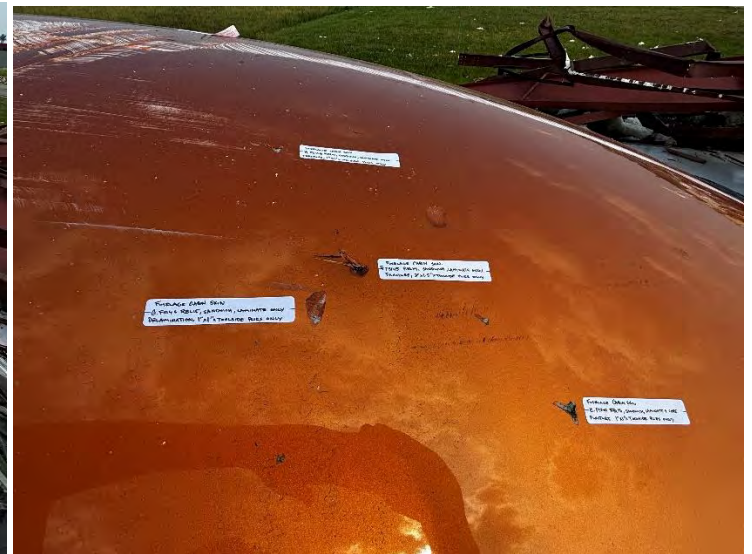
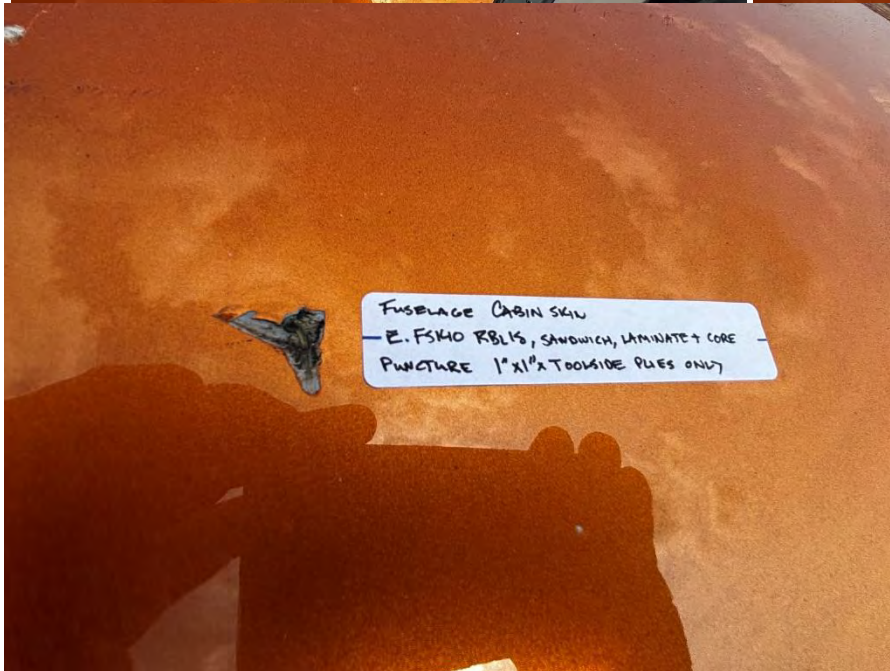
14. Fuselage - Cabin Skin, FS140 RBL18, Toolside / Sandwich Structure - Laminate Only - Non-Penetrating - Gouge / 1" x 1", Toolside Plies Only.

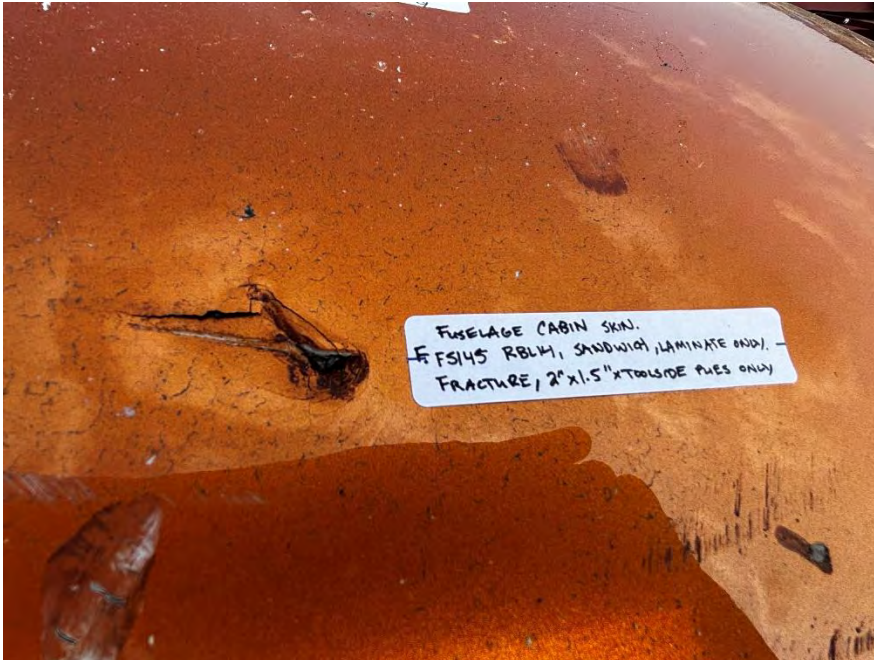
15. Fuselage - Cabin Skin, FS145 RBL14, Toolside / Sandwich Structure - Laminate Only - Non-Penetrating - Gouge / 2" x 1.5", Toolside Plies Only.

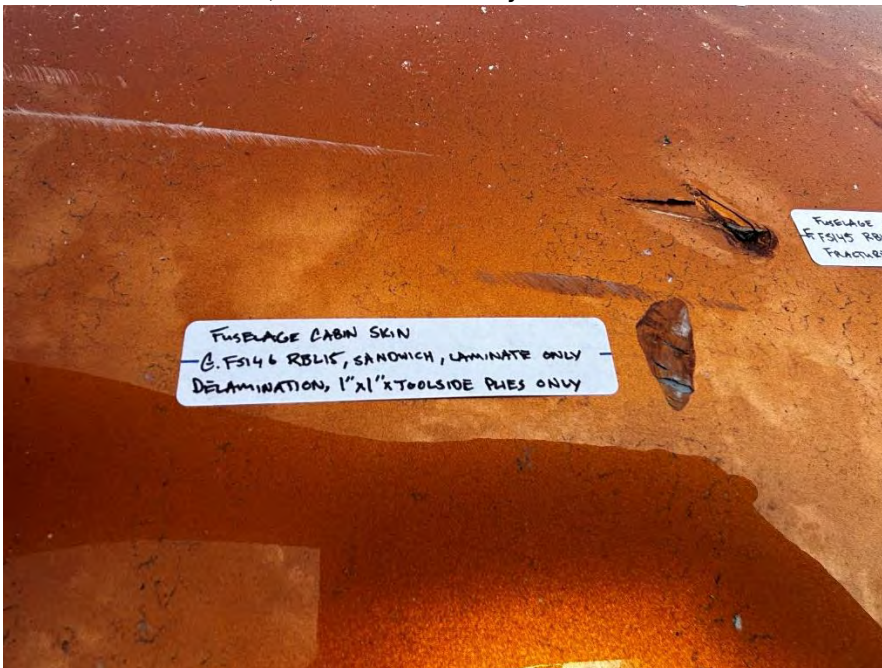
16. Fuselage - Cabin Skin, FS146 RBL15, Toolside / Sandwich Structure - Laminate Only - Non-Penetrating - Delamination / 1" x 1", Toolside Plies Only.

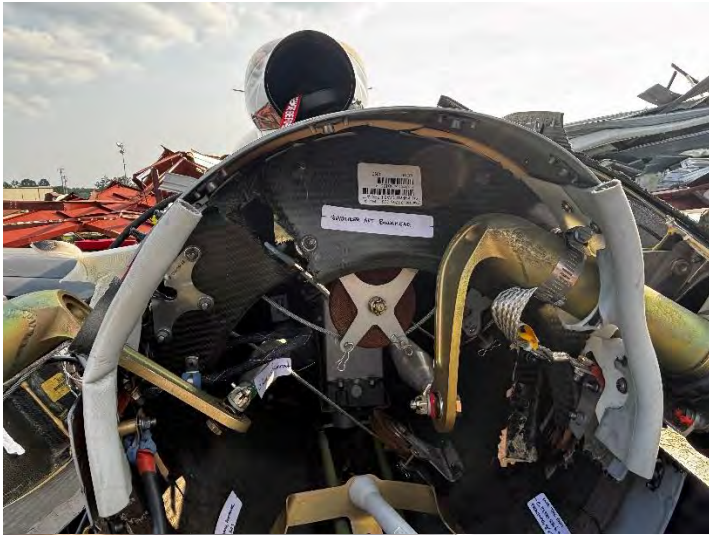
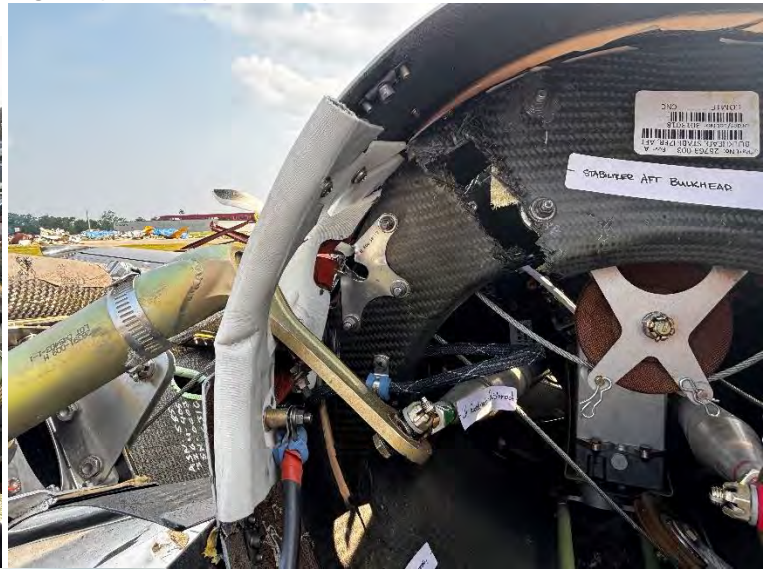
26. Fuselage - Stabilizer Aft Bulkhead / Component - Damage Beyond Repair

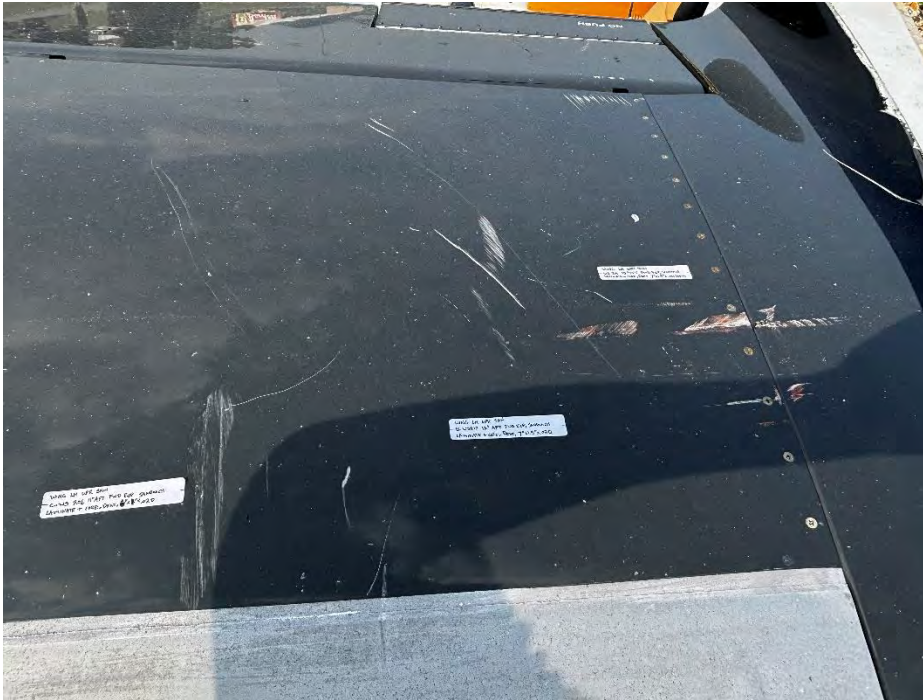
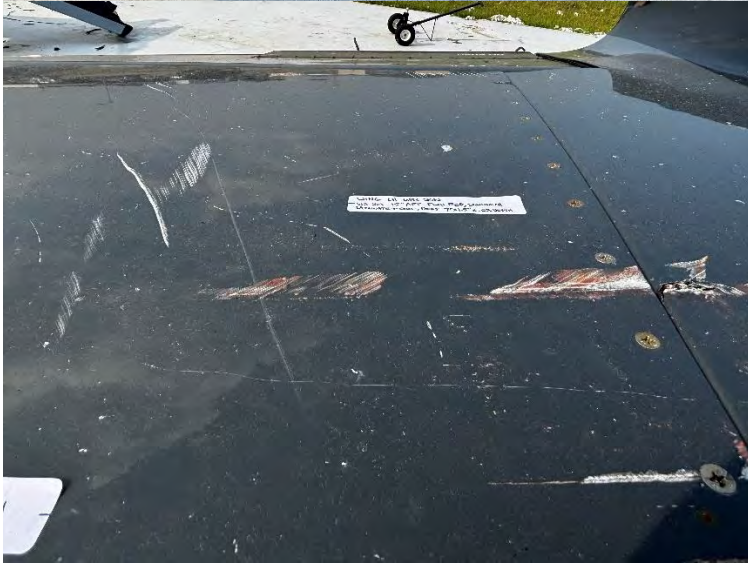
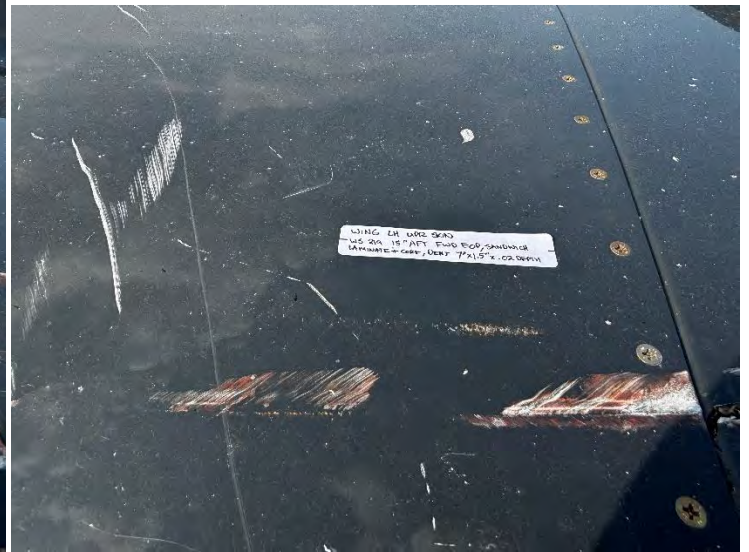
27. Wing - LH UPR Wing Skin, WS219, 15" Aft of FEOP, Toolside / Sandwich Structure - Laminate and Core / 7" x 1.5" x .02"D, Core Compression.

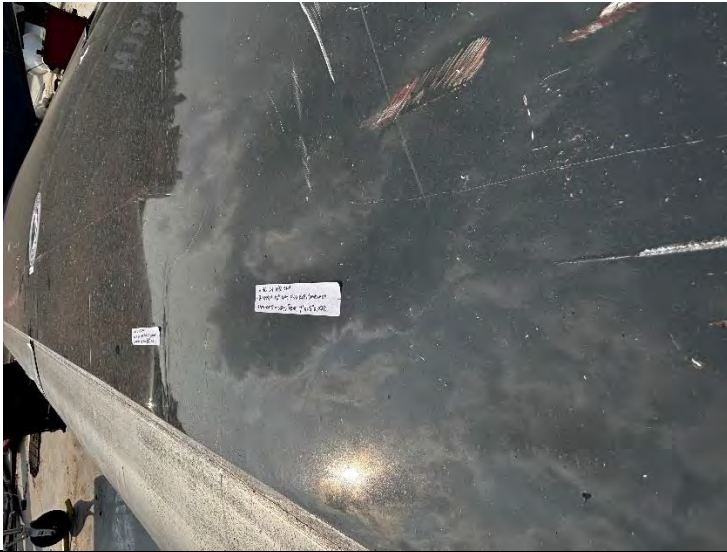
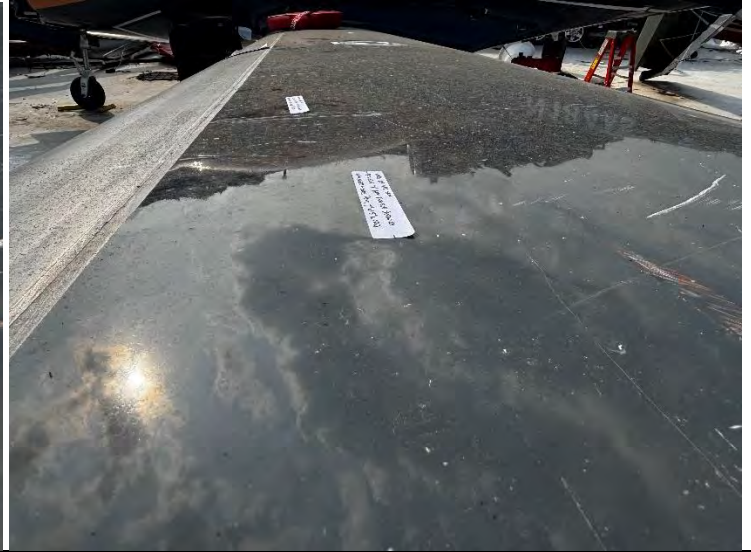
28. Wing - LH UPR Wing Skin, WS217 12" Aft of FEOP, Toolside / Sandwich Structure - Laminate and Core / 7" x 1" x .02"D, Core Compression.

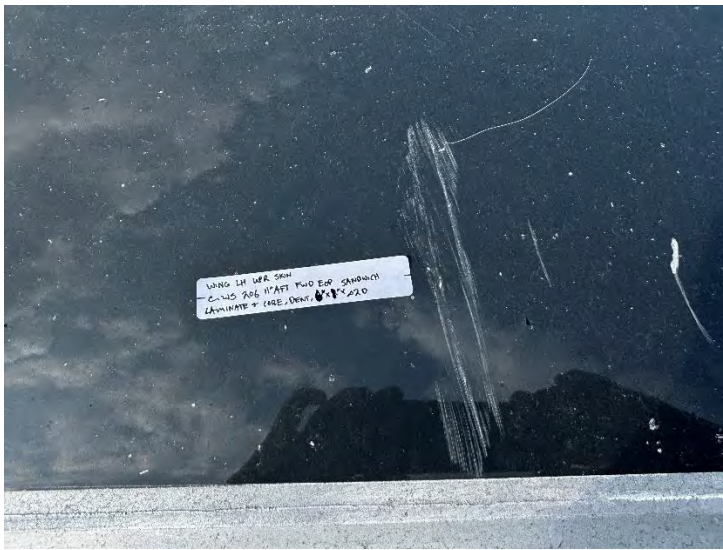
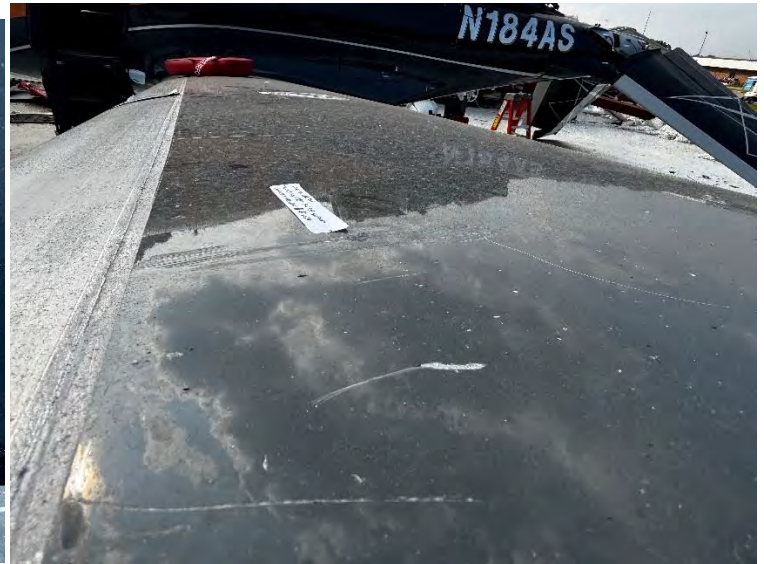
29. Wing - LH UPR Wing Skin, WS206, 11" Aft of FEOP, Toolside / Sandwich Structure - Laminate and Core / 6" x 1" x .02"D, Core Compression.

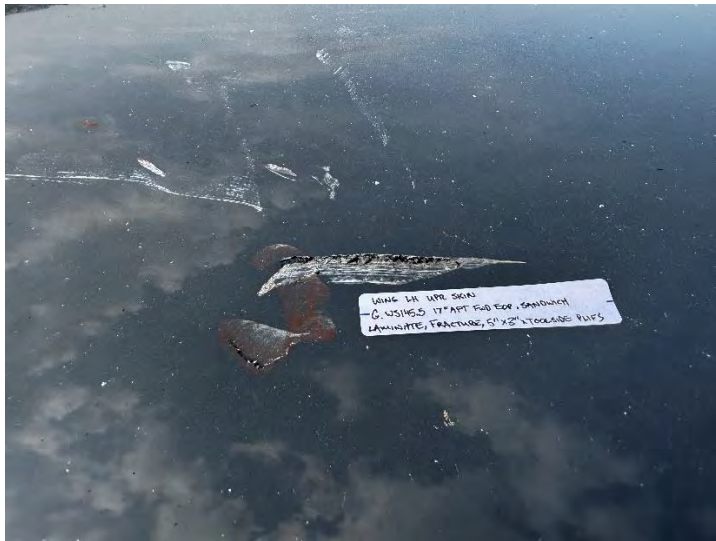
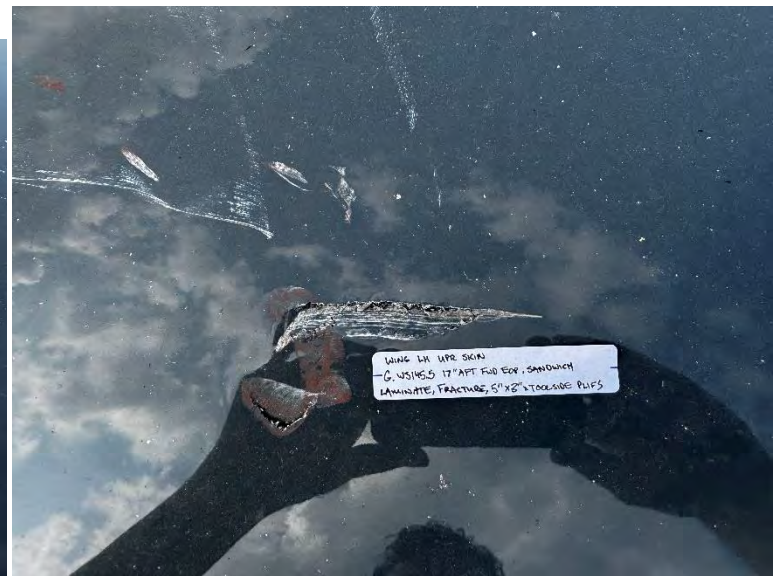
33. Wing - LH UPR Wing Skin, WS145.5 17" Aft of LEOP, Toolside / Sandwich Structure - Laminate Only - Penetrating - Fracture / 5" x 3", Toolside Plies Only.

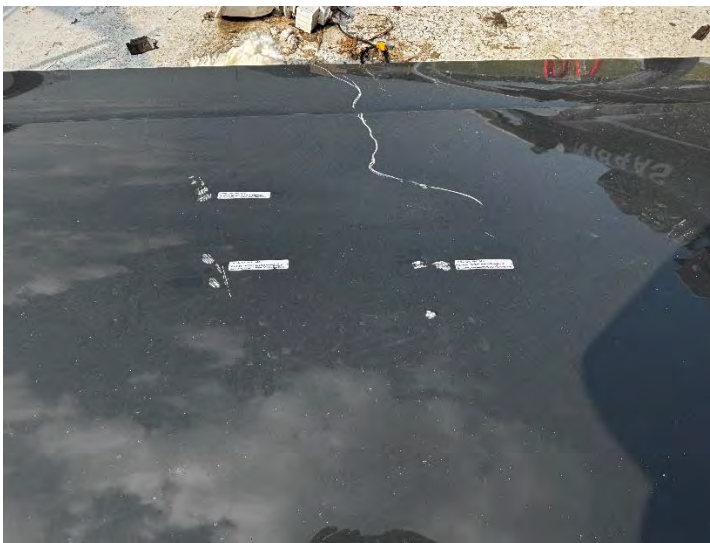
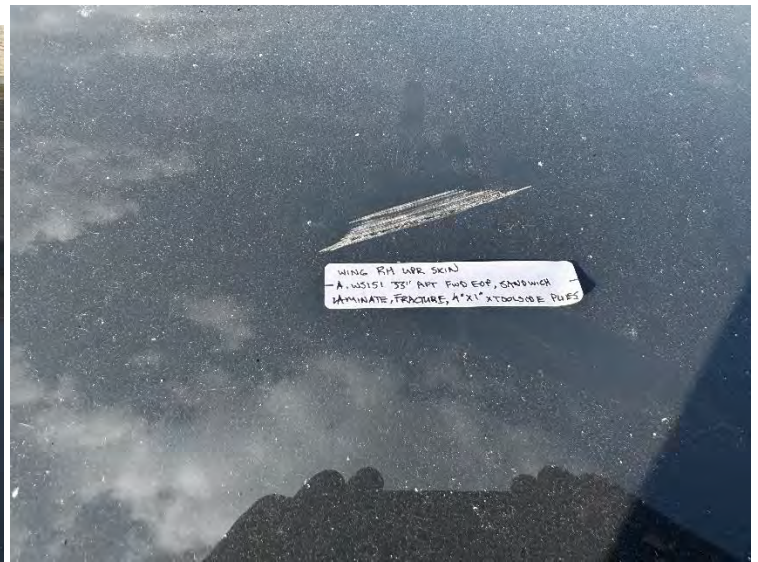
35. Wing - RH UPR Wing Skin, WS151 33" Aft of LEOP, Toolside / Sandwich Structure - Laminate Only - Penetrating - Fracture / 4" x 1", Toolside Plies Only.

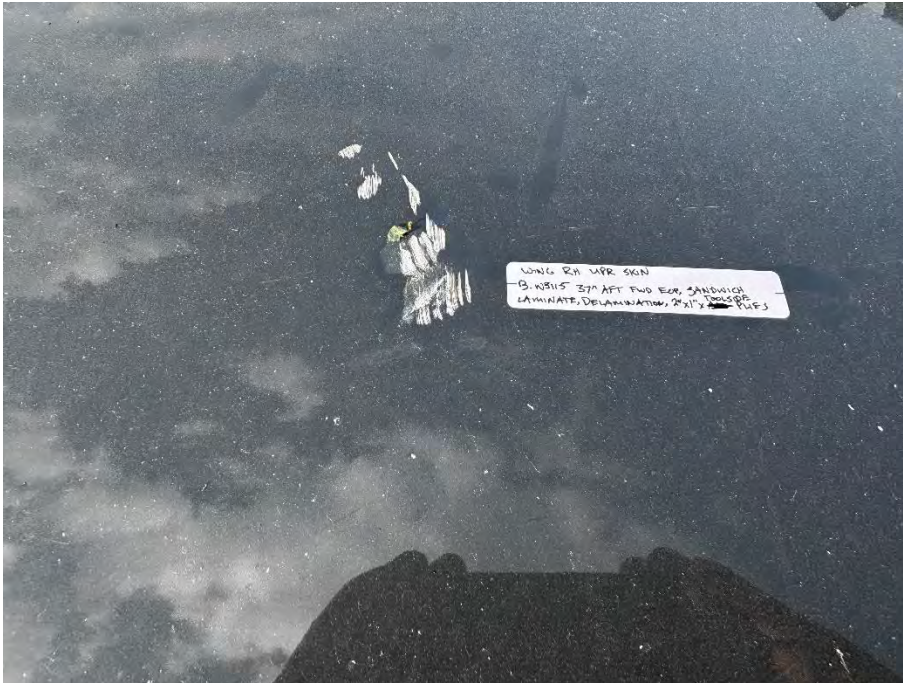
36. Wing - RH UPR Wing Skin, WS115 37" Aft of LEOP, Toolside / Sandwich Structure - Laminate Only - Non-Penetrating - Delamination / 2" x 1", Toolside Plies Only.

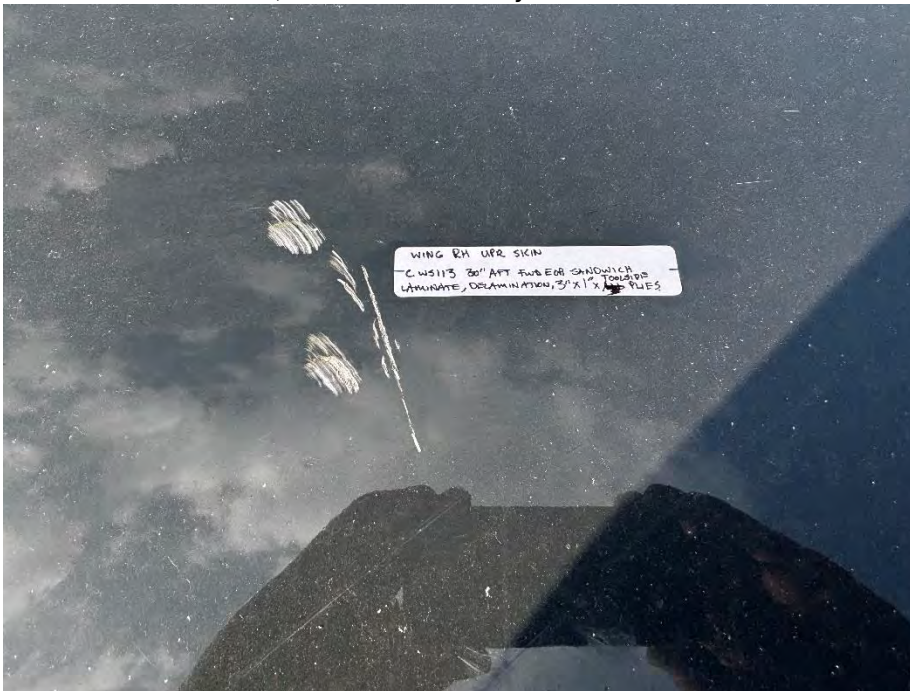
37. Wing - RH UPR Wing Skin, WS113 30" Aft of LEOP, Toolside / Sandwich Structure - Laminate Only - Non-Penetrating - Delamination / 3" x 1", Toolside Plies Only.

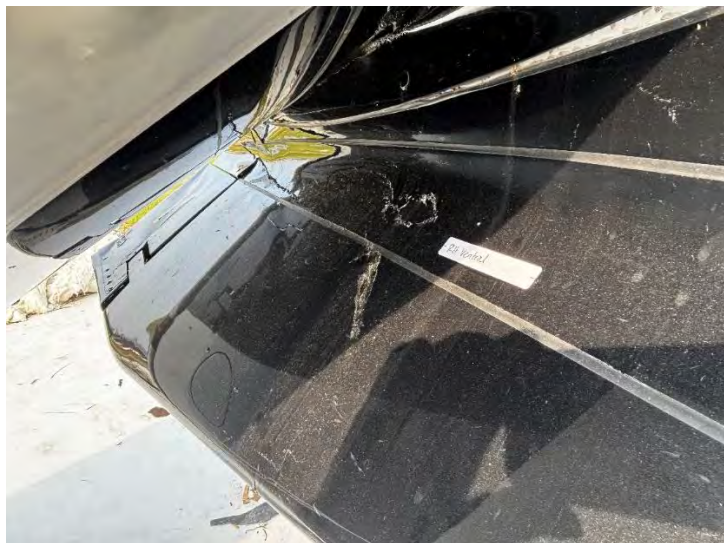
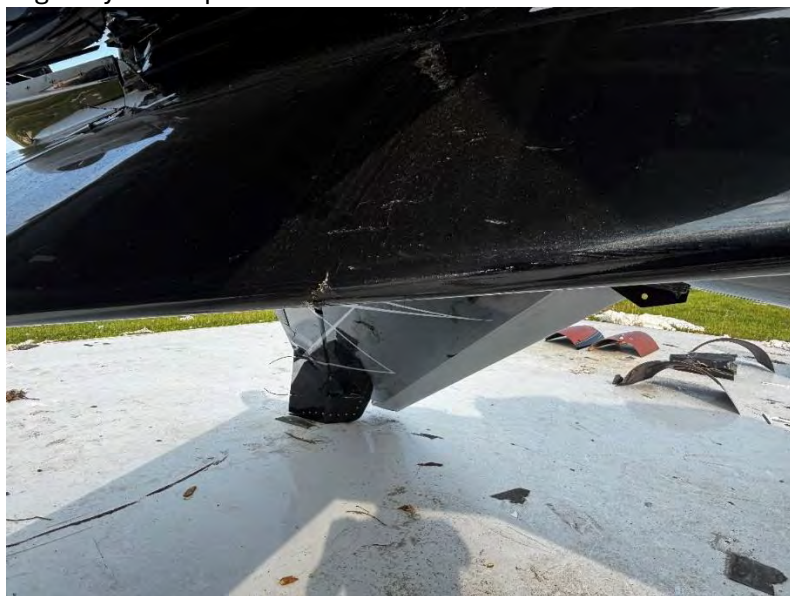
50. Composite Detail Part - RH Ventral / Component - Damage Beyond Repair

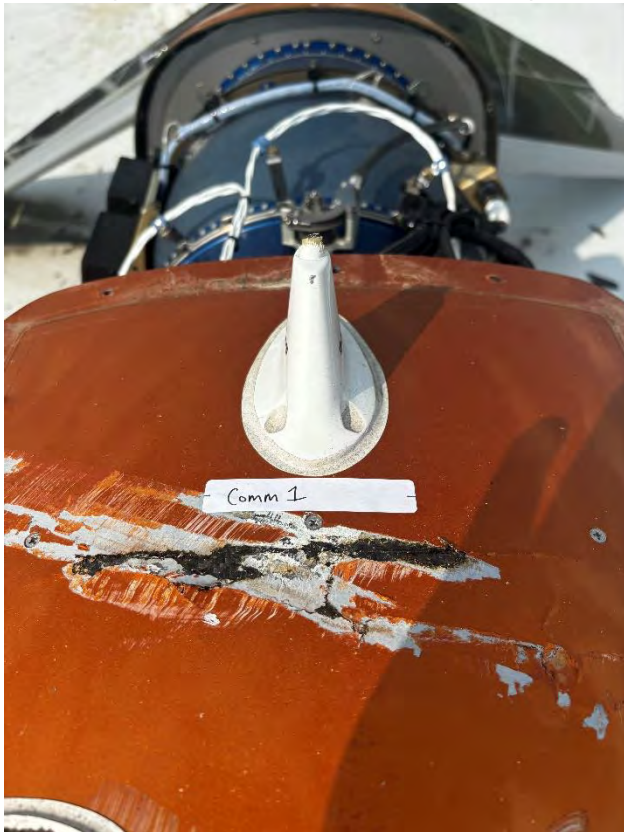
53. Component - Comm 1 Antenna / Component - Damage Beyond Repair

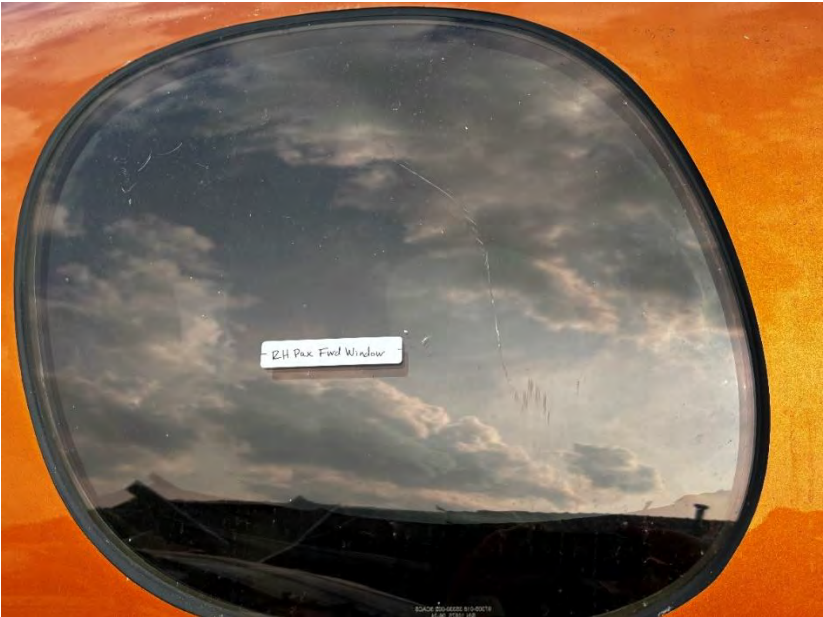
63. Component - RH Pax Fwd Window / Component - Damage Beyond Repair

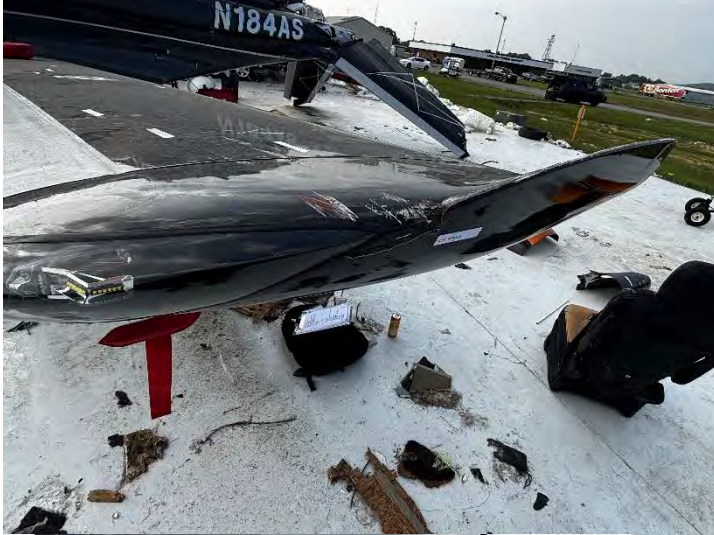
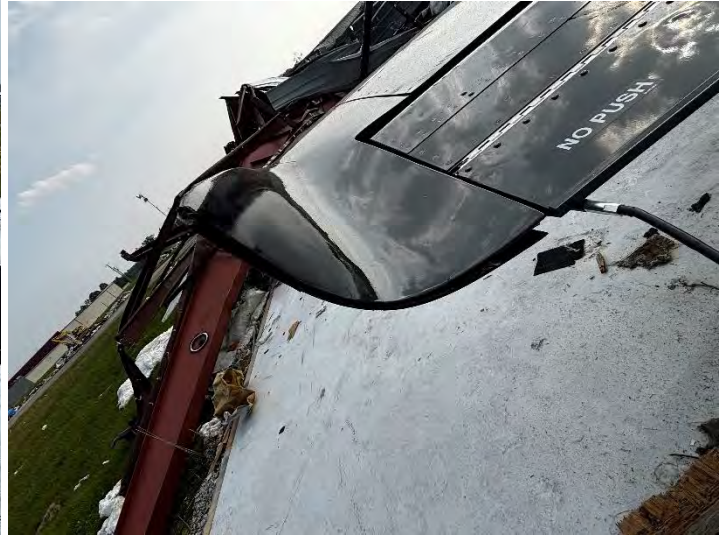
68. Composite Detail Part- LH Wingtip / Component - Damage Beyond Repair
