AIRCRAFT DAMAGE ASSESSMENT REPORT

Model:	SF50	Registration:	N184AS	Serial:	0585	Hobbs:	114.1	Flight Hours:	95.4
Location:	KLOZ London, KY			A/C Operator:					
Work Order #:	DLH23637-06-2025			Date of Damage:	5/16/2025				
Cirrus Case #:	00449020			Report Completed:	6/9/2025				
Inspector:		Phone:		Email:					
DOM:		Phone:		Email:

Hangar Collapse Due to Tornado

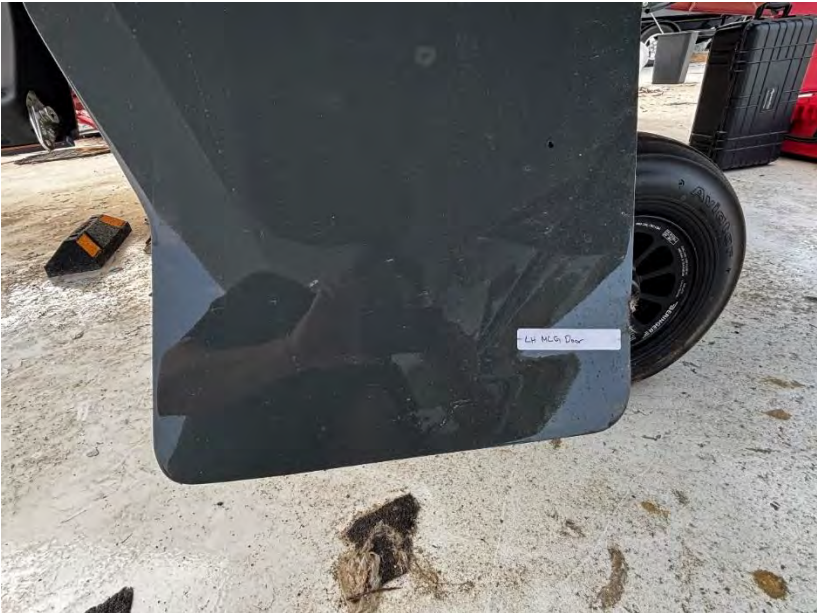
70. Composite Detail Part - LH MLG Door / Component - Damage Beyond Repair

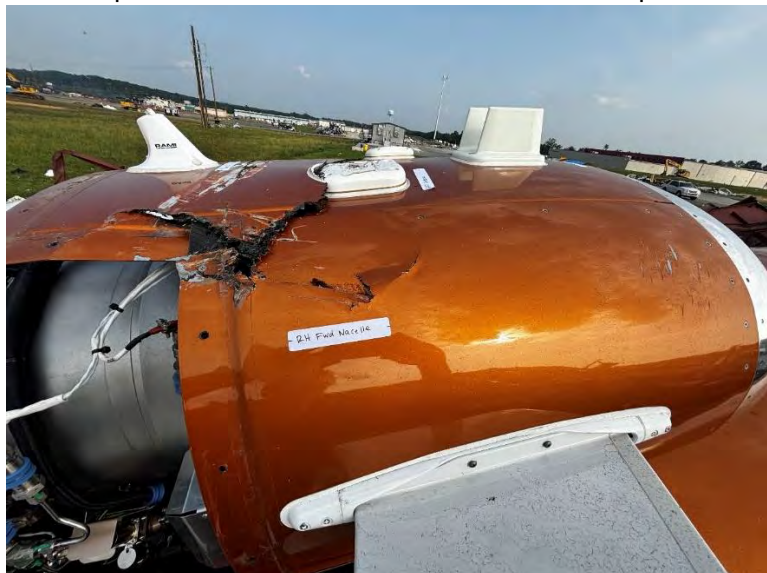
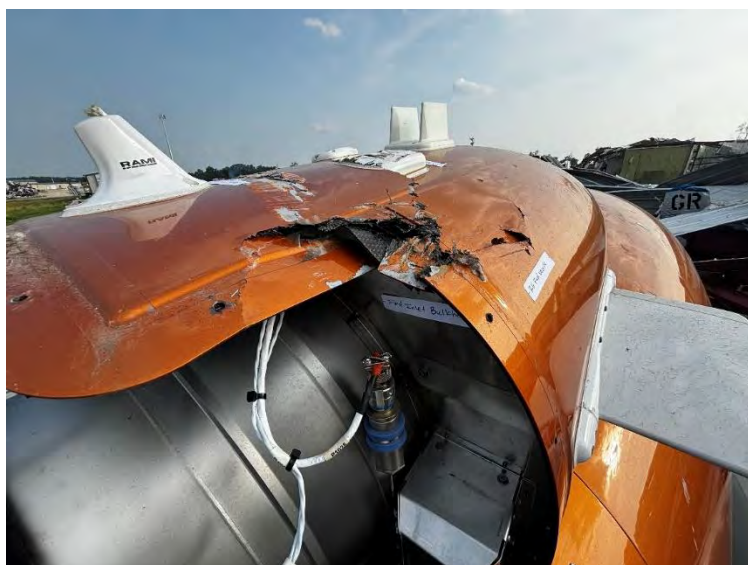
73. Composite Detail Part - RH Fwd Nacelle / Component - Damage Beyond Repair

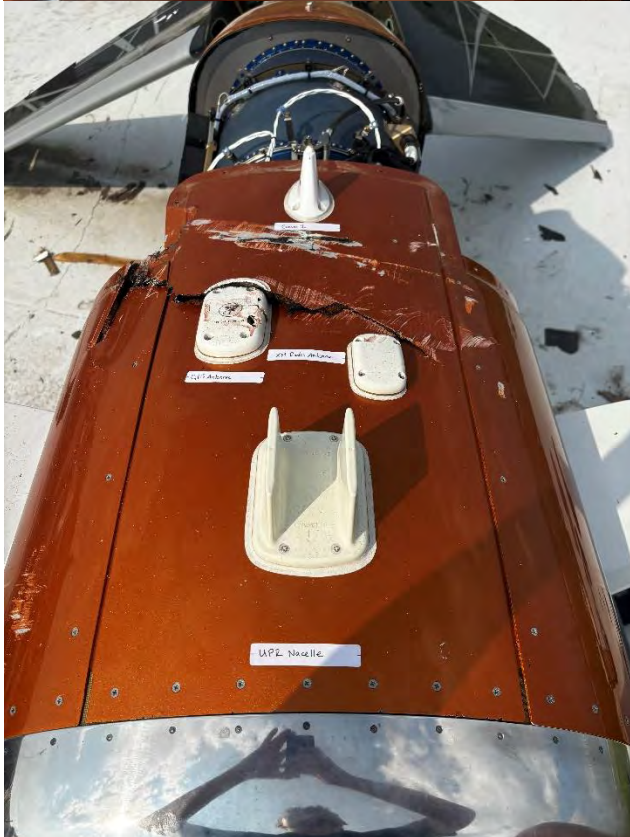
74. Composite Detail Part - UPR Nacelle / Component - Damage Beyond Repair

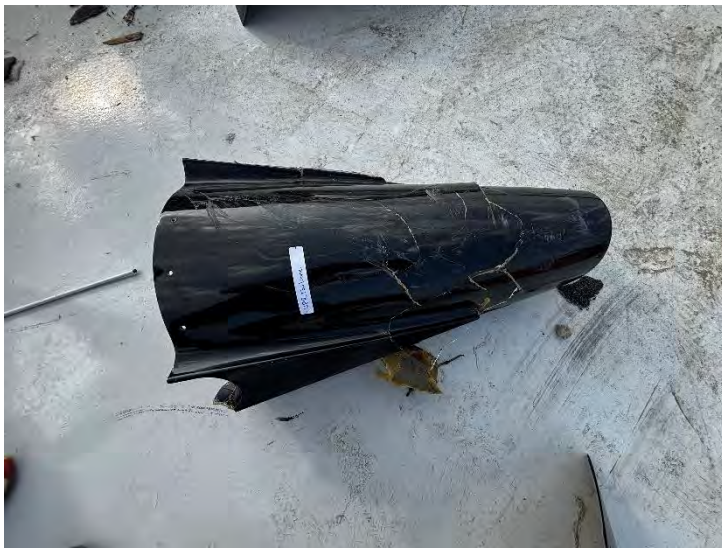
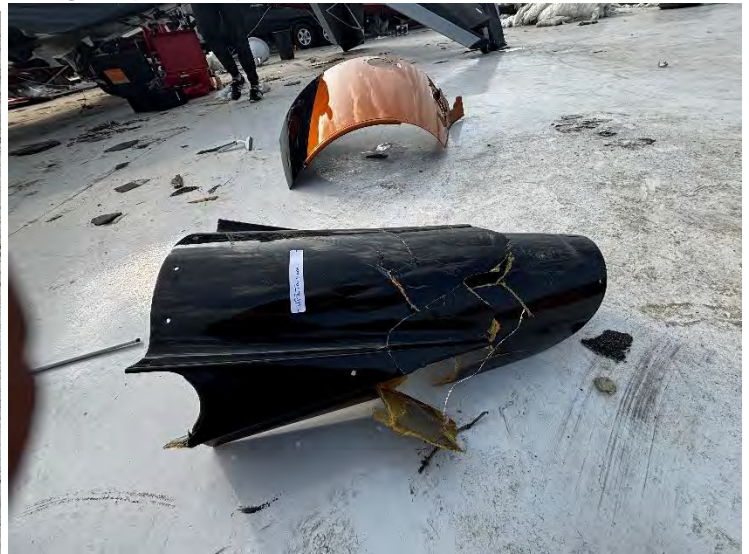
78. Composite Detail Part - UPR Tailcone / Component - Damage Beyond Repair

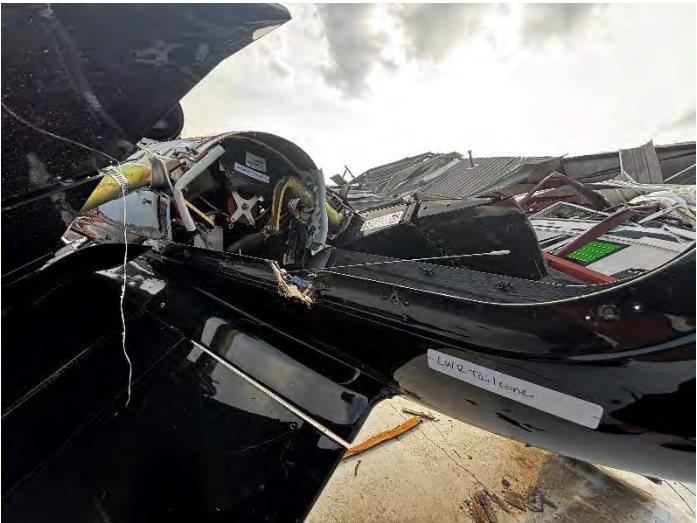
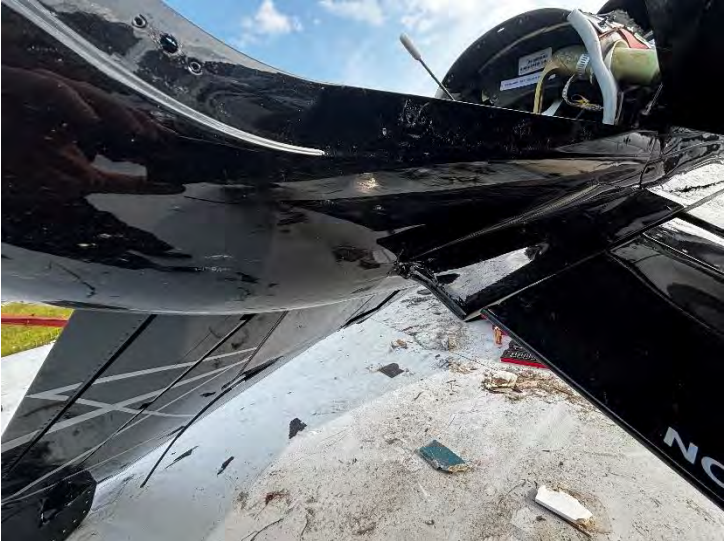
79. Composite Detail Part - LWR Tailcone / Component - Damage Beyond Repair

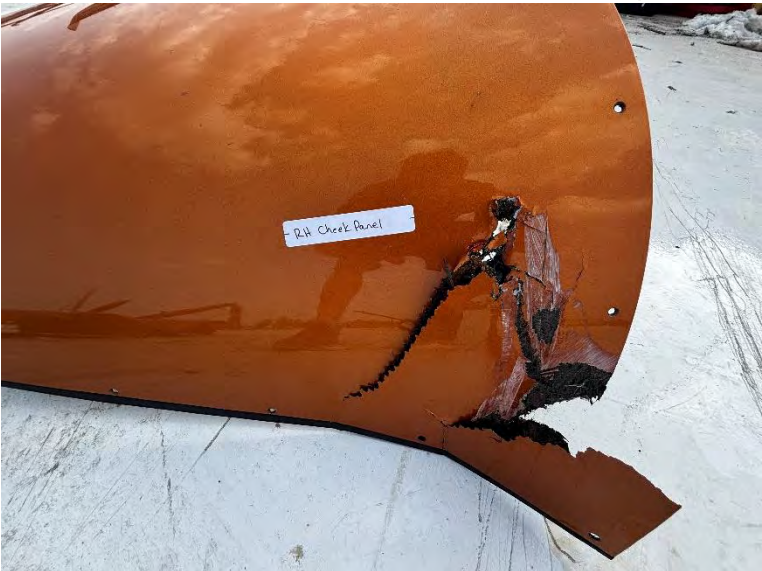
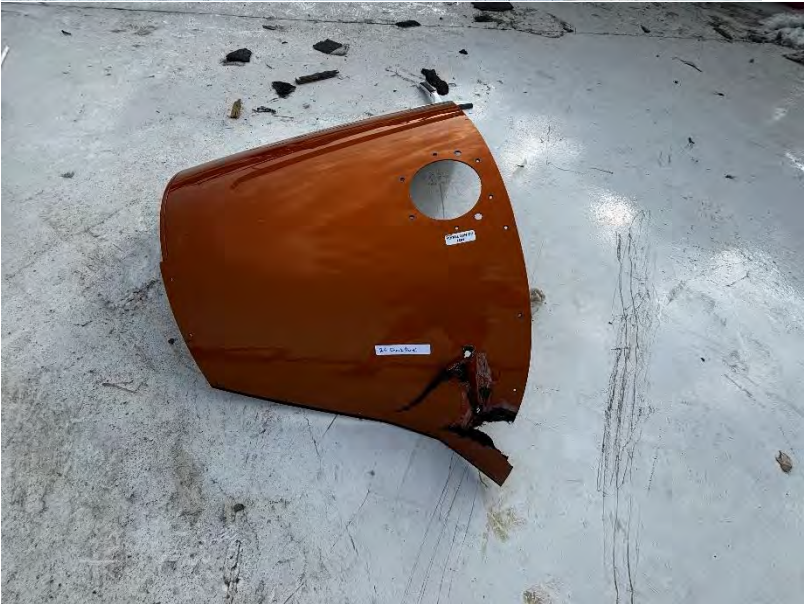
85. Composite Detail Part - RH Cheek Panel / Component - Damage Beyond Repair

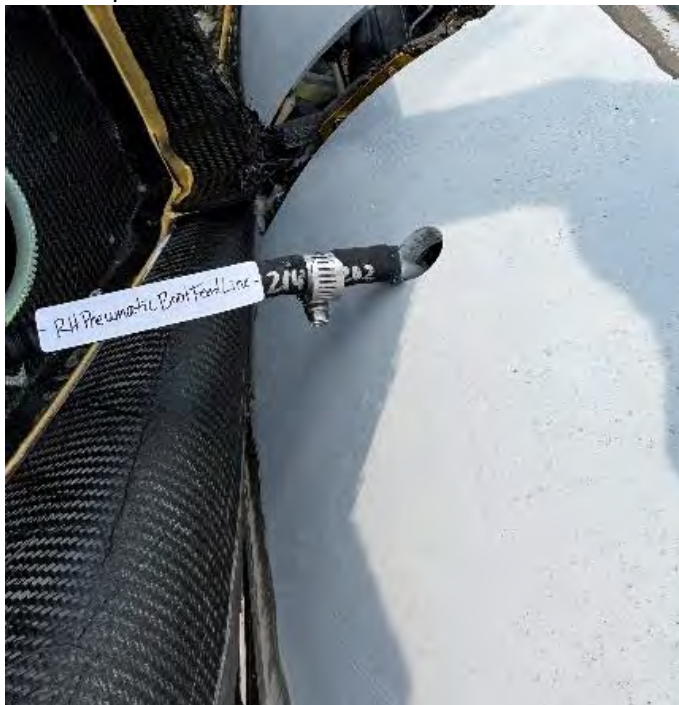
91. Component - RH Pneumatic Boot Feed Line / Component - Damage Beyond Repair
